# CERTIFICATE OF APPROPRIATENESS APPLICATION FORM

Address 1809 Summer St., Houston TX 77007  
Historic District / Landmark High First Ward HD HCAD # 00513 000 000 10  
Subdivision \_\_\_\_\_ Lot 10 + TR-11A Block 306

DENTLER BUILDING  
1809 SUMMER STREET

**EXTERIOR SHUTTERS**

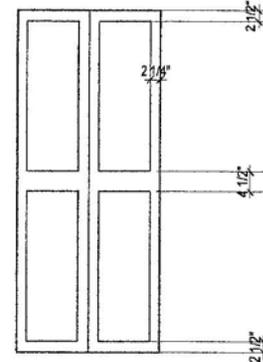
01 SHUTTER AT EAST WALL (2ND FLOOR)  
3/8" = 1'-0"

NOTE: SHUTTERS ARE PAINTED TREATED WOOD, PAINTED TO MATCH SURROUNDING TRIM.

- Wooden exterior shutters will be placed over the small window at the very rear.
- Wooden exterior shutters will be placed on the rearmost window of the double window nearest to the small window at the rear.

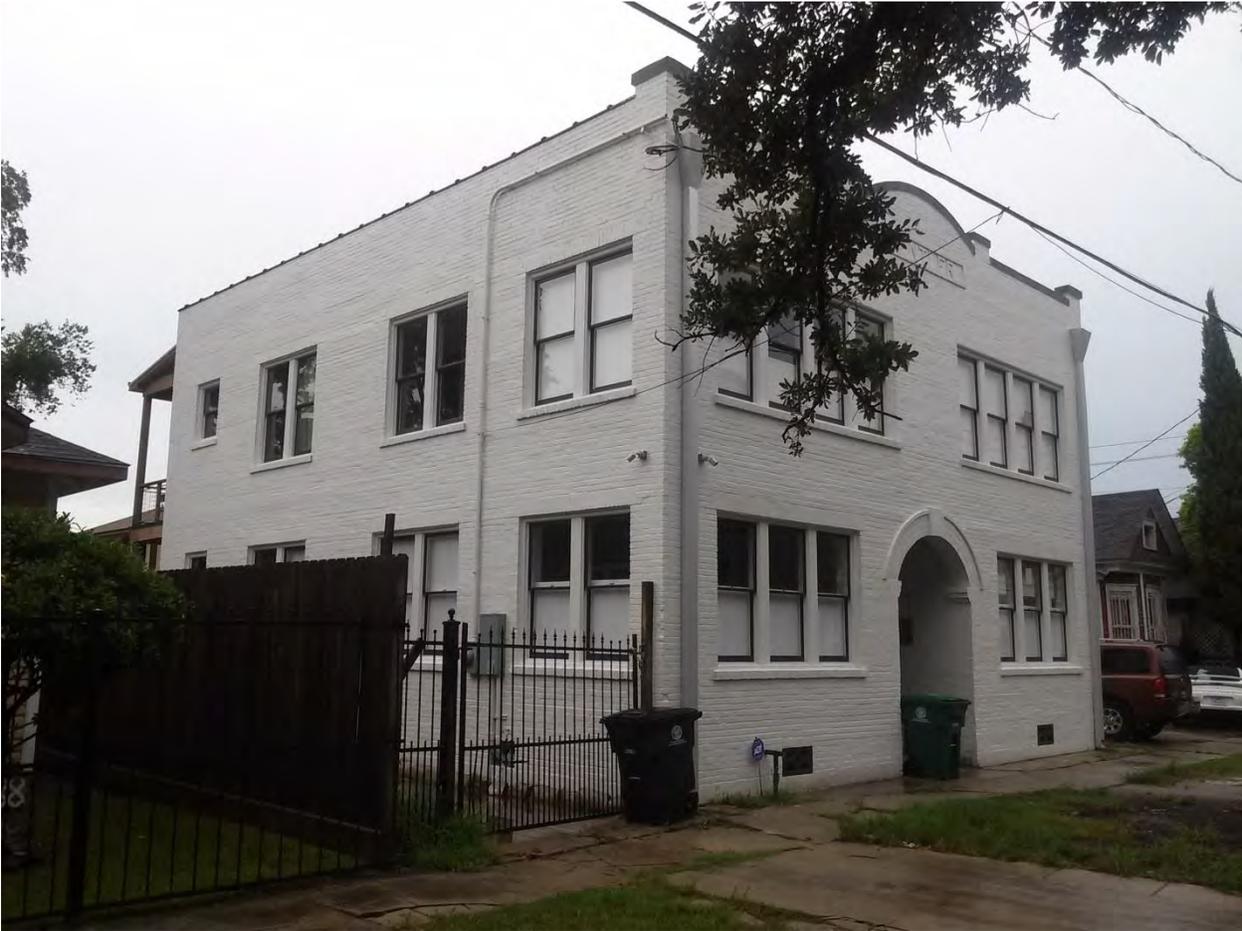
Side view of the building, showing the affected area

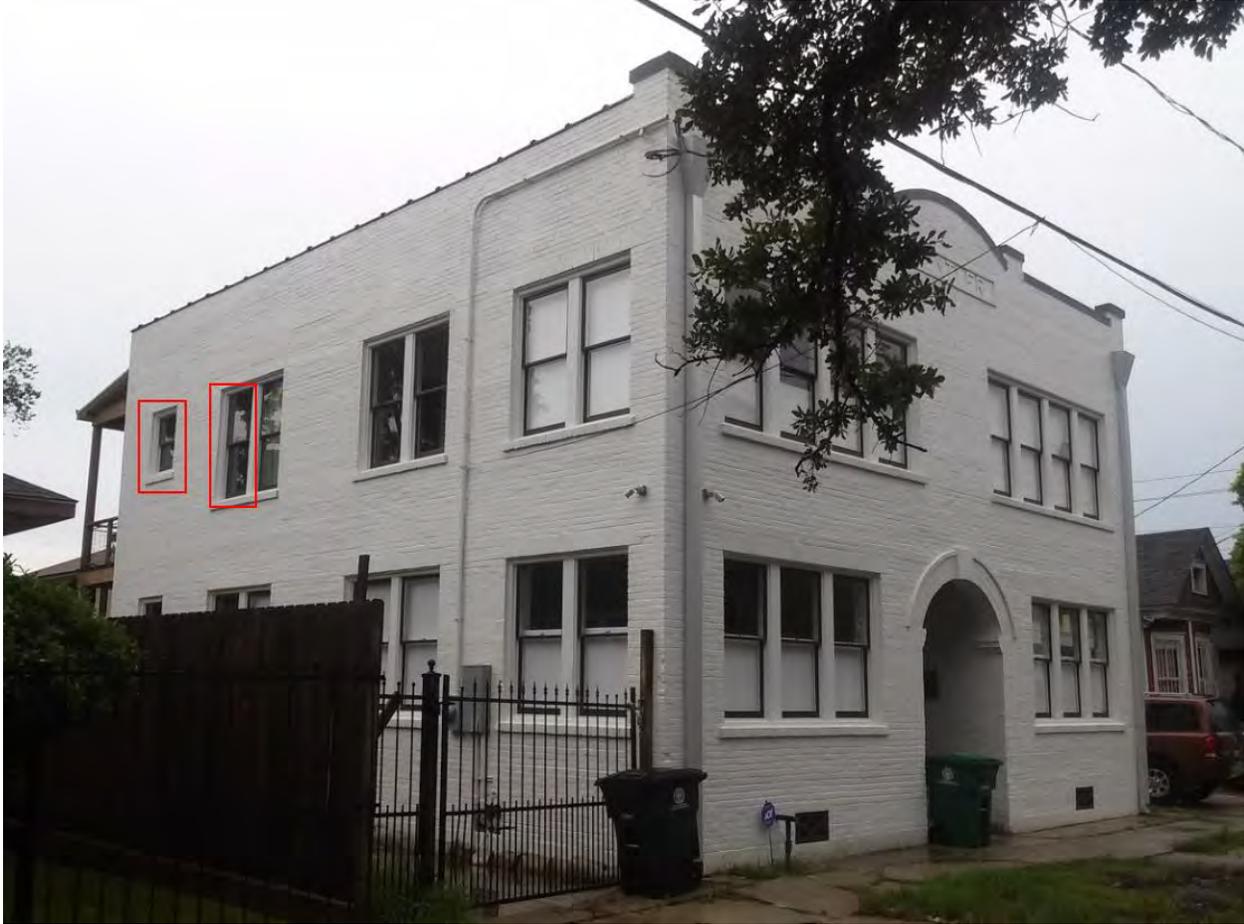
Red rectangles indicate the two windows for which exterior shutters are being proposed

The proposed alterations affect the two rearmost second-story windows on the east face of the building. These changes are as follows:
