**CERTIFICATE OF APPROPRIATENESS**

**Property:** 8011 Glen Valley Drive, lot 4, block 6, Glenbrook Valley Section 2 Subdivision. The property includes a historic 2,395 square foot brick single family residence situated on a 14,699 square foot (150, by 95') interior lot.

**Proposal:** Alteration – *Resubmittal* Replace 17 of the house’s original windows on the front and side elevations. This work has already been performed and was reported by a neighbor.

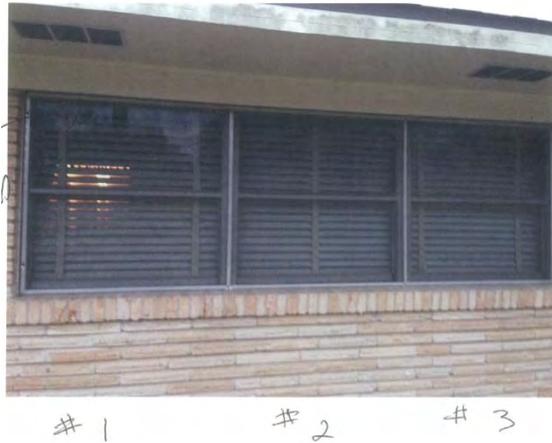
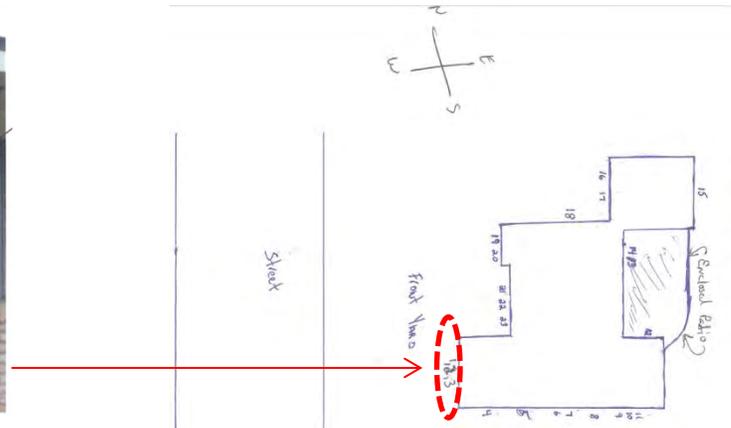
**WINDOWS 1, 2, AND 3 - FRONT FACING GLEN VALLEY DRIVE**  
**PREVIOUSLY EXISTING**

**Front Elevation (West):** Viewing the house from the street, Windows 1, 2, and 3 were a contiguous row of metal 1 over 1 windows on the right side of the front elevation. These were replaced with matching vinyl windows.

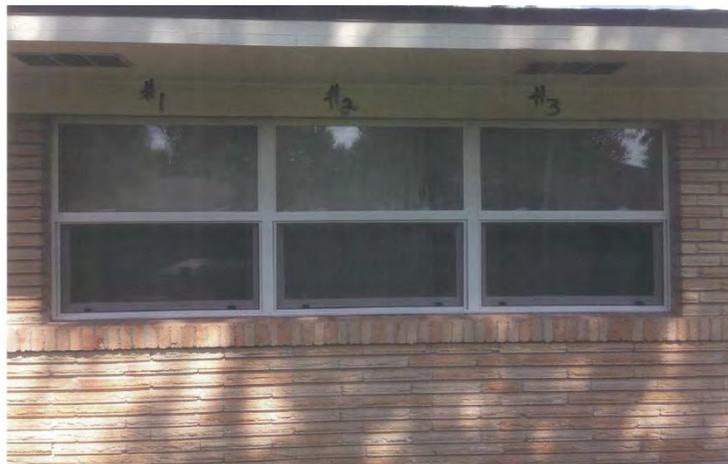
**REPLACEMENTS INSTALLED**

Line-1 MASTER BED  
Rough Opening: 112 1/2 X 36 1/4

Frame Size: 112 x 35 3/4  
Evenly Divided Flanker = 37,  
Three Wide Builders Vinyl Single Hung Window Tilt Block Frame,  
Ext/Int, Vent Height = 18 1/8,  
Low-E Clear 0 - 3500 feet  
Standard Screen with Fiberglass Mesh,  
Int Hardware, Cam Lock(s),  
, Muller  
US National-AAMA PG20, DP+20J-20,  
PEV 2014.1.0.1022/PDV 6.059 (01/02/14) SW

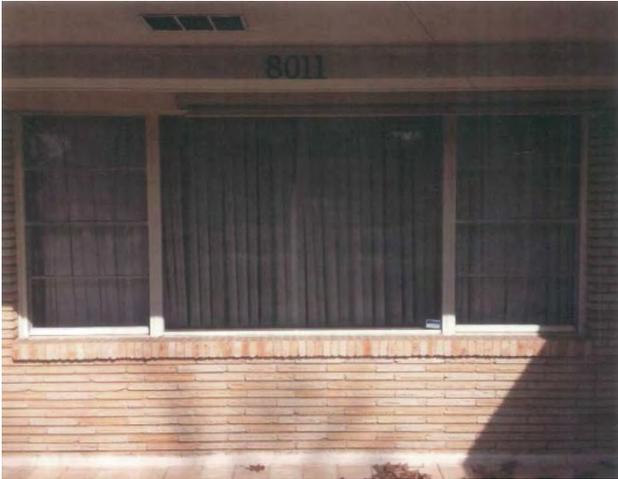
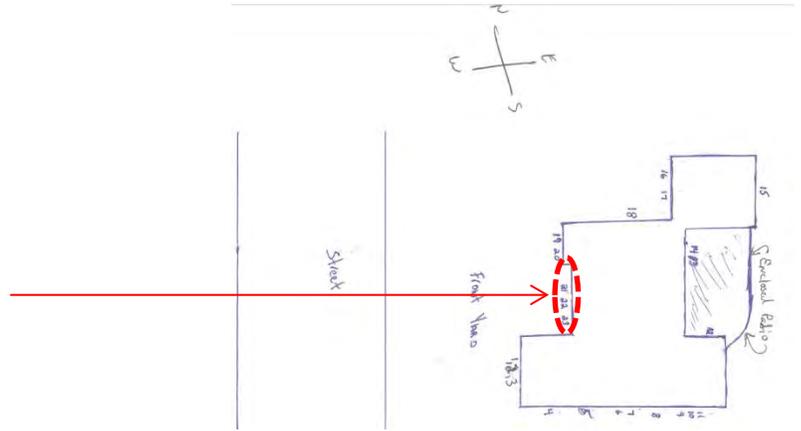
**WINDOWS 21, 22, AND 23 – FRONT FACING GLEN VALLEY DRIVE  
PREVIOUSLY EXISTING**

Windows 21, 22, and 23 were the metal framed picture window flanked by a pair of 4 lite horizontal lite windows. These were replaced with a vinyl picture window flanked by a pair of 1 over 1 vinyl windows installed within the existing window openings.

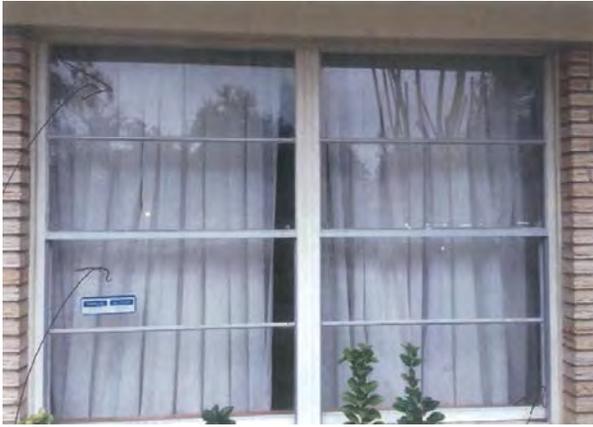
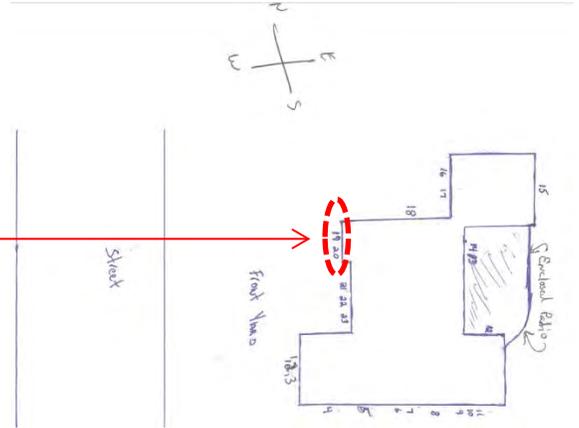
**WINDOWS 19 AND 20 – FRONT FACING GLEN VALLEY DRIVE  
PREVIOUSLY EXISTING**

Windows 19 and 20 were a pair of 4 lite horizontal lite metal windows on the left side of the front elevation. These were replaced with vinyl 1 over 1 windows installed within the existing window openings.

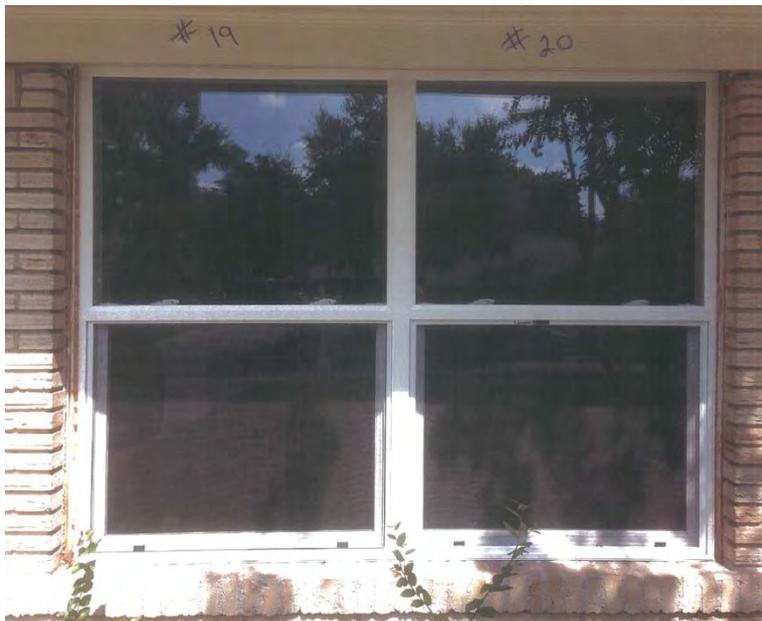
**REPLACEMENTS INSTALLED**

Rough Opening: 74 1/2 X 55 3/4

Main Line Item  
Frame Size: 74 x 55 1/4  
Builders Vinyl Block Frame,  
2 Wide 1 High,  
PEV 2014.1.0.1022/PDV 6.059 (01/02/14) SW

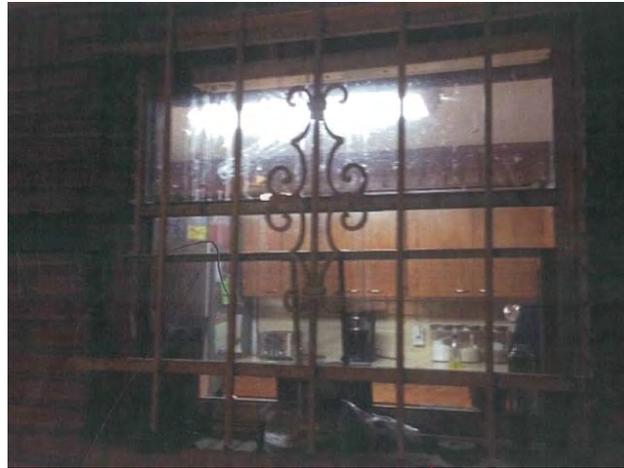
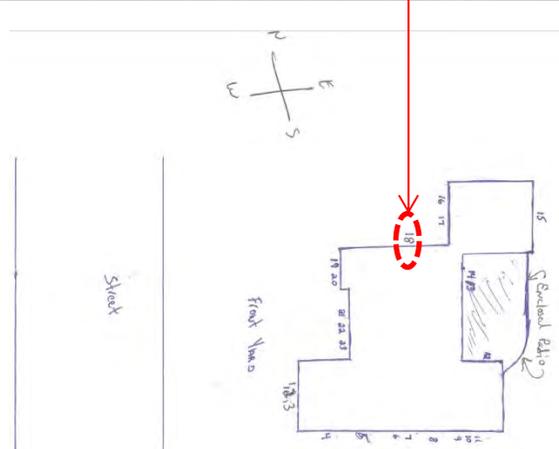
**WINDOW 18 – FACING NORTH SIDE PROPERTY LINE  
PREVIOUSLY EXISTING**

Frame Size: 36 1/2 x 35 1/4  
Builders Vinyl Single Hung Window Side Load Block Frame,  
Ext" Int, Vent Height = 17 7/8,  
LOW-E Clear 0 - 3500 feet  
Standard Screen with Fiberglass Mesh,  
Int Hardware, Cam Lock(s), 2 Locks, \*Does Not Meet Egress\*  
US National-AAMA PG20, DP+20/-20,  
U-Factor: 0.33, SHGC: 0.35, VT: 0.61, CR: 51.00, ER: 19.00, CPD:  
JEL-A-177-02496-00001  
PEV 2014.1.0.1022/PDV 6.059 (01/02/14) SW

**Side Elevation (North):** Window 18 was a 1 over 1 metal framed window. It was replaced with a vinyl 1 over 1 window.

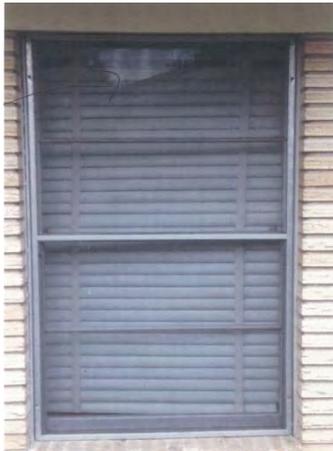
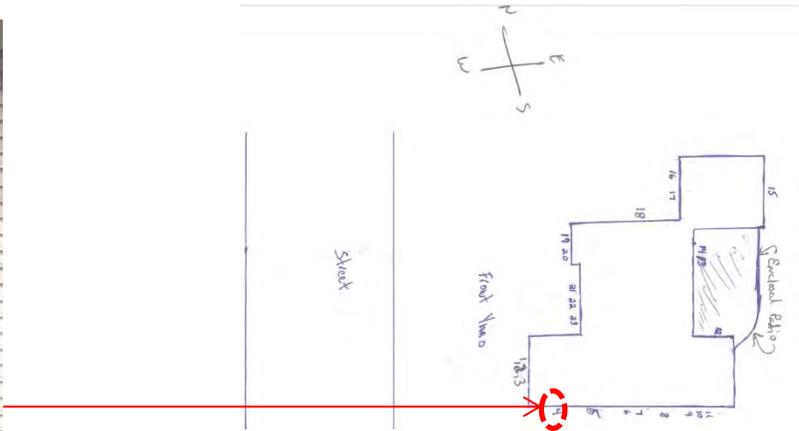
WINDOW 4 – FACING SOUTH SIDE PROPERTY LINE

**Side Elevation (South):** Viewing from front to back: Window 4 was a 4 lite horizontal lite window. It was replaced with a vinyl 1 over 1 window installed within the existing opening.

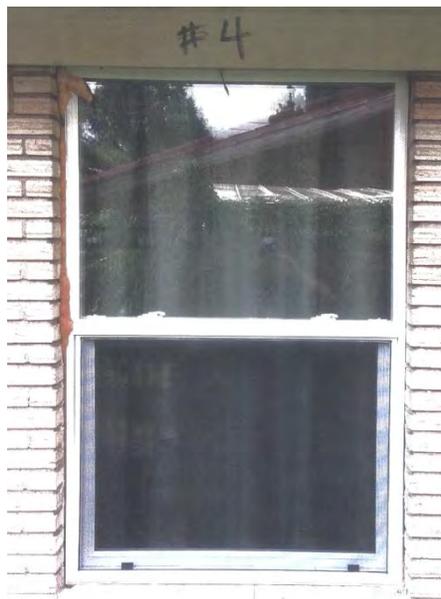
REPLACEMENTS INSTALLED

Line-2 MATER  
Rough Opening: 37 1/4 X 56 1/4

Frame Size: 36 3/4 x 55 3/4  
Builders Vinyl Single Hung Window Tilt Block Frame,  
Vent Height = 28 1/8 ,  
Low-E Clear 0 - 3500 feet  
Without Balance Covers , Standard Screen with Fiberglass Mesh,  
Int Hardware, Cam Lock(s), 2 Locks, \*Meets 5.7 sqft Egress  
(All Floors)\*,  
US National-AAMA PG20, DP+20/-20,  
U-Factor: 0.34, SHGC: 0.35, VT: 0.60, CR: 51.00, ER: 16.00, CPD:  
JEL-A-225-01168-00001  
PEV 2014.1.0.1022/PDV 6.059 (01/02/14) SW

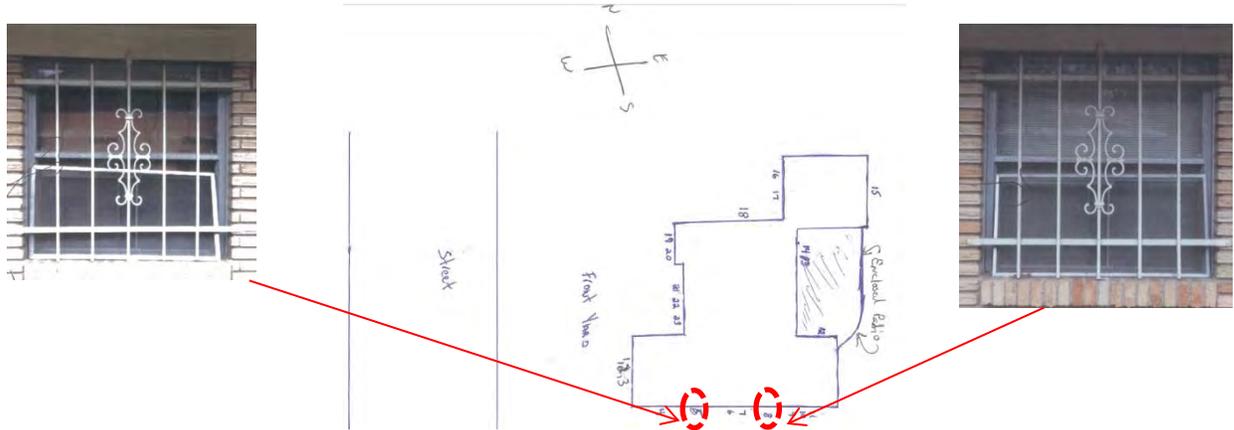
WINDOW 5 AND 8 – FACING SOUTH SIDE PROPERTY LINE

Windows 5 and 8 were 1 over 1 metal windows. They were replaced with matching vinyl windows.

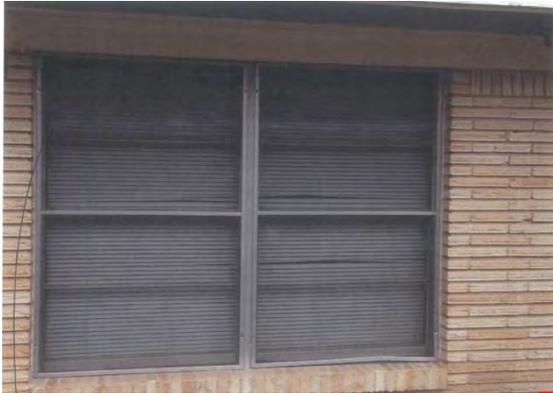
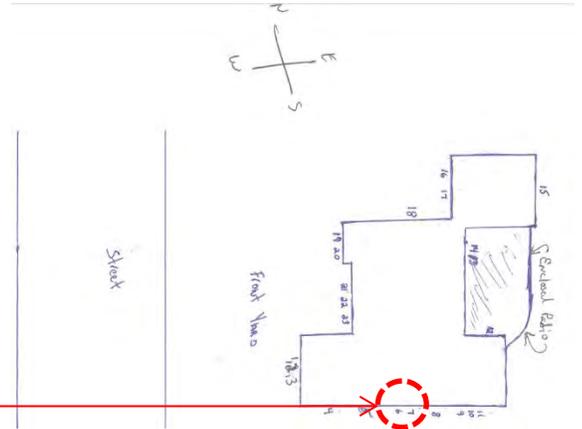
**WINDOWS 6 AND 7 – FACING SOUTH SIDE PROPERTY LINE  
PREVIOUSLY EXISTING**

Windows 6 and 7 were 4 lite horizontal lite metal windows. They were replaced with vinyl 1 over 1 windows installed within the existing openings.

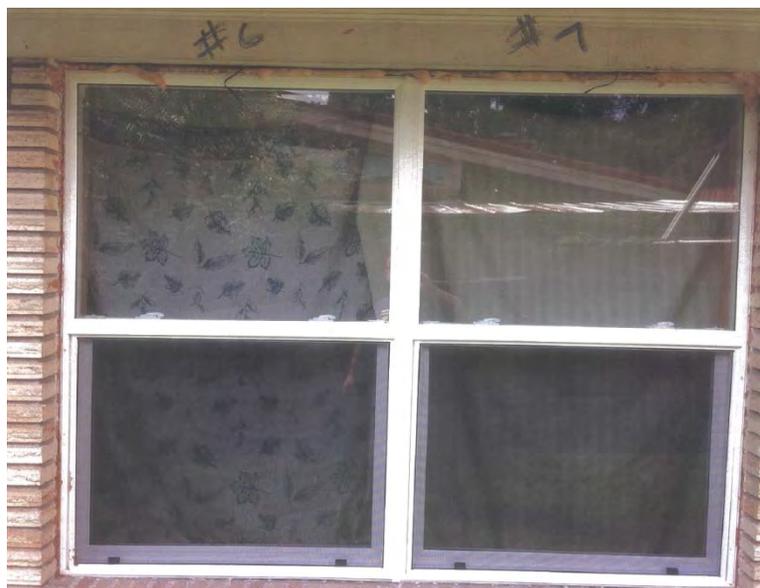
**REPLACEMENTS INSTALLED**

Line-4  
Rough Opening: 72 3/4 X 56 3/4

Frame Size: 72 1/4 x 56 1/4  
Evenly Divided Left Unit Width = 35 7/8 ,  
Two Wide Builders Vinyl Single Hung Window Tilt Block Frame,  
Ext Int , Vent Height = 28 3/8 ,  
Low-E Clear 0 - 3500 feet  
Standard Screen with Fiberglass Mesh,  
Int Hardware, Cam Lock(s),  
, Muller  
TDI# WIN-1759 TDI-AAMA, PG50, DP+50/-50,  
PEV 2014-1.0.1022/PDV 6.059 (01/02/14) SW

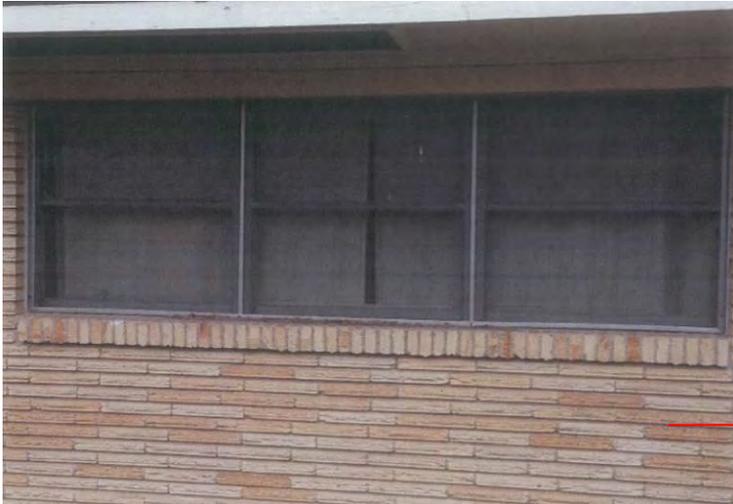
**WINDOWS 9, 10, AND 11 – FACING SOUTH SIDE PROPERTY LINE  
PREVIOUSLY EXISTING**

Windows 9, 10, and 11 were a contiguous row of metal 1 over 1 windows. These were replaced with matching vinyl windows.

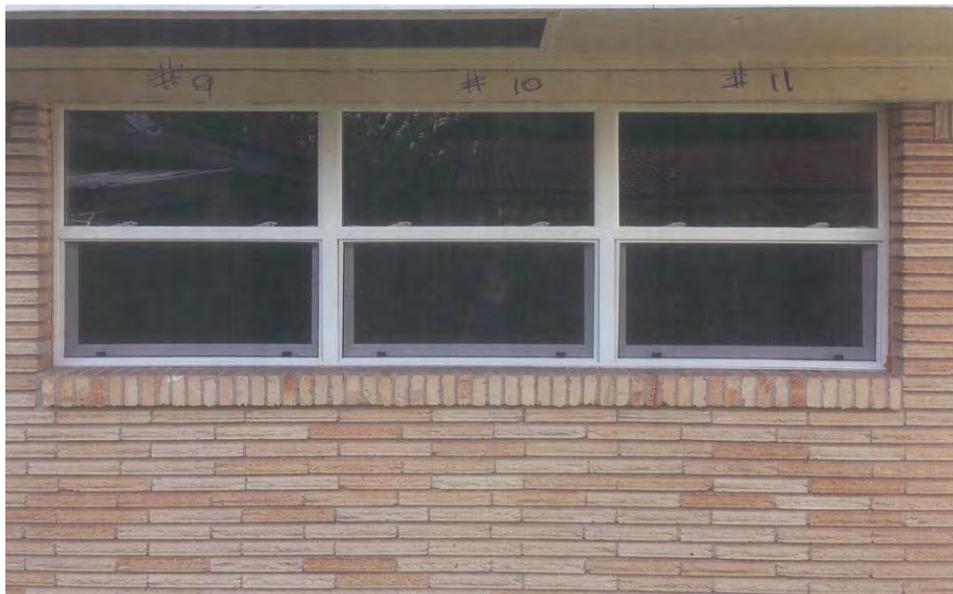
**REPLACEMENTS INSTALLED**

Line-5  
Rough Opening: 111 3/4 x 36 1/4

Main Line Item  
Frame Size: 111 1/4 x 35 3/4  
Evenly Divided Flanker= 36 3/4 ,  
Three Wide Builders Vinyl Single Hung Window Tilt Block Frame,  
Ext' Int, Vent Height = 18 1/8 ,  
Low-E Clear 0 - 3500 feet  
Standard Screen with Fiberglass Mesh,  
Int Hardware, Cam Lock(s),  
Mulled  
US National-AAMA PG20, DP+20/-20,  
FEV 2014.1.0.1022/PDV 6.059 (01/02/14) SW
