CERTIFICATE OF APPROPRIATENESS

Property: 7707 Lakewind Street, tract 35, block 21, Glenbrook Valley Subdivision. The property includes a historic 3,469 square foot, one-story wood frame single-family residence and an attached garage situated on a 35,524 square foot interior lot.

Proposal: Alteration – Window Replacement

- Replace 7 original aluminum framed windows on the east and west side elevations with new vinyl windows.
- Proposed replacement windows will utilize the existing window openings.
- Applicant asserts the existing windows are inoperable and cannot be repaired. Staff performed a site visit on 7-14-15 and confirmed this assertion.

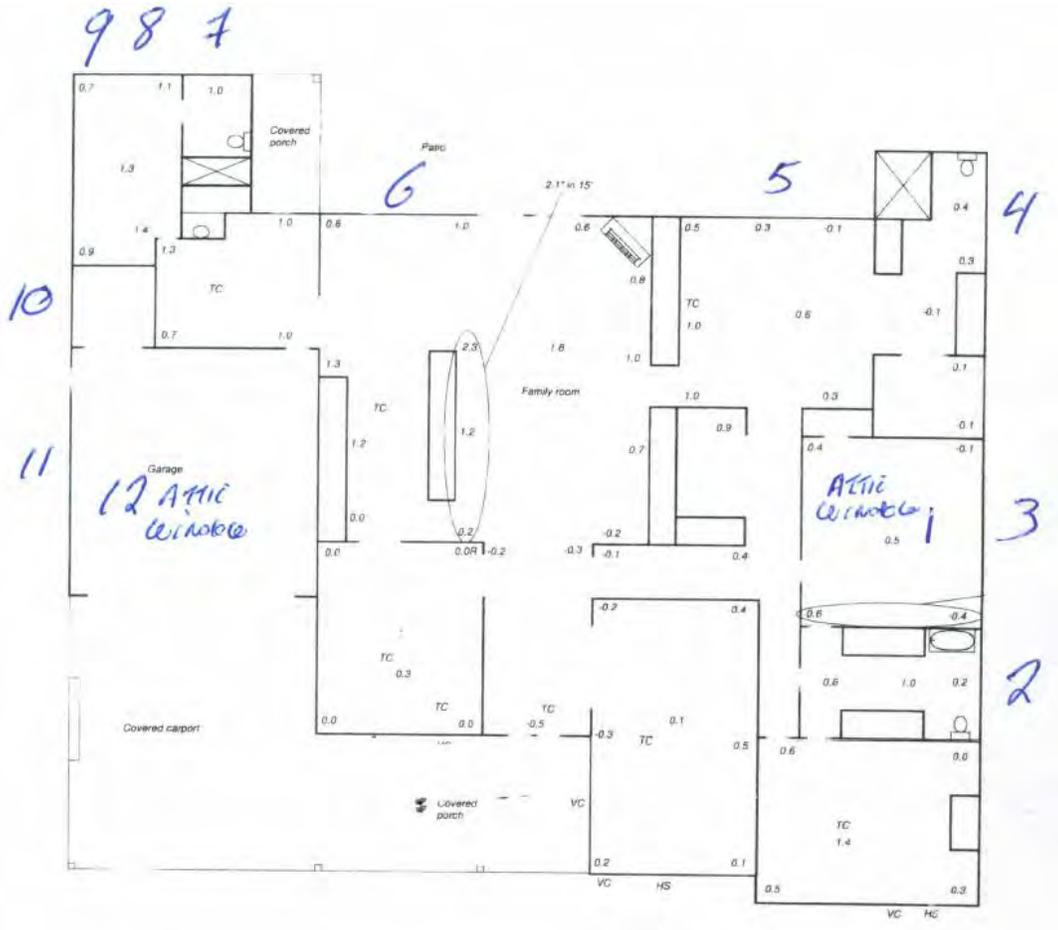
FLOOR PLAN

WINDOWS 5 THROUGH 9 ARE NOT VISIBLE FROM THE RIGHT OF WAY

Windows 5 through 9 are not visible from the public right of way.

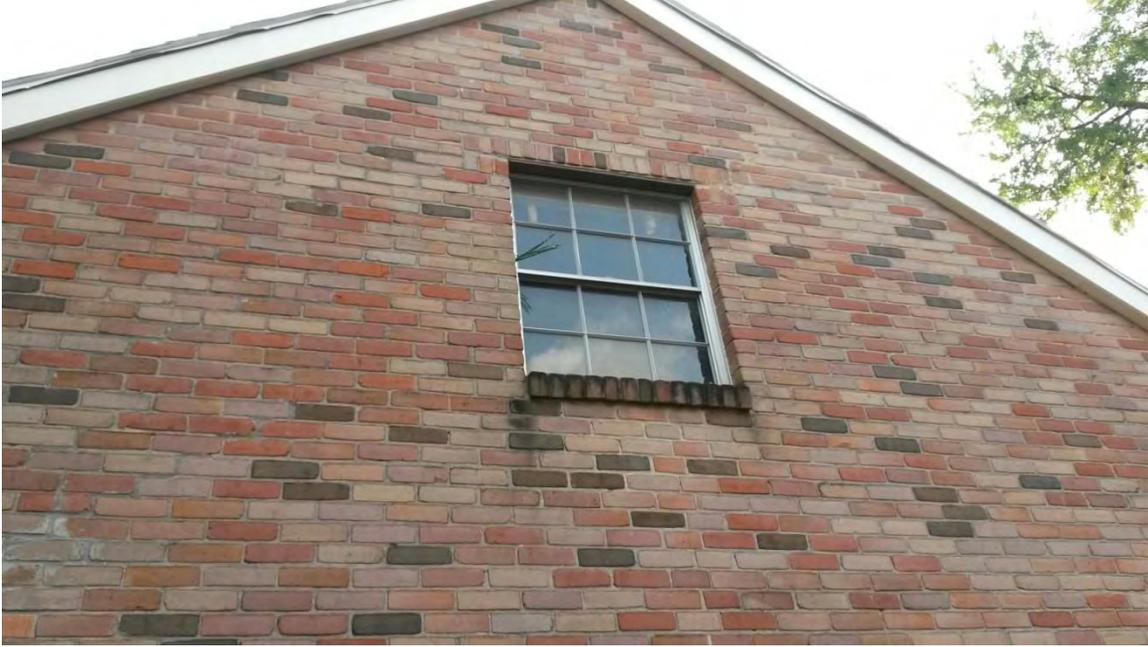
EXISTING WINDOW #1

Window 1: Existing attic level aluminum single hung 6-over-6 window proposed to be replaced with a vinyl single hung 1-over-1 window.

Windows/Doors: Replace all existing side facing windows with new windows. The proposed replacement windows will utilize the existing window openings. The applicant has asserted that each of these windows are damaged beyond reasonable repair. Staff performed a site visit on 7-14-15 and observed visual evidence of differential settlement in the foundation and in the brick veneer. This has caused the window frames to pull away from their openings resulting in bent and inoperable frames.

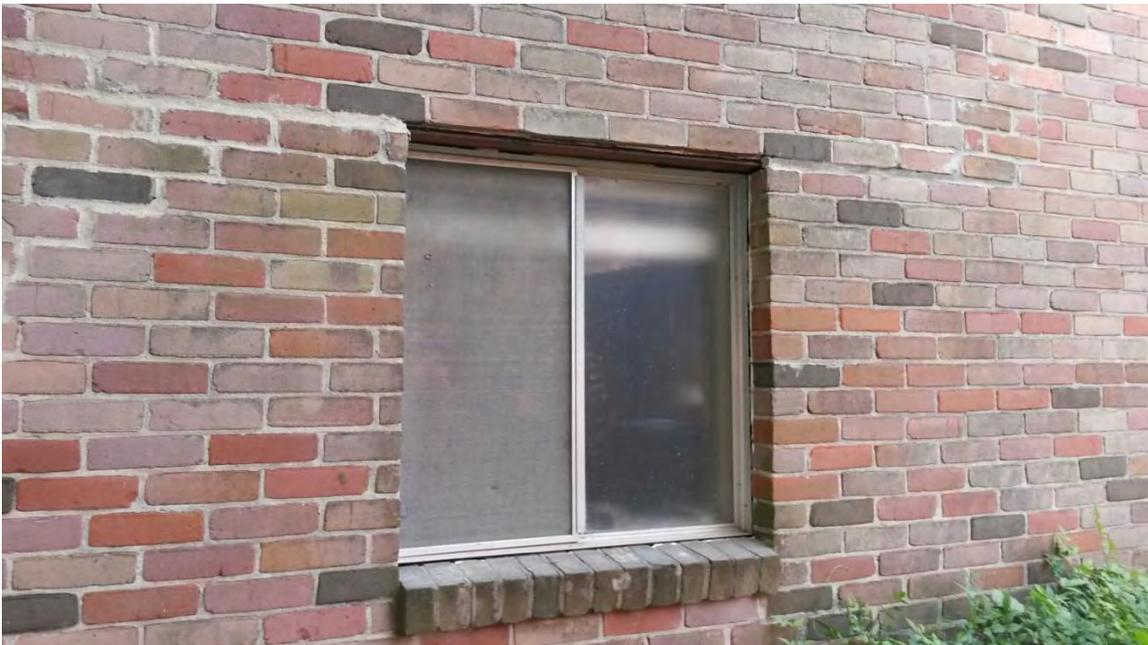
EXISTING WINDOW #2

Window 2: Existing first floor aluminum two-lite sliding window to be replaced with a vinyl 1-over-1 single hung window.

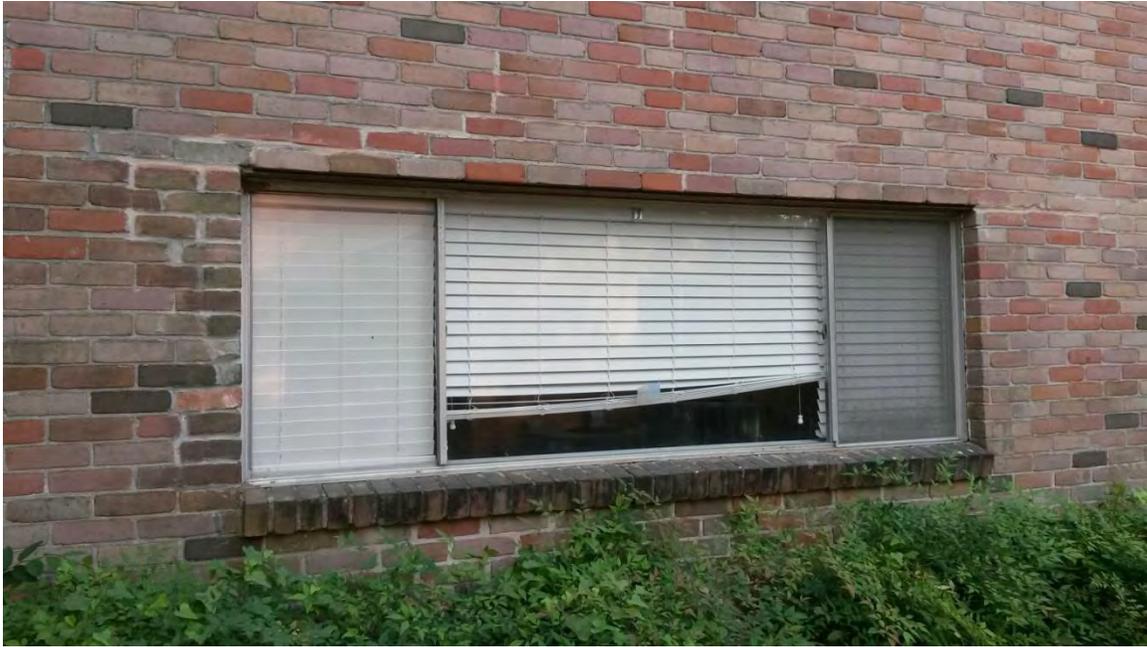
EXISTING WINDOW #3

Window 3: Existing first floor aluminum three-lite picture window to be replaced with a matching vinyl picture window.

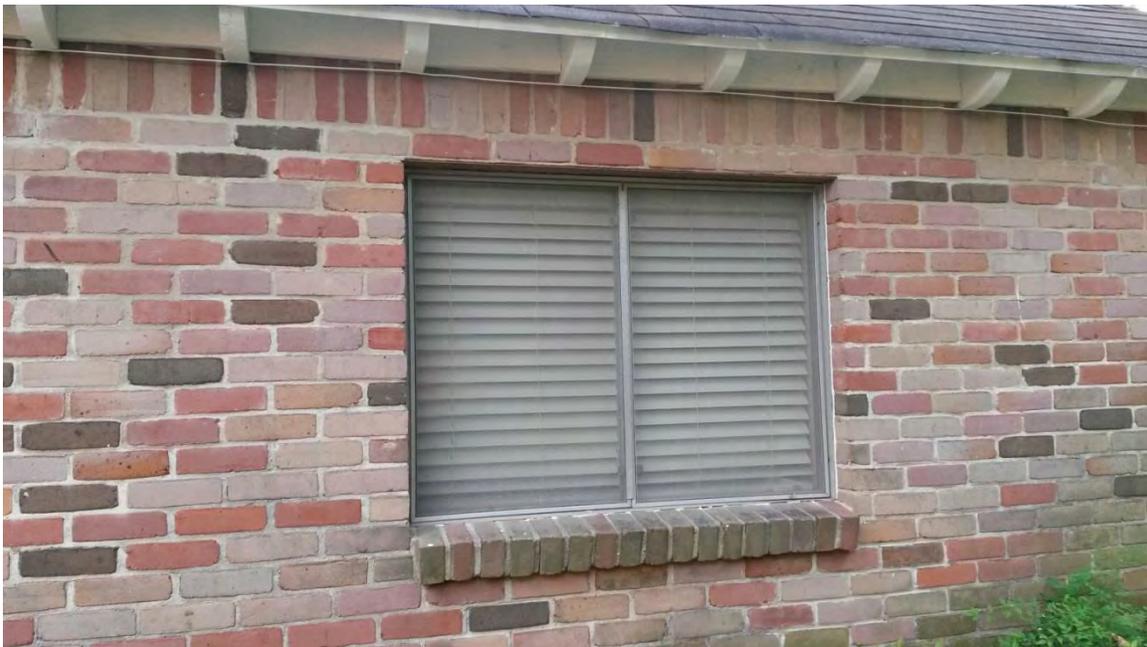
EXISTING WINDOW #4

Window 4: Existing first floor aluminum two-lite sliding window to be replaced with a vinyl 1-over-1 single hung window.

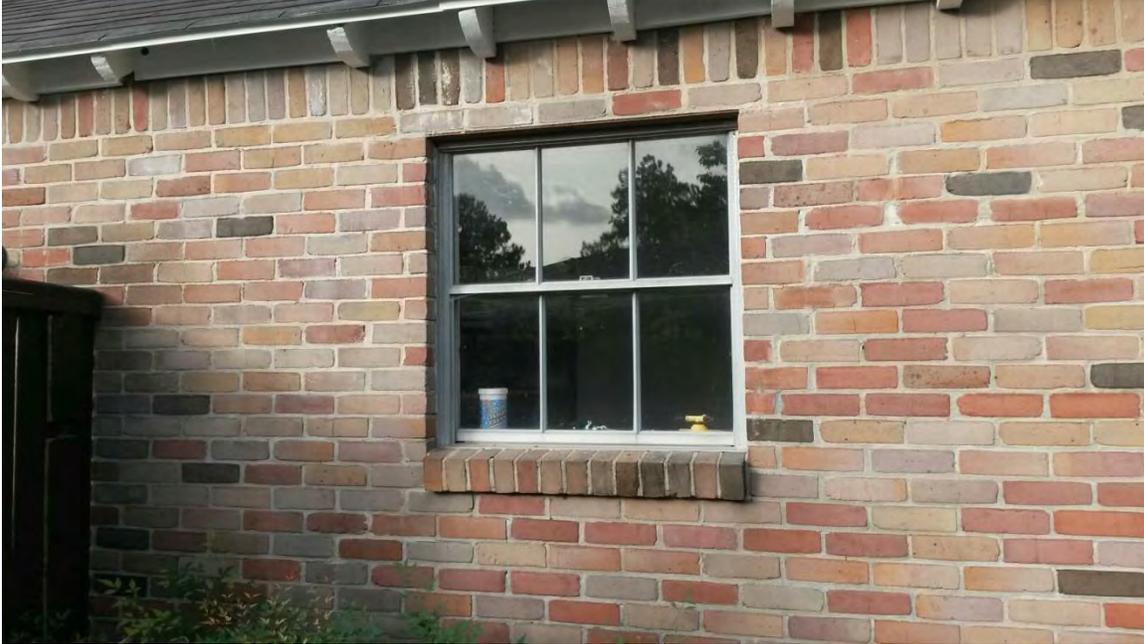
EXISTING WINDOW #10

Window 10: Existing first floor aluminum 6-over-6 single hung window to be replaced with a vinyl 1-over-1 single hung window.

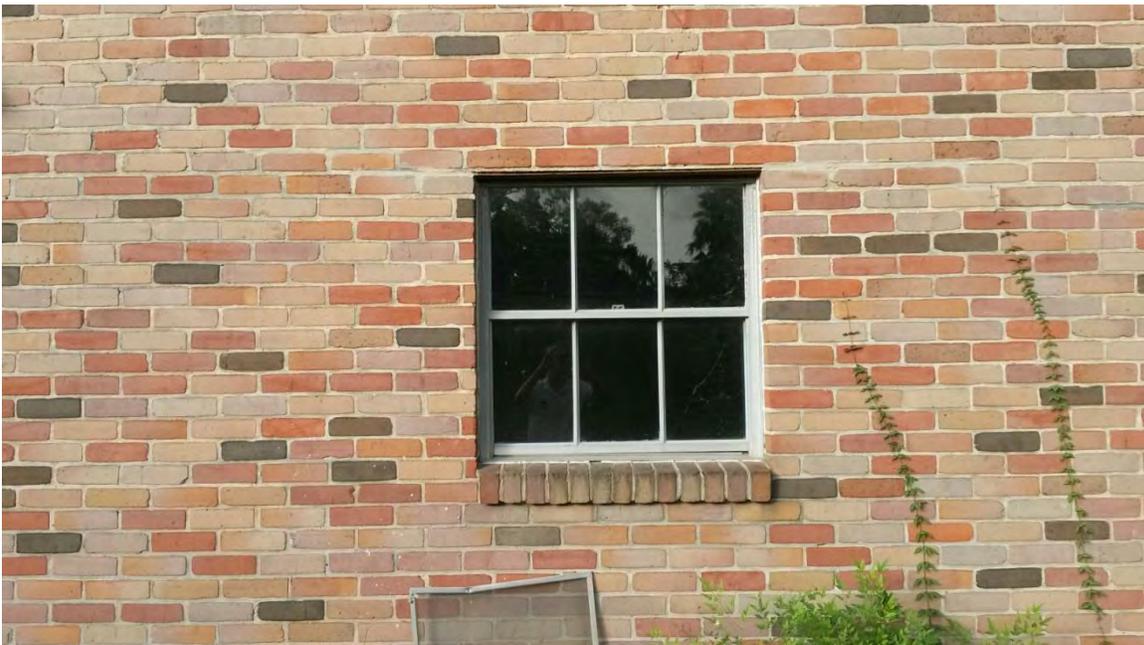
EXISTING WINDOW #11

Window 11: Existing first floor aluminum 6-over-6 single hung window to be replaced with a vinyl single hung window.

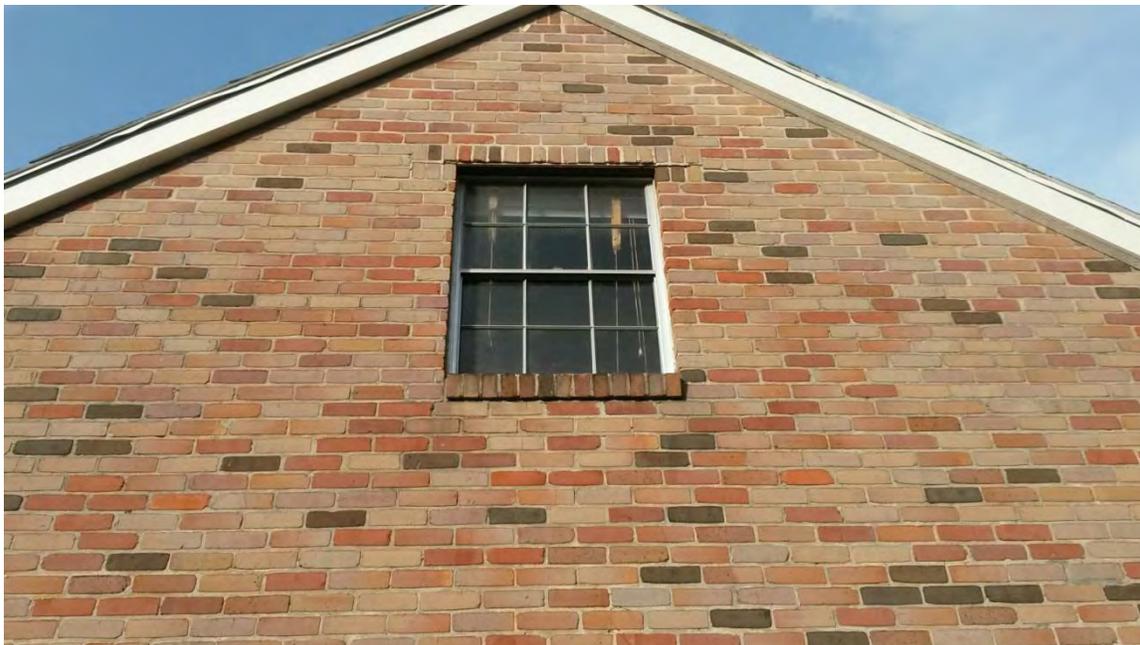
WINDOW # 12

Window 12: Existing attic level aluminum 6-over-6 single hung window to be replaced with a vinyl single hung window.

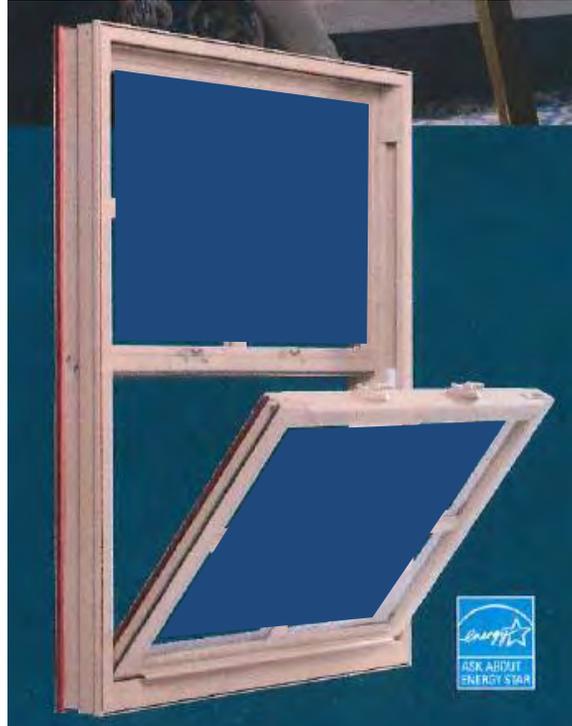
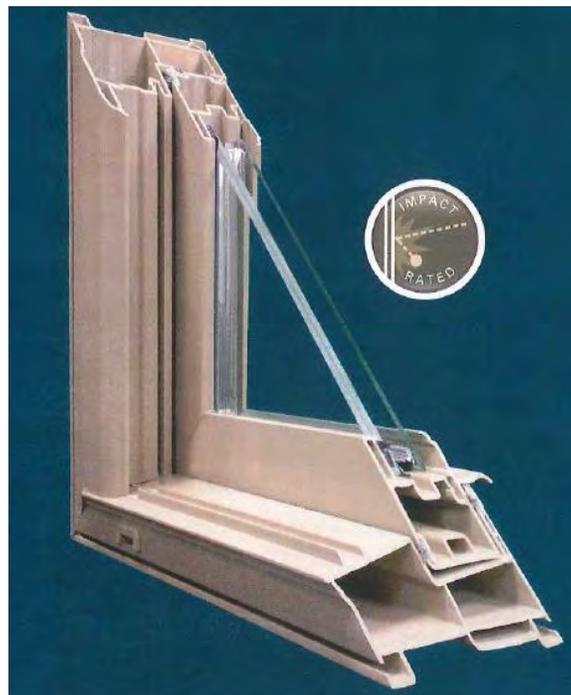
PROPOSED REPLACEMENT WINDOW

WINDOWS WILL NOT FEATURE DIVIDED LITES
