**CERTIFICATE OF APPROPRIATENESS**

**Property:** 2006 Decatur Street, Lot 5, Block 418, Baker W R NSBB Subdivision. The property includes a historic 1,080 square foot, one-story wood frame single-family residence and detached garage situated on a 5,000 square foot (50' x 100') interior lot. The detached garage is not classified in the building inventory.

**Proposal:** Demolition of a contributing one-story residential structure with the intent to construct a single-family residence on site.

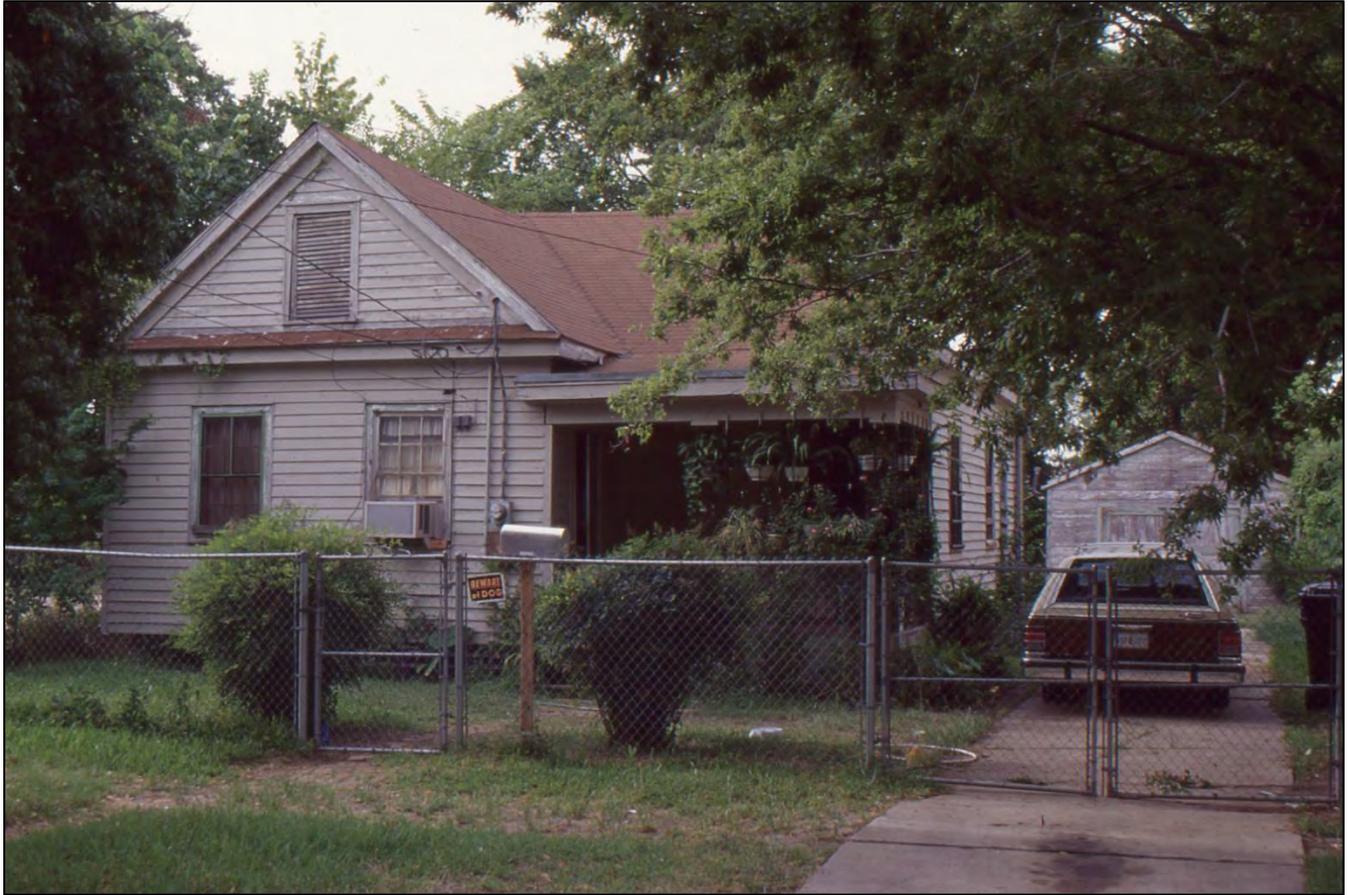
INVENTORY PHOTO

The house at 2006 Decatur Street was classified as a Contributing Structure in the Old Sixth Ward at the time of Historic District designation. It retains the characteristics of other contributing structures located throughout the district in its scale, massing, design, and detailing. Despite its current condition, upon closer inspection much original material still exists. The cypress clapboard siding and 6-over-6 pane windows with rounded gothic muntin bars, hint at a much earlier house (possibly from the 1880s), that has been reshaped over the passing decades.

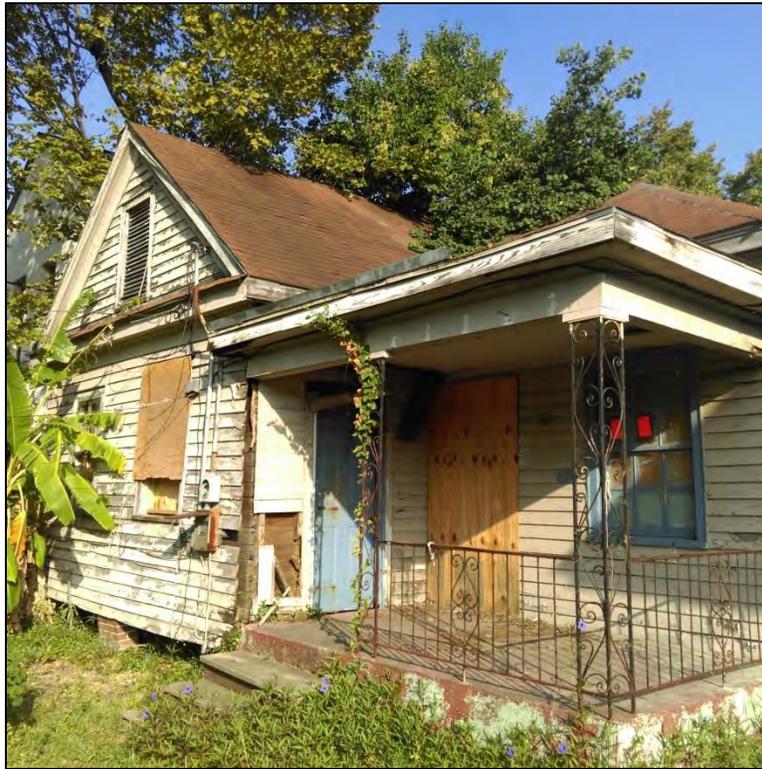
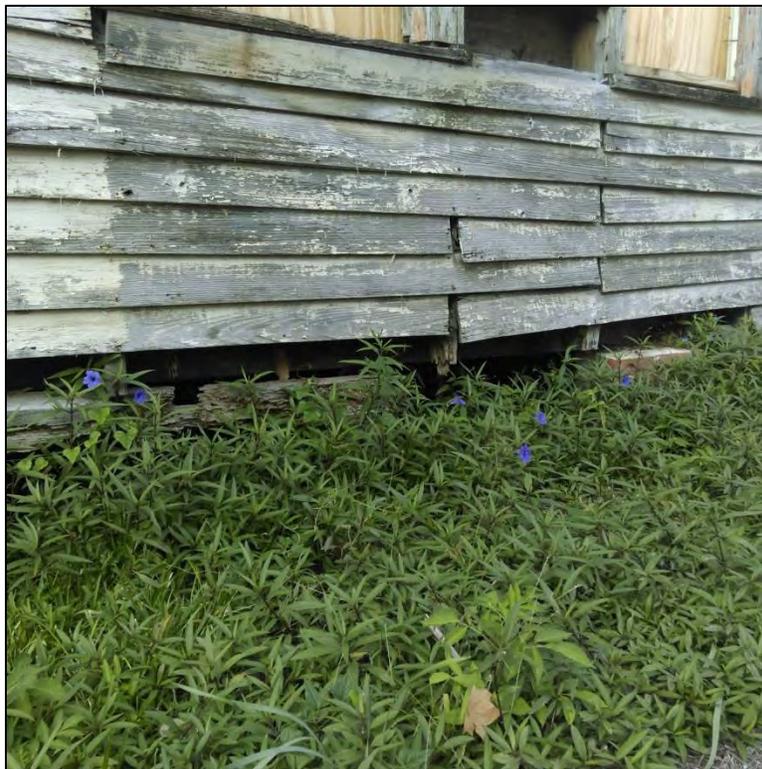
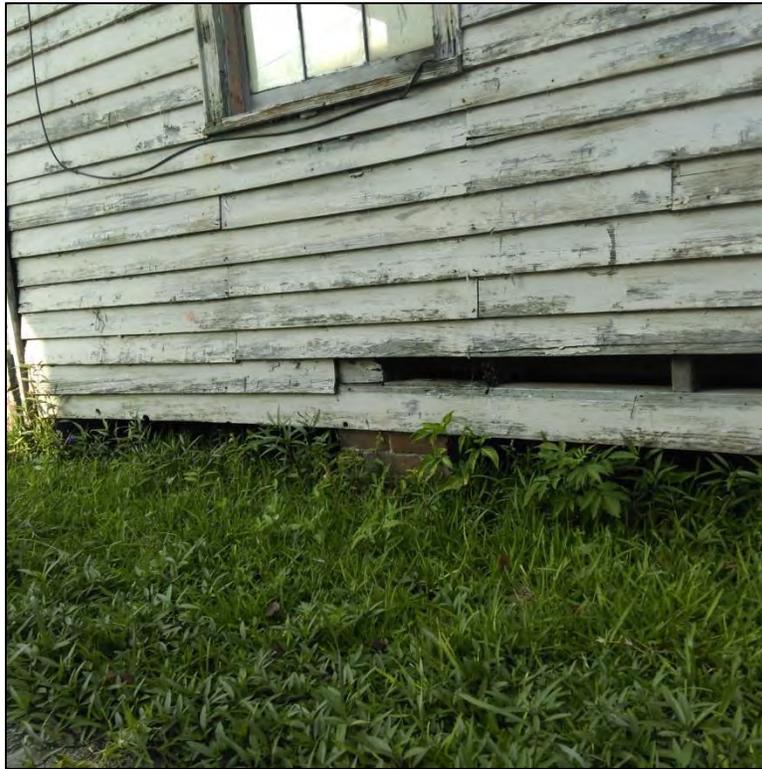
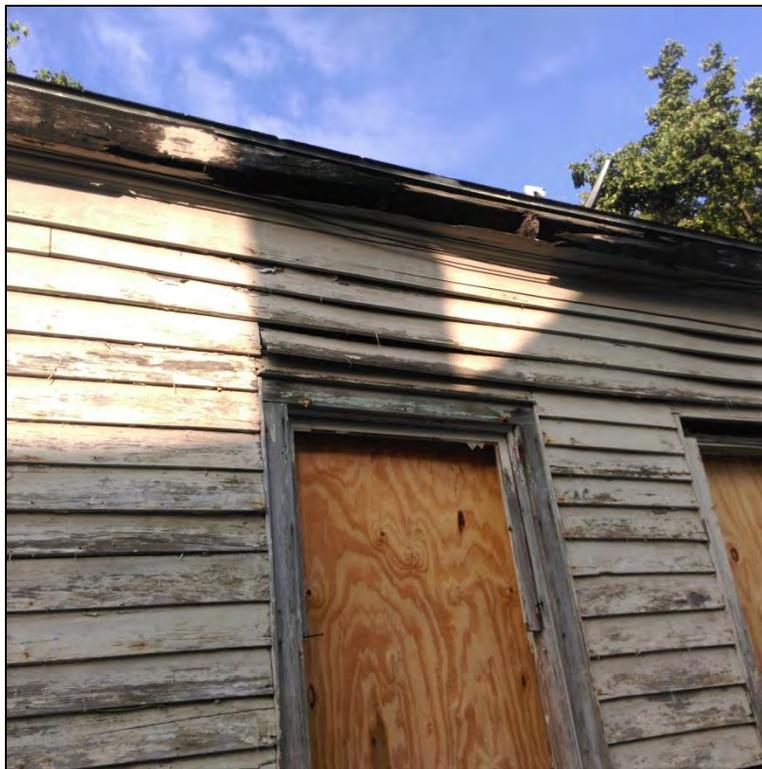
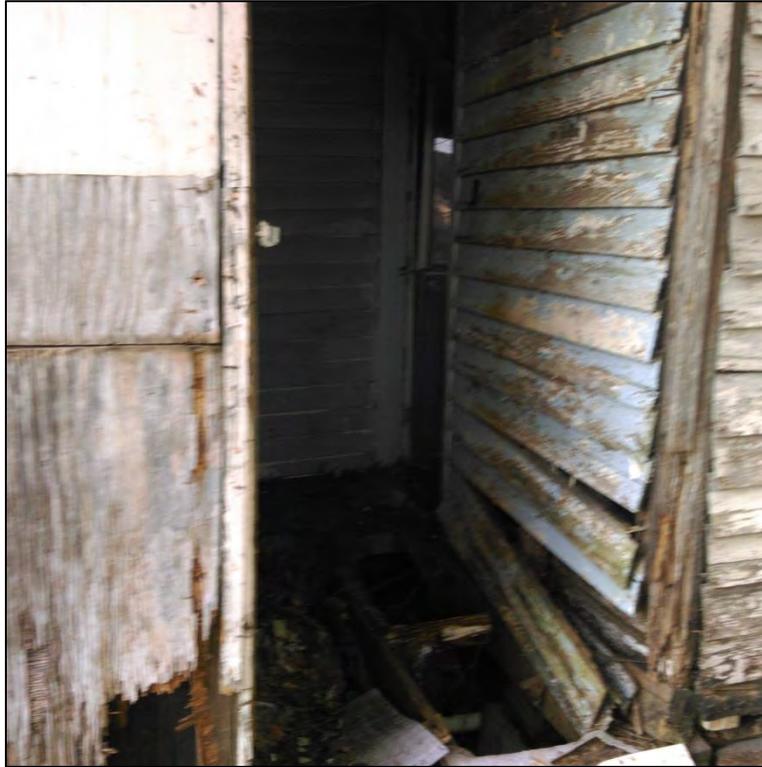
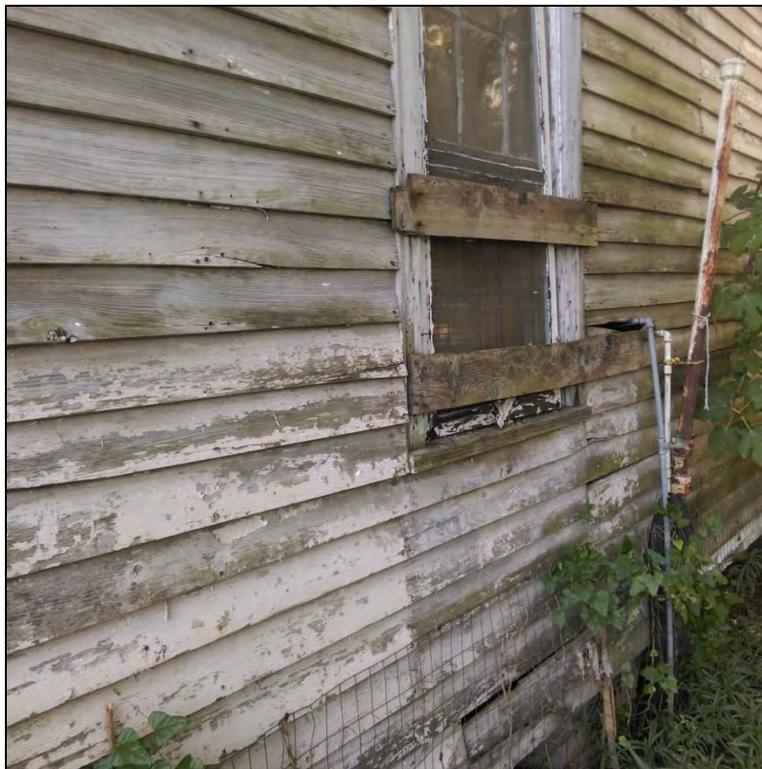
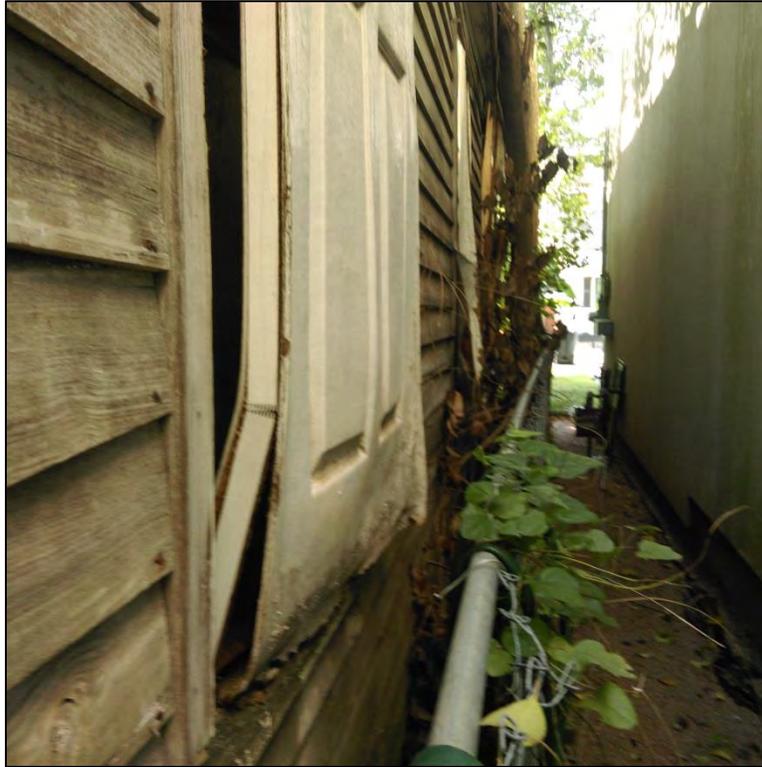
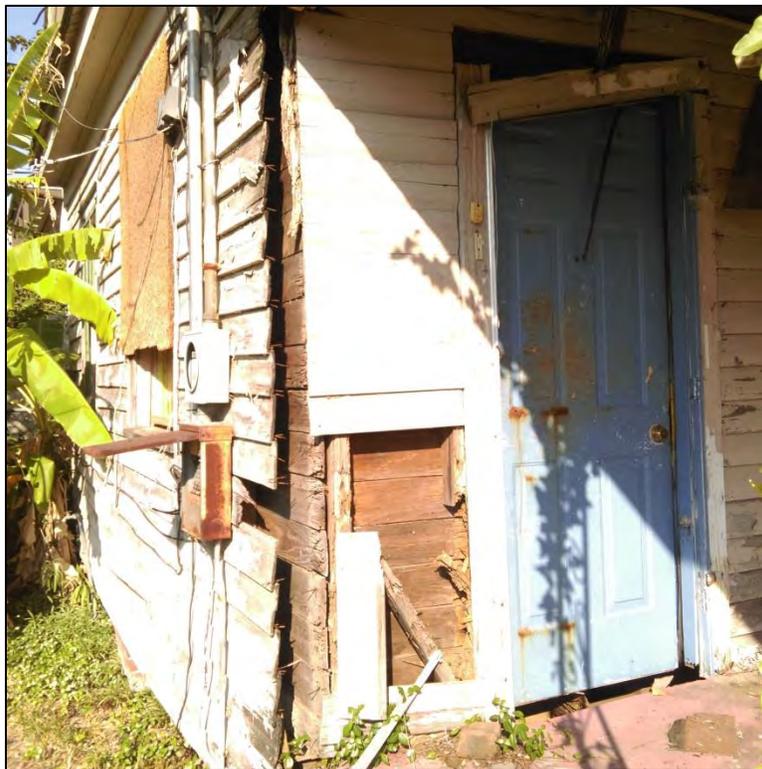
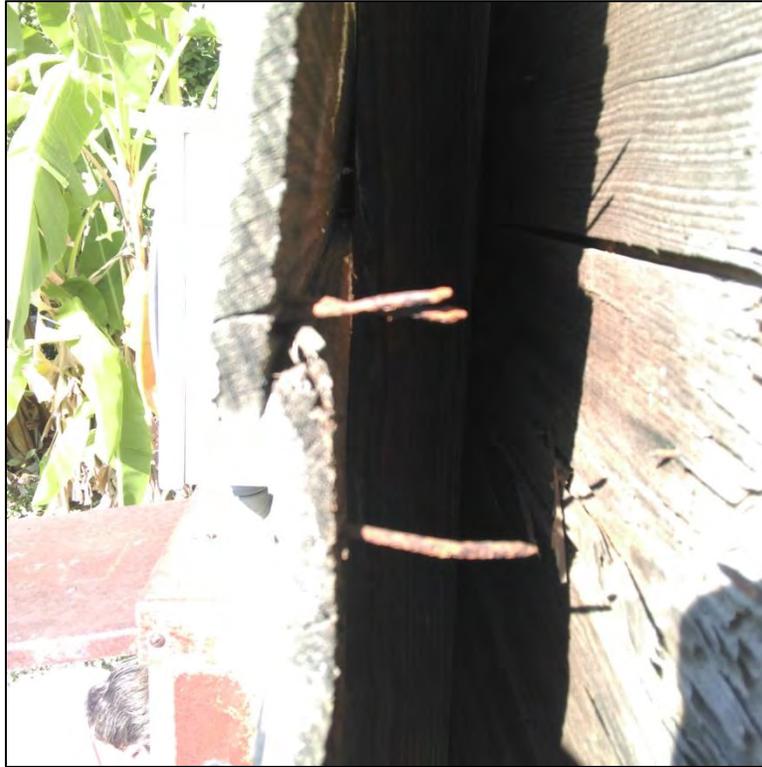
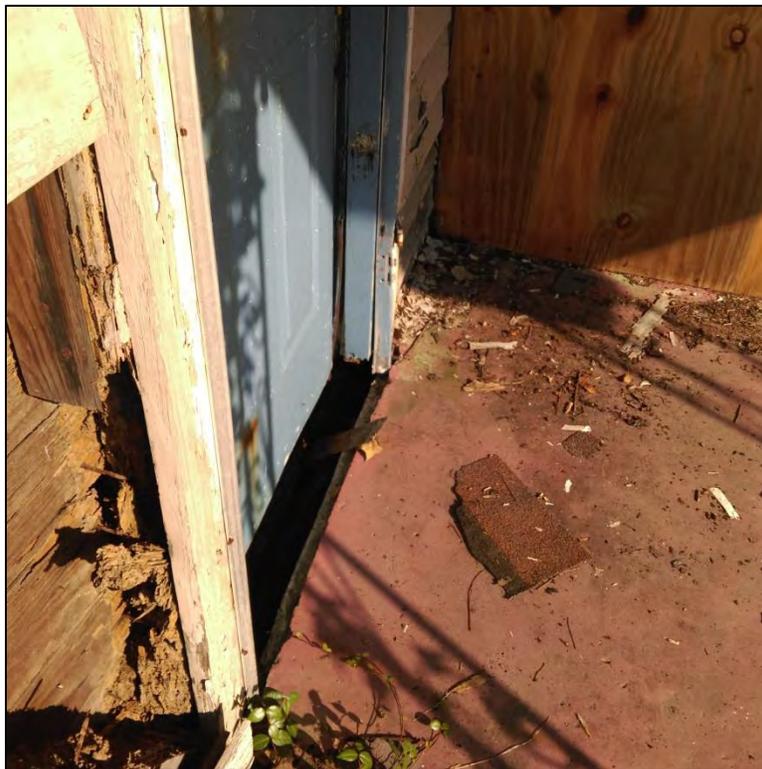
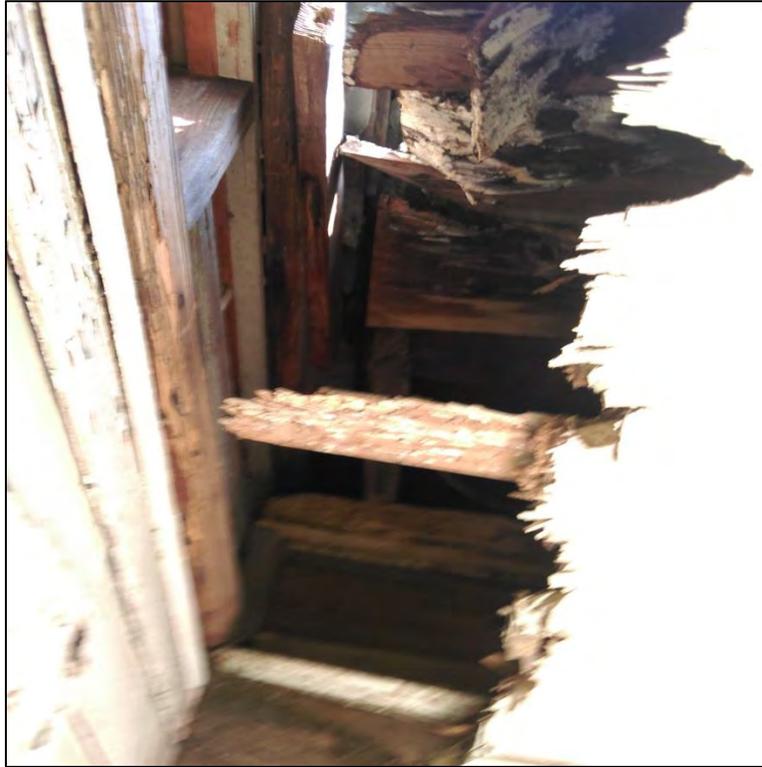
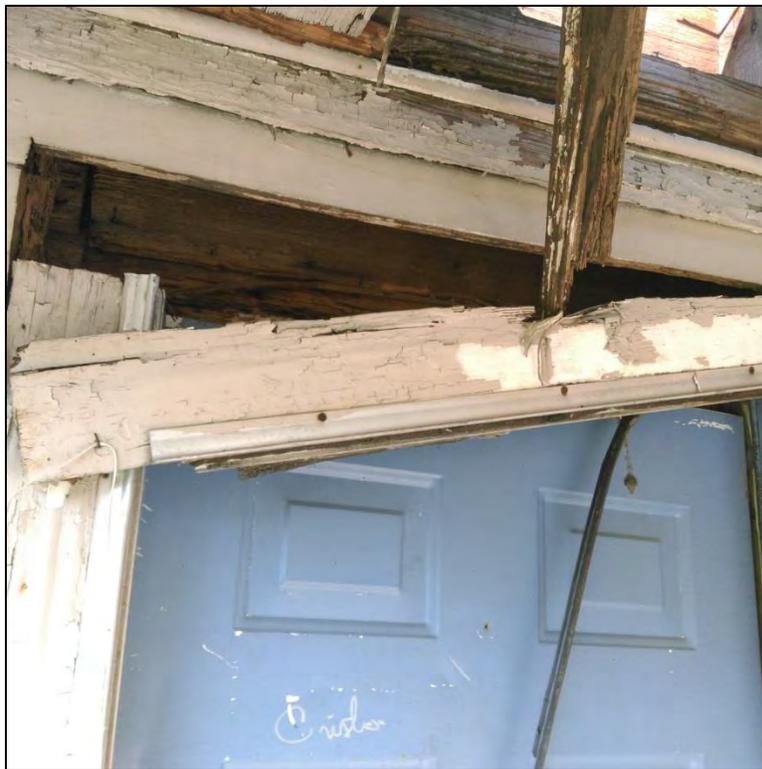
STAFF PHOTOS 10-2015

There is no dispute that the house needs considerable repair and is not currently in safe or habitable condition. This condition, however, is the result of approximately a decade of illegal demolition by neglect. The Old Sixth Ward was designated in 1998 and made a protected district in 2007. This house has been a contributing structure subject to protections by the historic preservation ordinance, including demolition by neglect provisions, during this time.

After the owner purchased the property in November 2014, she continued to neglect the structure. The doors and windows were not secured, the holes in the roof were not covered, and the building continued to deteriorate. On June 29, 2015, the City of Houston secured the building by boarding up the windows and doors, and a lien was placed on the house to cover the cost of the work.

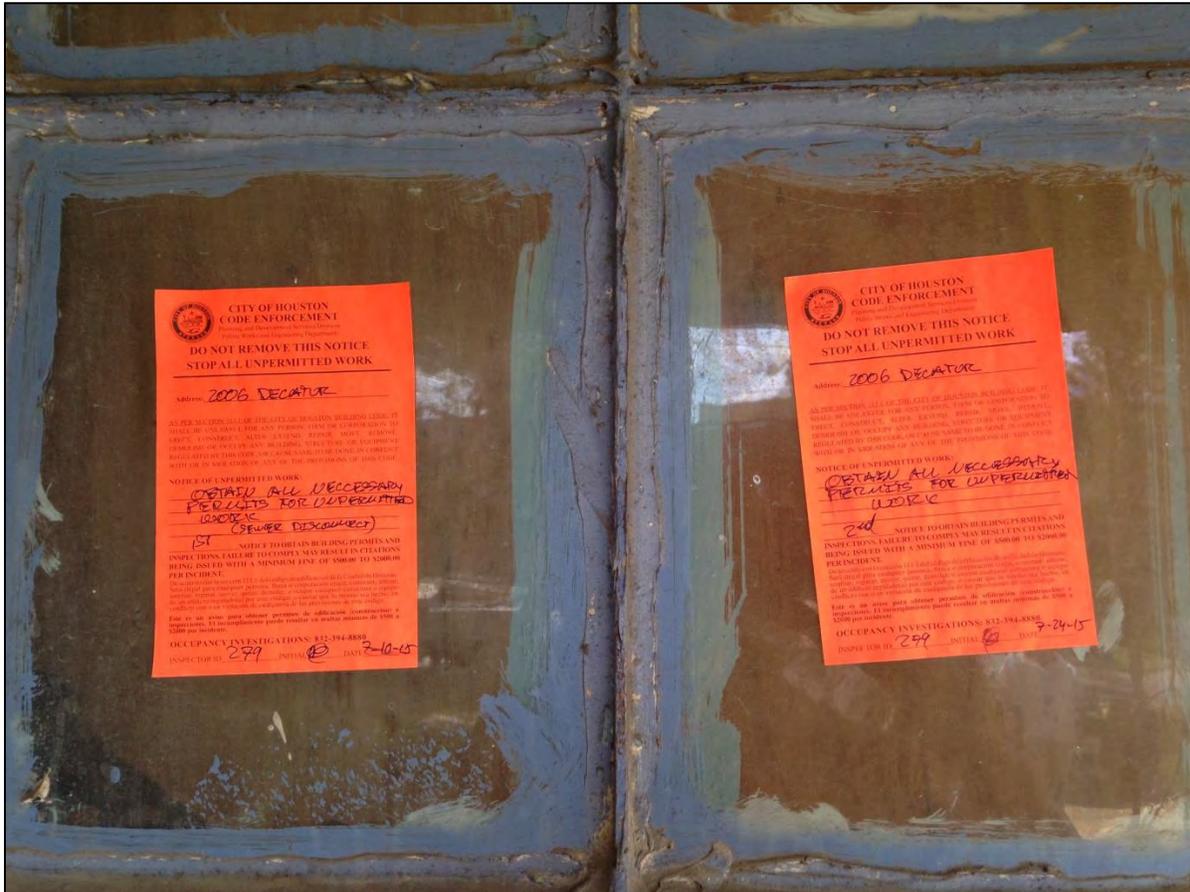
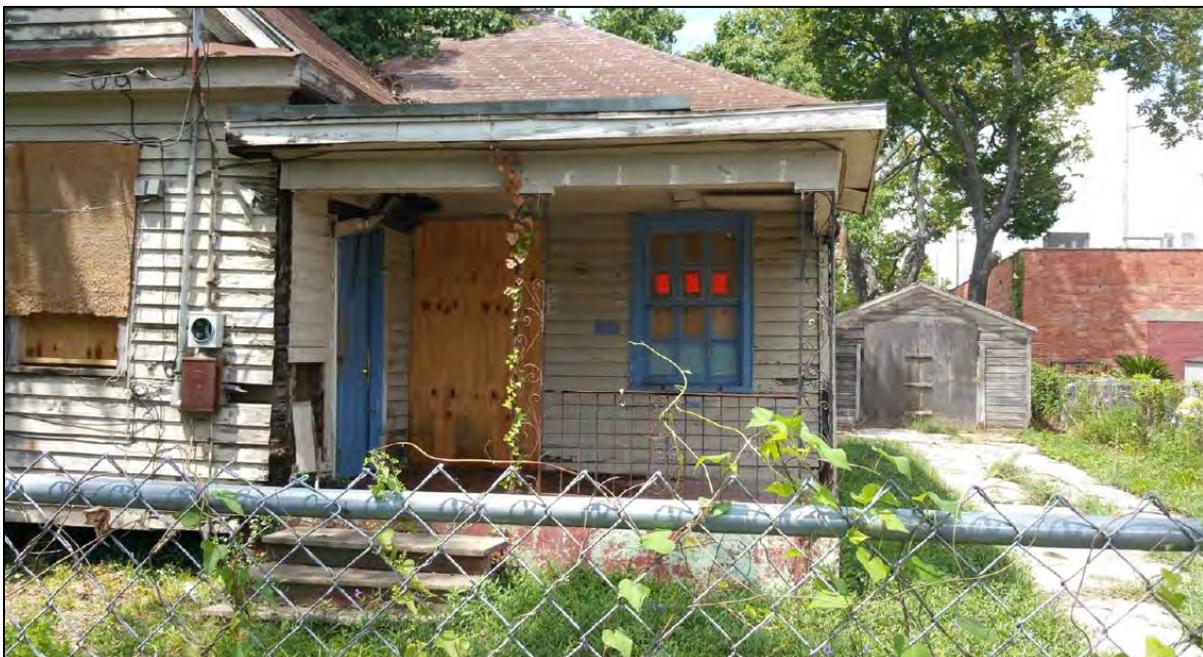
RED TAGS

The property has received several 'red tags' from Code Enforcement for unpermitted work pertaining to a botched sewer disconnect attempt in July 2015.

July 9, 2015: A complaint was received from neighbors that the owner had attempted to disconnect the sewer, the first step in a demolition, without any permits. The property received several Red Tags for this unpermitted work pertaining to the botched sewer disconnect attempt.
