CERTIFICATE OF APPROPRIATENESS

Property: 8223 Colgate Street, Lot 19, Block 46, Glenbrook Valley Subdivision. The property includes a historic 2,533 square foot, one-story wood, brick veneer frame single-family residence and an attached garage situated on a 10,800 square foot interior lot.

Proposal: Alteration – Siding

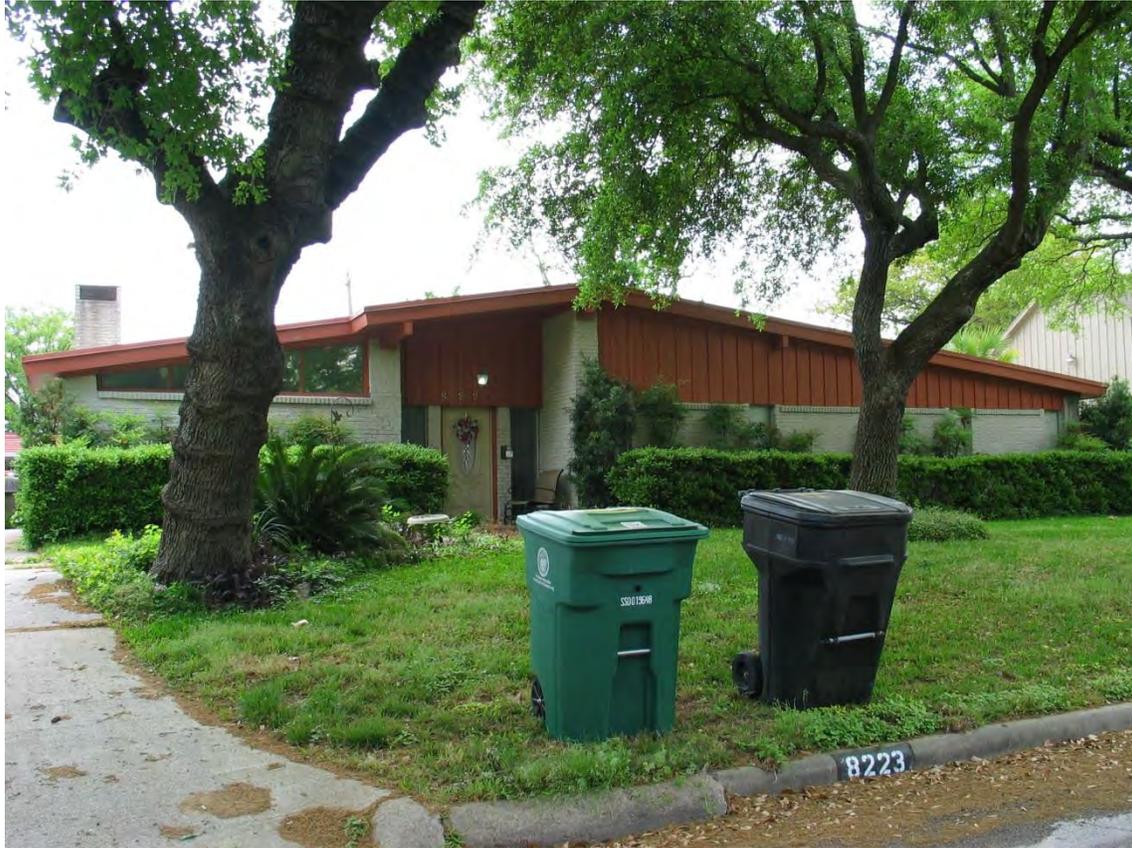
PHOTO OF SIDING

BEFORE

Staff recommends a Certificate of Remediation for the siding replacement. Since the historic siding has been disposed of and these actions therefore cannot be reversed, a Certificate of Remediation will allow the project to be finalized without the Commission deeming the unauthorized siding removal as appropriate.

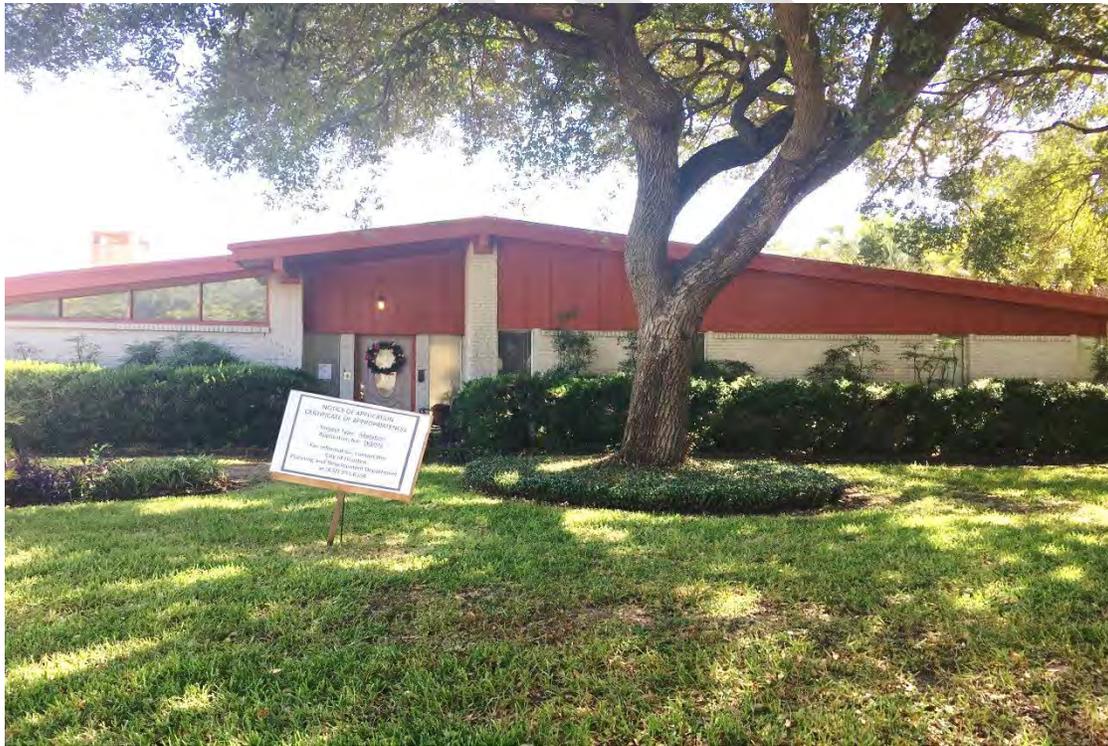
AFTER

- Removed all original Board and Batten wood siding from the front gable and eaves on the entire house.
- Replaced removed siding with cementitious Board and Batten siding to simulate the material removed.
- The applicant made the replacement prior to learning a permit was required and is applying now for retroactive approval. Because work has already been complete, staff was unable to verify the condition of the original material and whether it required replacement.

<i>The removal and disposal of original wood siding destroyed significant historical material found on Mid-century Modern homes. Historic siding should be retained unless damaged beyond reasonable repair. Because the applicant replaced the siding before speaking with staff, staff was unable to evaluate the condition of the siding prior to removal.</i> |
