CERTIFICATE OF APPROPRIATENESS

Property: 210 E 16th St, Tracts 1A & 2A, Block 139, Houston Heights Subdivision. The property includes a historic 1,880 square foot, one-and-a-half- story wood frame single-family residence and a detached garage situated on a 5,500 square foot (55' x 100') interior lot.

Proposal: Alteration – Remove a wood door and replace with a new wood and glass door. The applicant states safety concerns as the reason to replace the door and has provided a photo of a similar house that has been demolished as evidence to support the installation of a new door. A staff inspection confirmed that the existing door is historic.

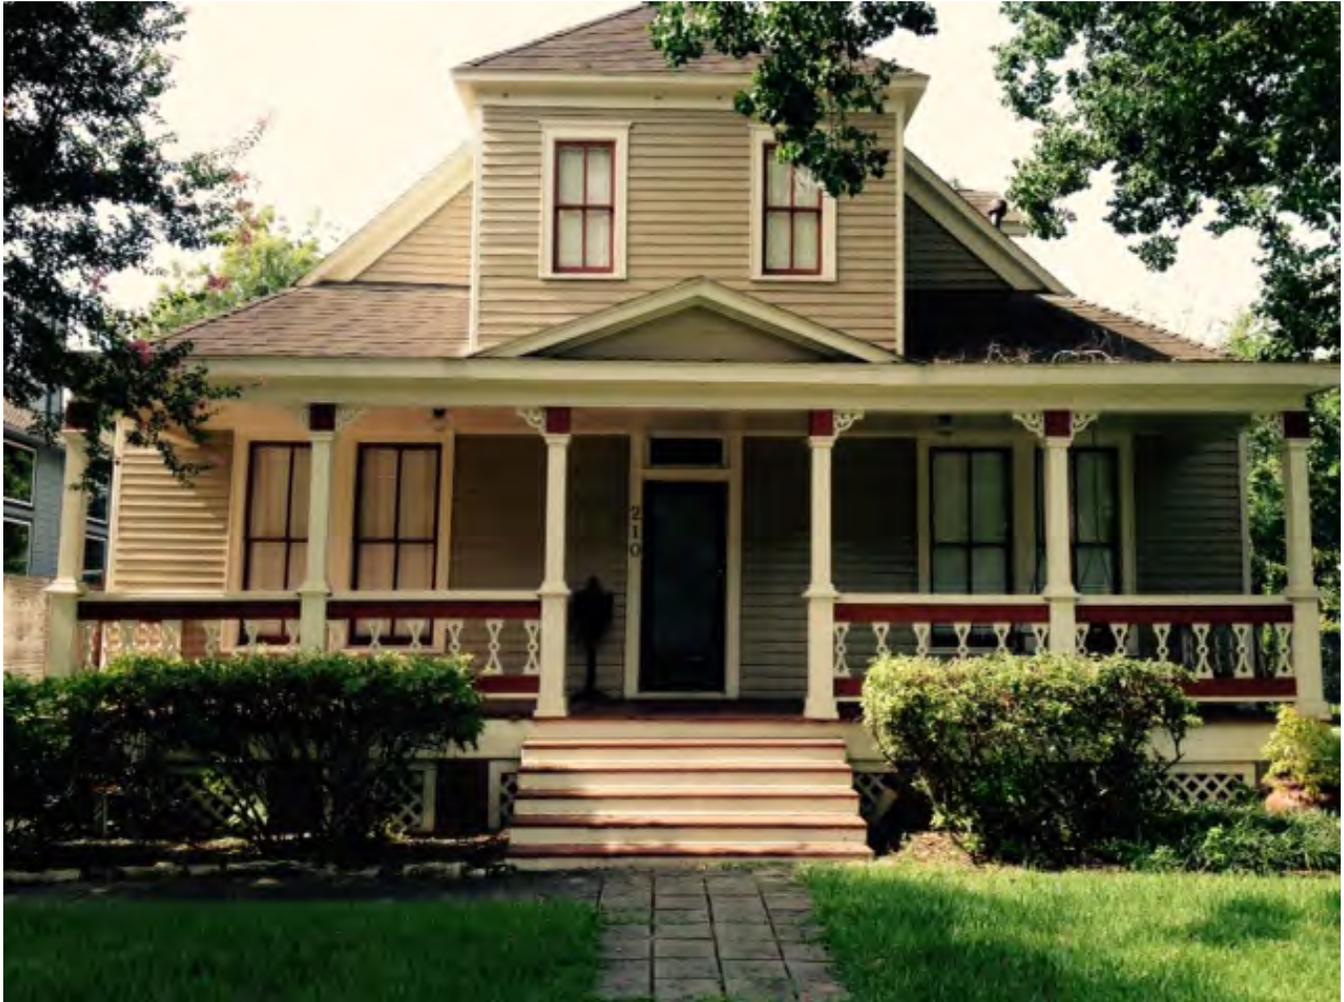
CURRENT PHOTO

NORTH ELEVATION – FRONT FACING E 16th STREET

Front Elevation: The residence contains a wood and glass front door and steps with no railing. The alteration
(North) replaces the historic front door with a new door with a 4-lite glass insert and installs new decking and handrails on the steps to match the porch.

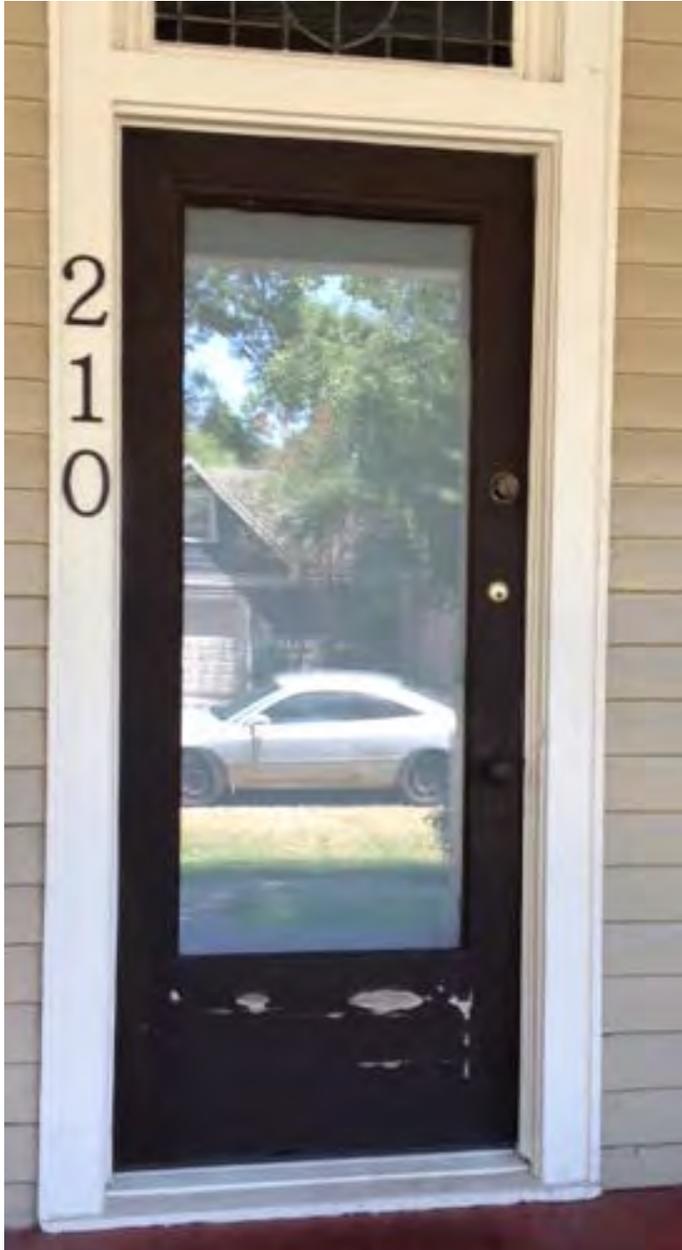
EXISTING DOOR

<i>The existing front door is a historical feature of the property and should be preserved. Though the house shown in the historic photo is similar, there is no evidence this structure had a door like the one in the photo.</i> | |

Recommendation: Partial Approval: Denial to replace the front door; Approval to install the handrails and new porch decking.

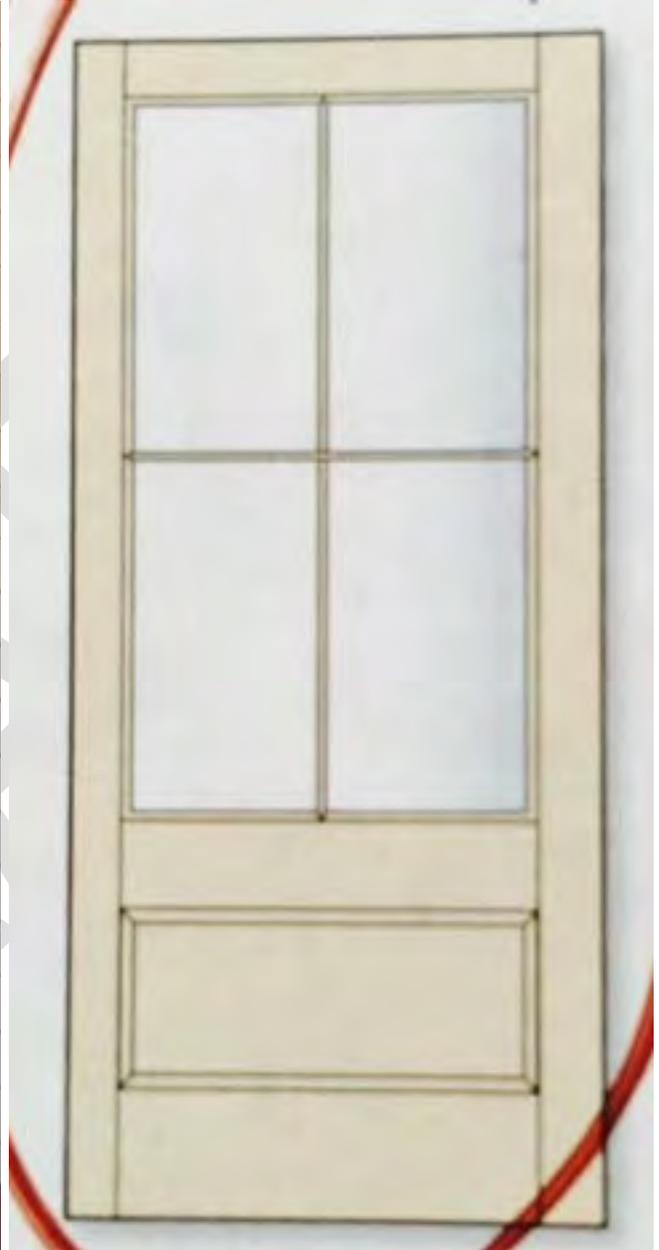
PROPOSED DOOR

Windows/Doors: The residence contains a wood and glass front door. The alteration replaces the door with a wood door with a 4-lite glass insert.

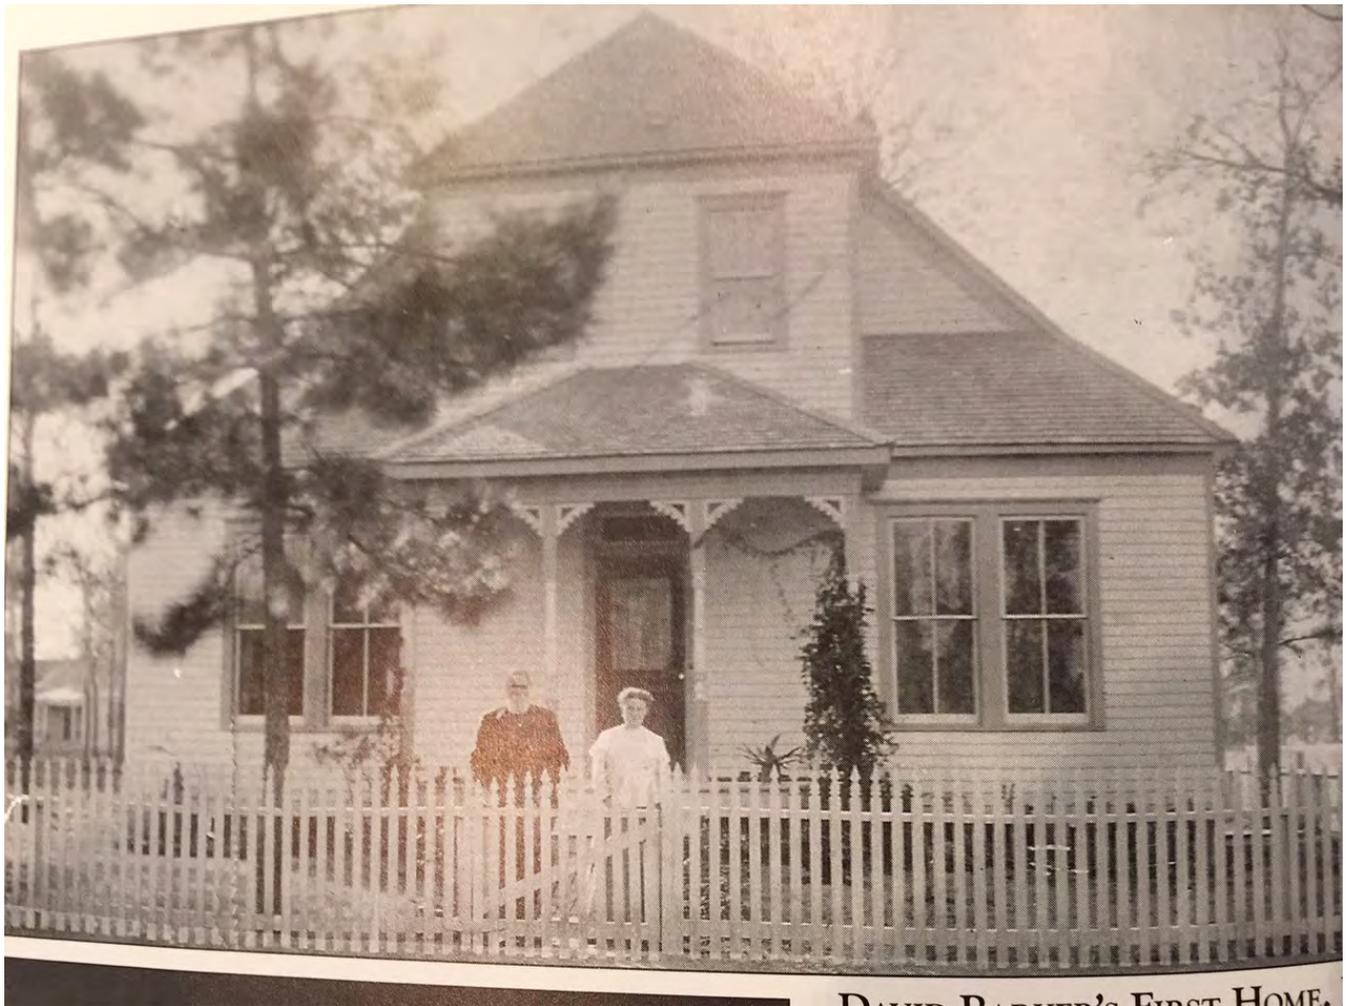
APPLICANT PHOTO OF SIMILAR HOUSE (DEMOLISHED)

DAVID BARKER'S FIRST HOME. Located at Sixteenth Avenue and Cortlandt Street (and now demolished), this is the home where Barker brought his wife in 1905. They lived here until he built the larger home one block away at Sixteenth Avenue and Harvard Street. (Courtesy of Gail Rosenthal.)

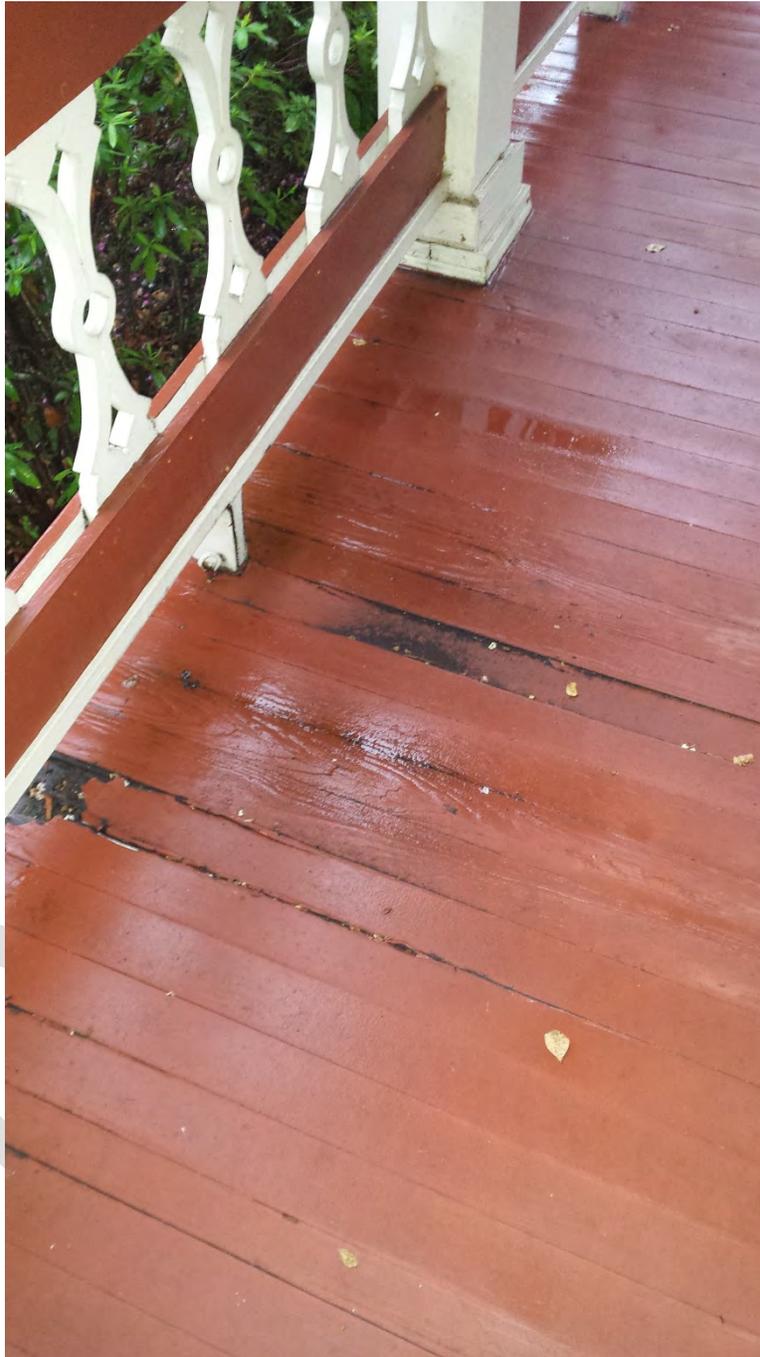
DAMAGED DECKING TO BE REPLACED WITH WOOD TO MATCH

Exterior Materials: The residence contains wood railings, decking and lattice. The alteration installs wood railing on the steps and new wood decking.

- Remove the damaged porch decking and replace with new wood porch decking to match;
- Install handrails on the porch steps to match the existing handrails for safety reasons;
