CIRCULATION STUDY

The Area adjacent to Hillcroft Avenue and Harwin Drive

Transportation Group

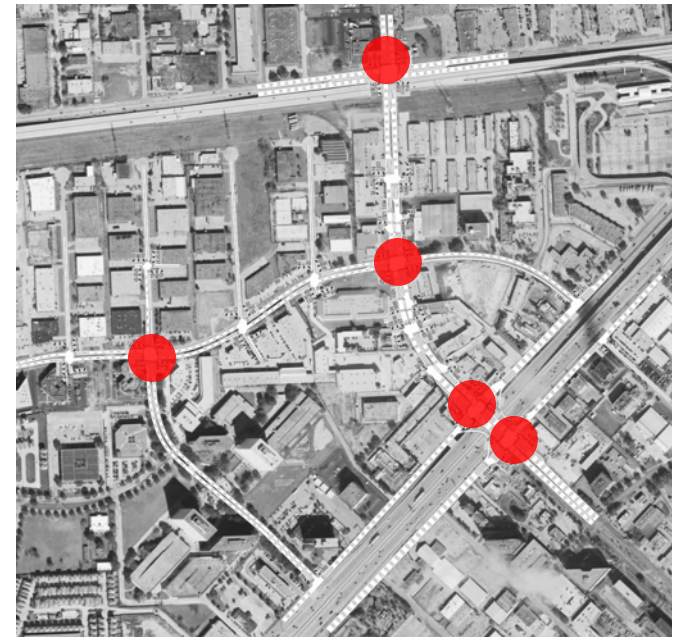
- Retime the existing five signals

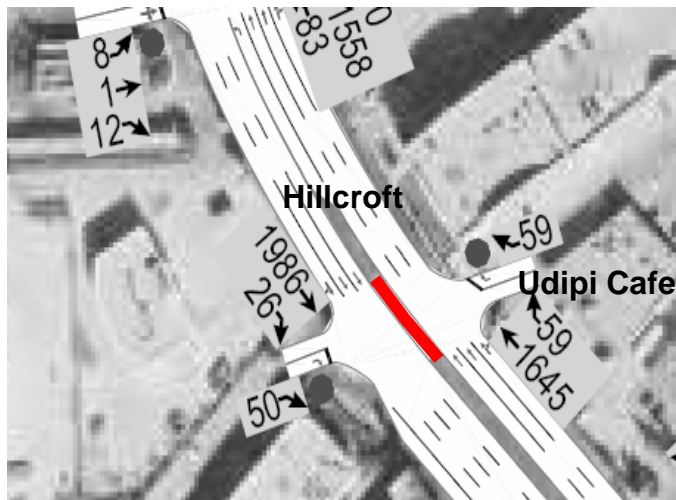
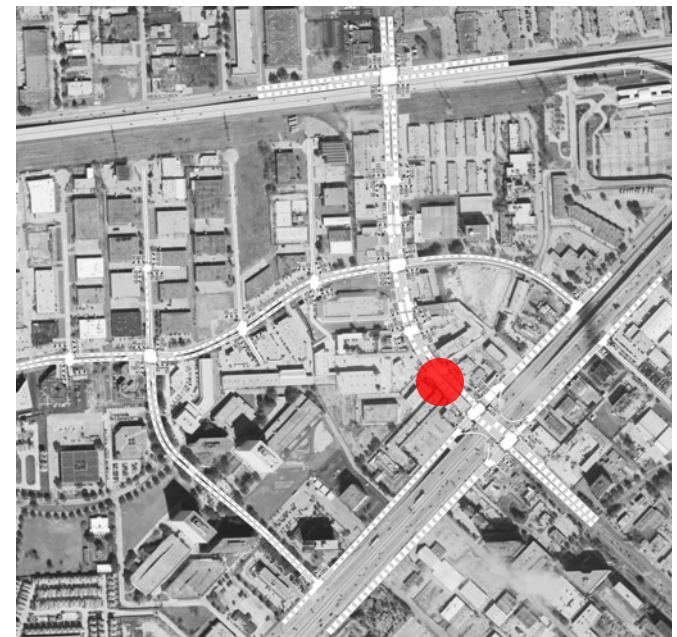
- Close the median on Hillcroft adjacent to the Udipi café Driveway

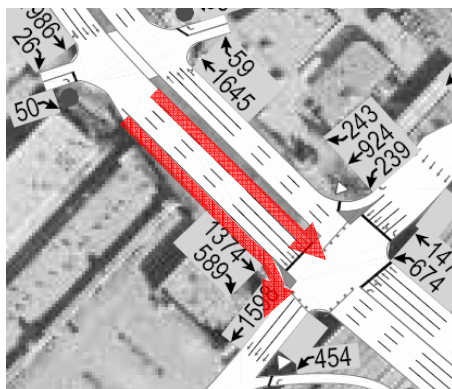
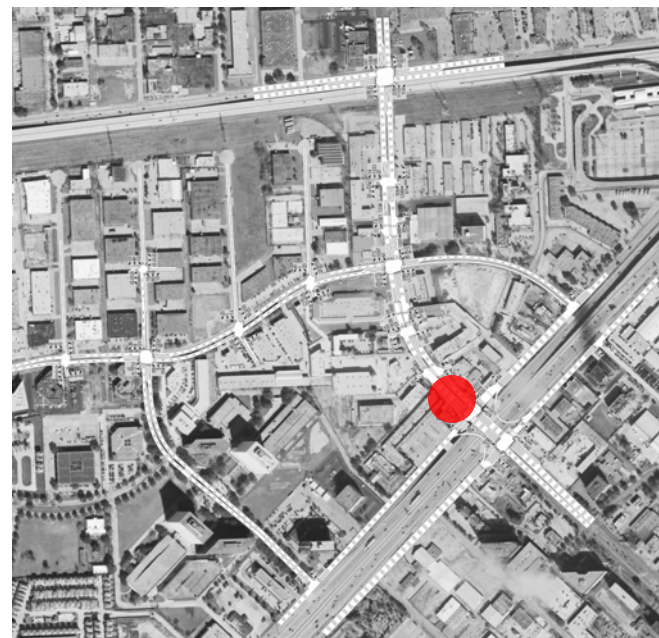
- Extend the right turn only lane to 400 feet on the southbound approach of Hillcroft at the US 59 and Hillcroft intersection
- Extend the existing striping of the left turn only lane on the southbound approach of Hillcroft at the US 59 and Hillcroft intersection

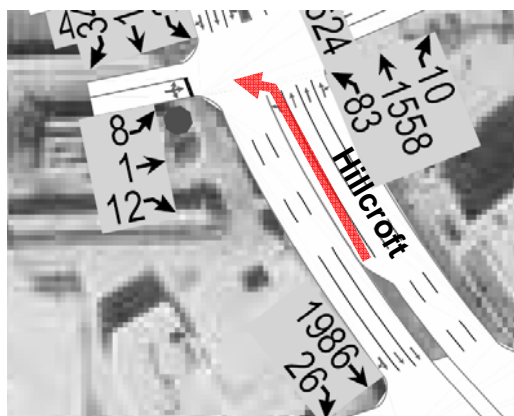
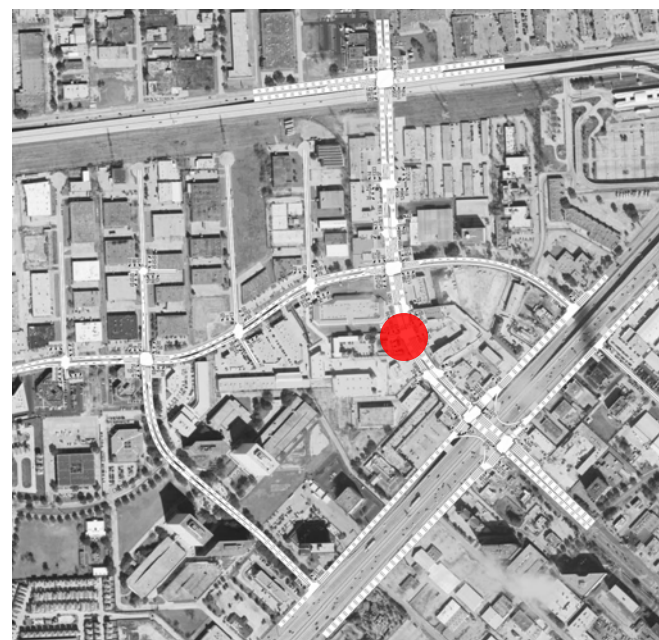
- Extend the existing left turn storage lane to 150 feet on the northbound approach of Hillcroft at the Sonic restaurant driveway and Hillcroft intersection

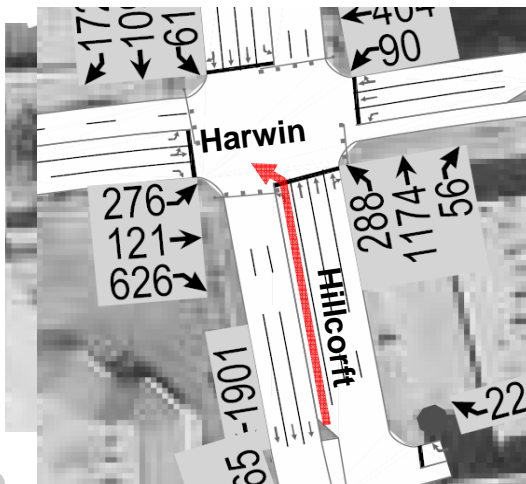
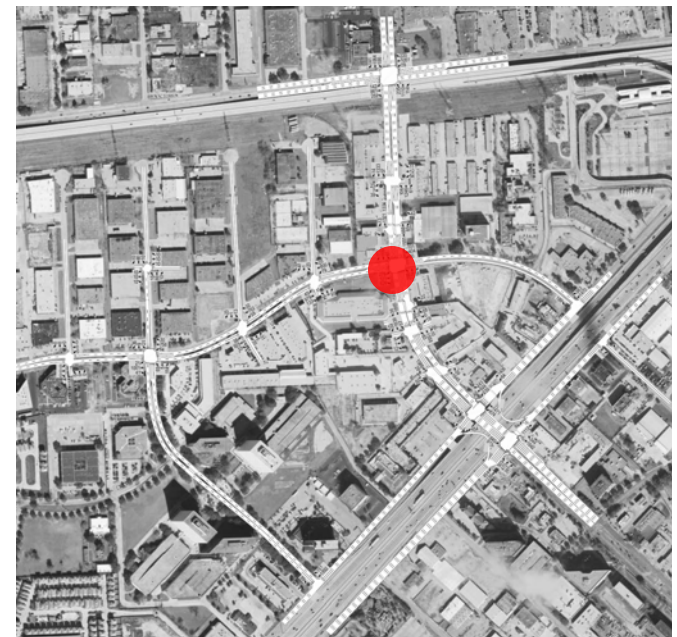
- Extend the existing left turn storage lane to 175 feet on the northbound approach of Hillcroft at the Harwin and Hillcroft intersection

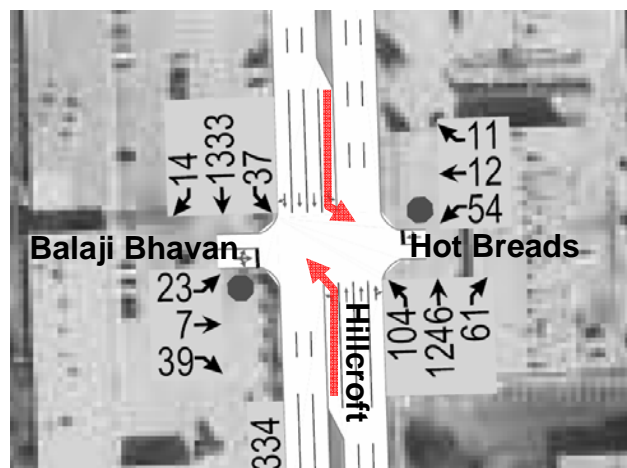
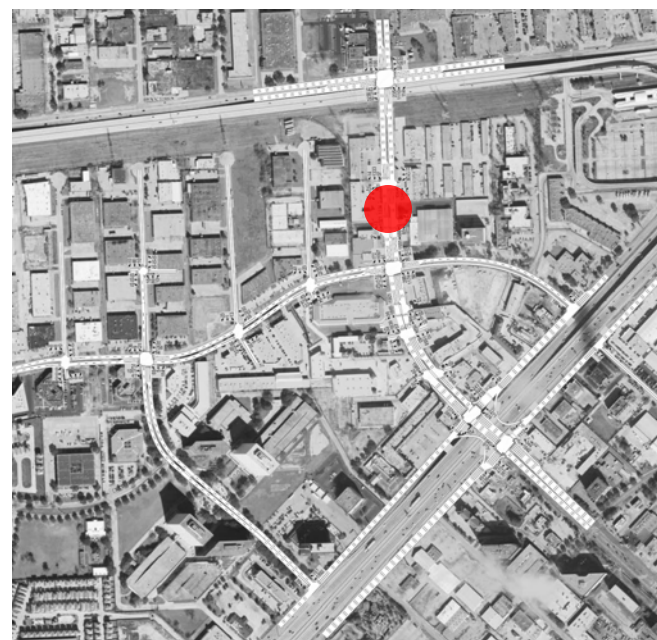
- Add left turn storage lanes of 100 feet on both south and northbound approaches of Hillcroft at the Hot Breads/Balaji Bhavan Driveways and Hillcroft intersection

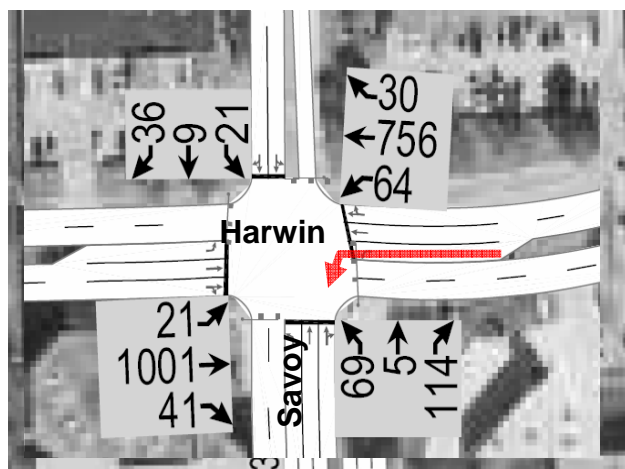
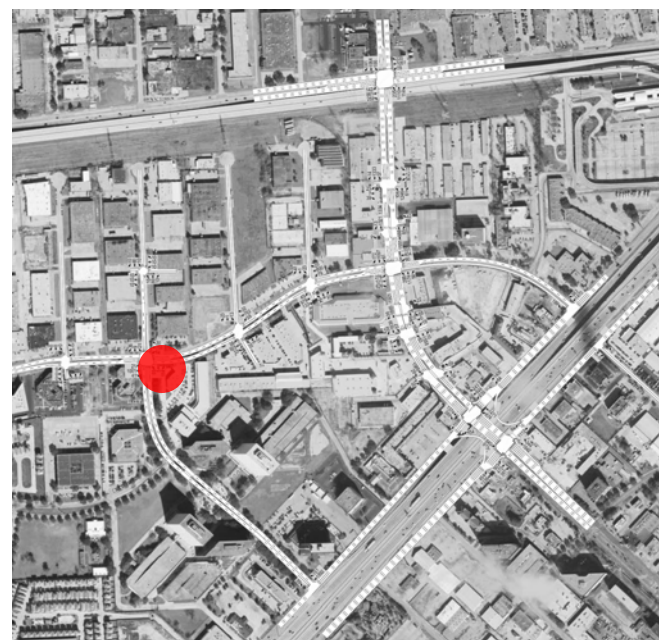
- Add left turn storage lane of 100 feet on eastbound approach of Harwin at the Savoy and Harwin intersection

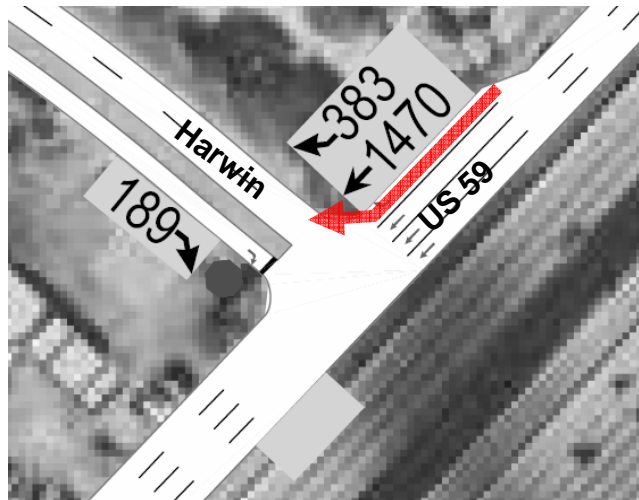
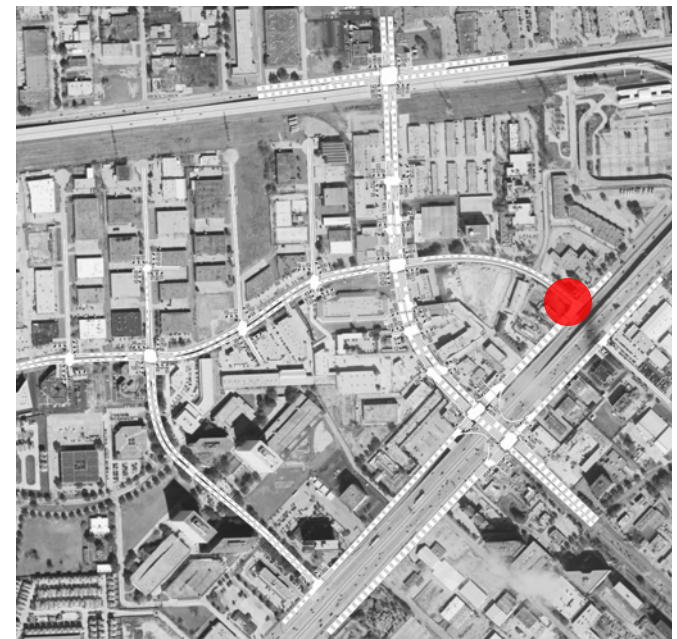
- Add right turn storage lane of 100 feet on westbound approach of US 59 at the Harwin and US 59 intersection

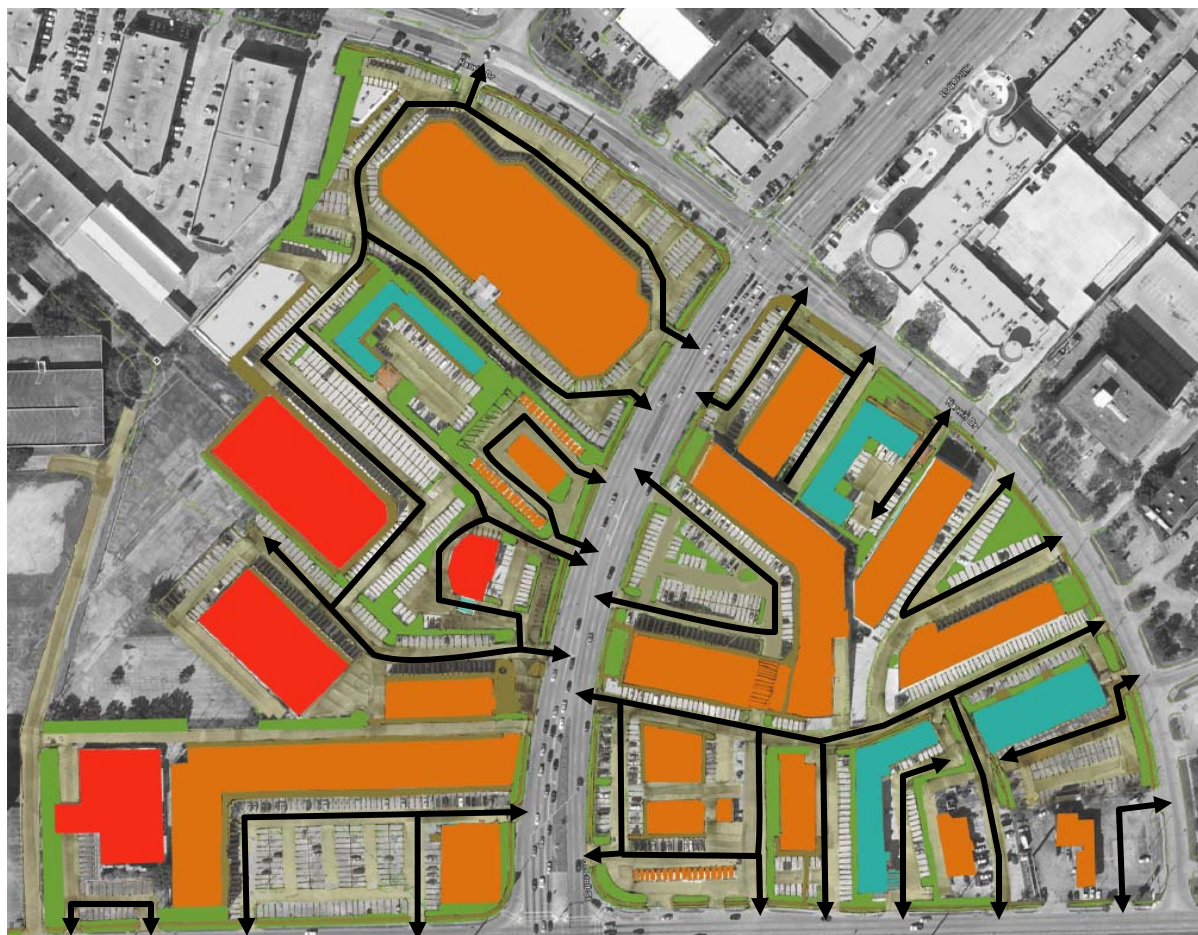
Internal Vehicle Circulation

1. **Inefficient driveway access management**
2. **Lack of internal connectors**
 - Dead-end driveways
 - Separation between properties
 - Obstructions between driveways (ex. Garbage dumpster)

↔ Existing Internal driveways

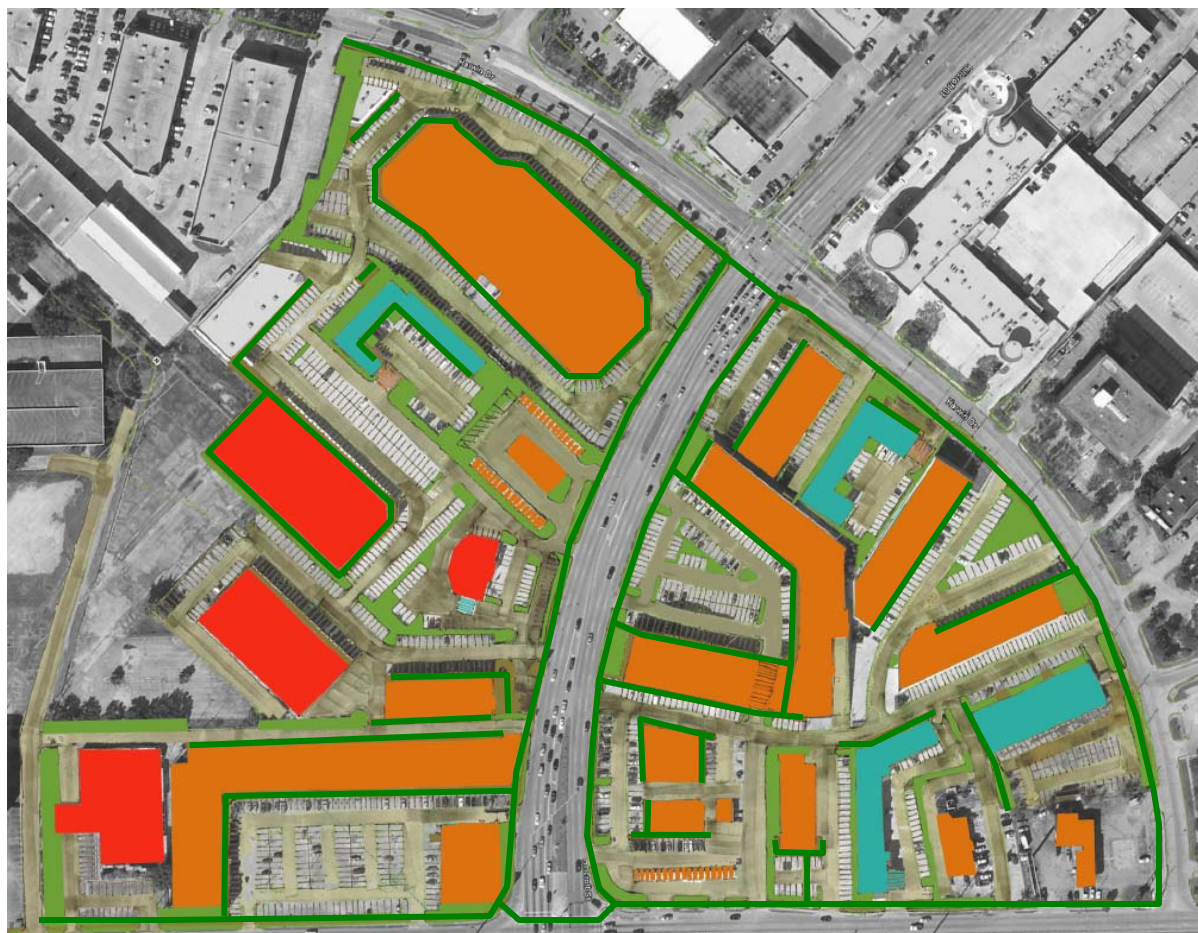
Pedestrian Circulation

1. **Lack of pedestrian connections between**
 - C and D sections
 - Public and private sidewalks
 - Adjacent complexes
2. **Lack of pedestrian environment**
 - Inconsistent landscapes
 - Anti-pedestrian parking design (ex. front parking)

Existing sidewalk
