PROTECTED LANDMARK DESIGNATION REPORT

LANDMARK NAME: House at 1918 Crockett Street

LOCATION: 1918 Crockett Street, Houston, Texas, 77007 – First Ward

TYPE OF APPROVAL REQUESTED: Protected Landmark Designation

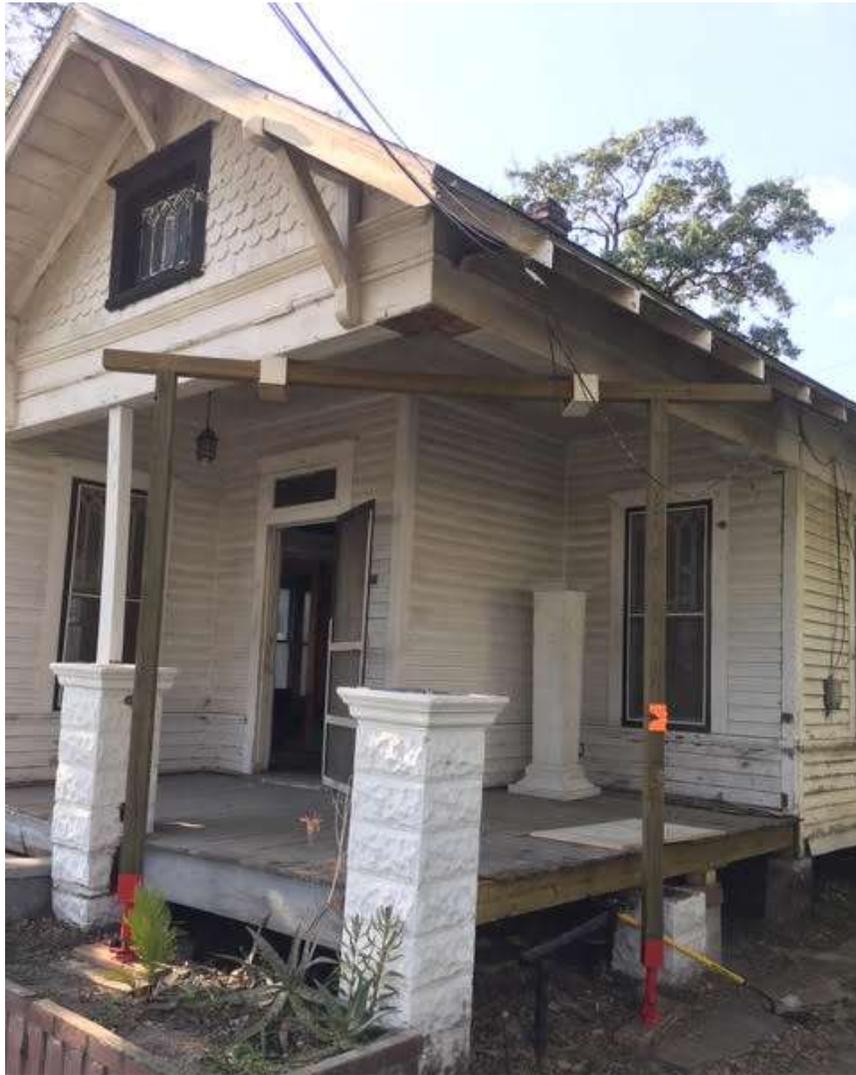
FRONT FAÇADE FACING CROCKETT STREET

The front façade facing Crockett Street is two bays wide. The first (left bay) contains one original sash window. The upper sash contains a Victorian picket fence window pattern. The lower sash has a single pane of plate glass. The window has a thin wood frame and simple wood surround with a simple ledge molding above the window.

The second (right bay) contains an inset, partial-width porch with a slightly projecting gable front. Lattice trim covers the pier and beam foundation. Concrete steps lead onto the porch. The front door contains an exterior screen door that has a thin wood frame and simple wood surround.

The owners removed the modern brick columns supporting the porch rail (not original to house), except for one tapered column in place that appeared to be original to the house based on the age of the wood. The column was located in the corner of the porch, and the owners moved it to the position closest to the front door. They reproduced two tapered columns using the same dimensions as the remaining original column. The masonry block column supports were taken down (one column was intact and two partially intact at the time of restoration). Some masonry blocks remained in their original positions, while others were stacked nearby after original columns collapsed. The column supports were reconstructed using original blocks.

New concrete footings were poured on top of the original footings after taking note of the placement of original concrete footings located below soil level. The owners leveled the porch floor and replaced rotten joists. They removed the modern plywood on the porch floor to reveal the tongue and groove floorboards, as well as replaced the rotten tongue and groove boards.

The owners determined that the porch railing stored nearby on the property was original due to the age of the wood and bread loaf pattern of stiles consistent with other houses in the First Ward. They reproduced and installed two sections of railing using the original as a template. Lattice panels were installed around the perimeter of the front porch.

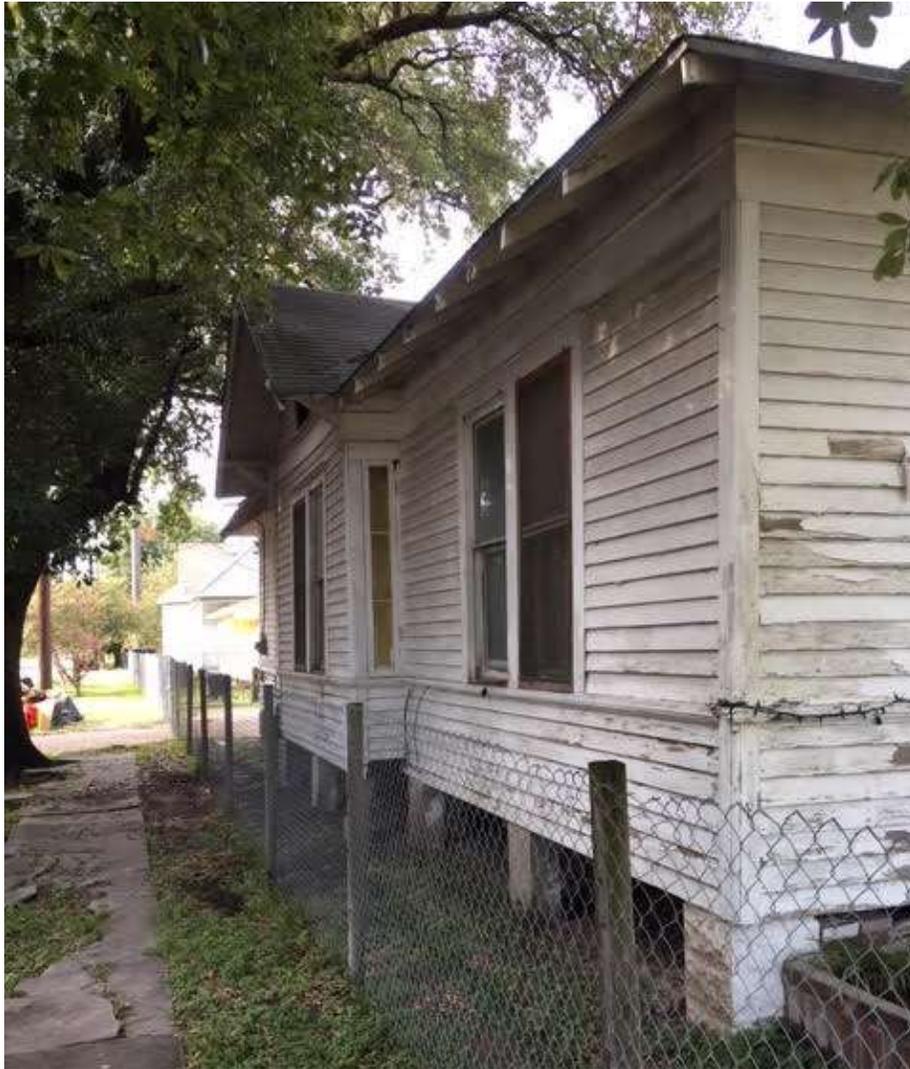
SIDE FAÇADE FACING WHITE STREET
PHOTOS BY BRUCE BOATNER

The façade facing White Street (the right side of the house) is three bays wide with a continuation of the wooden stringcourse with simple wood molding that runs the full-width of the façade. There is a slightly projecting gable front in the second (central bay).

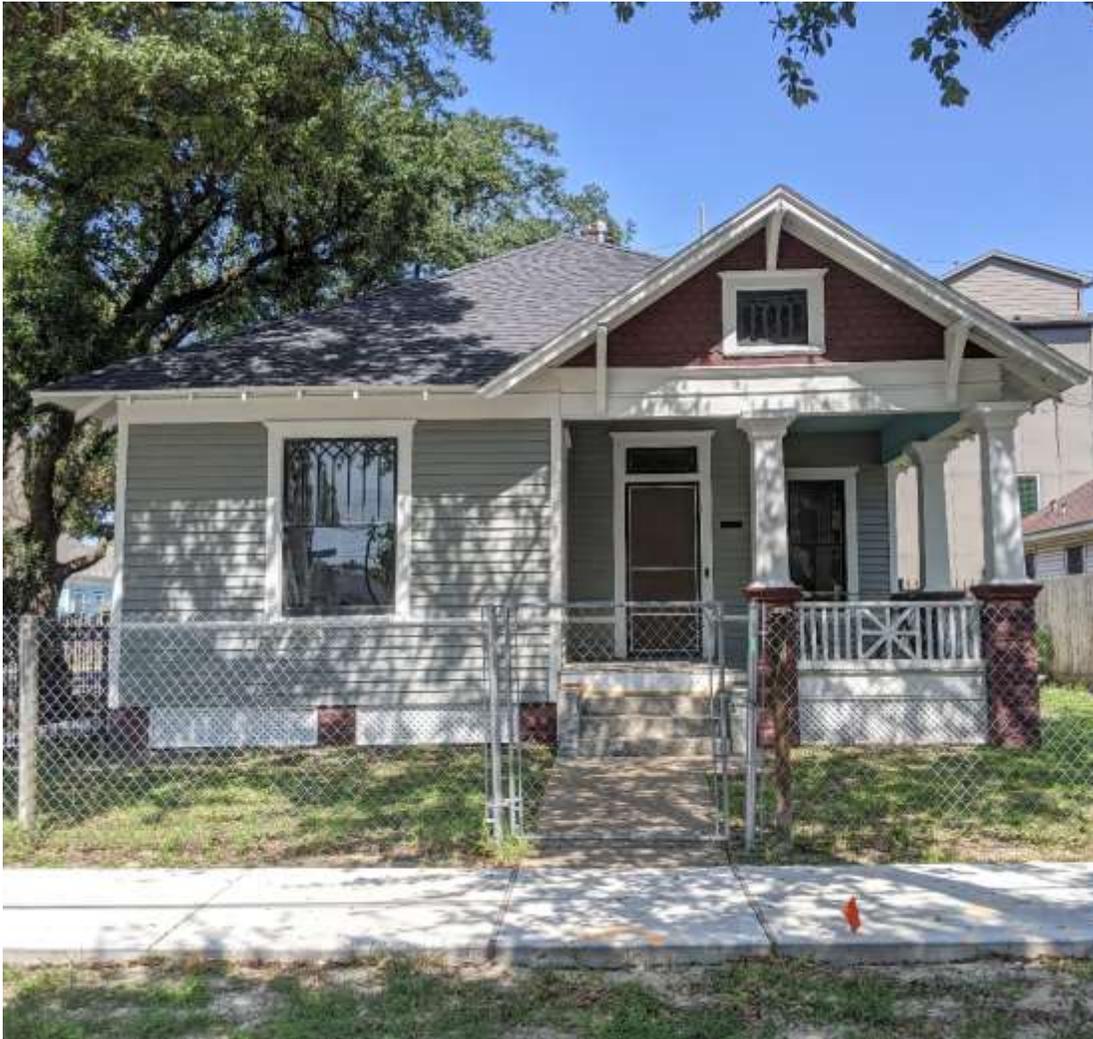
FRONT FAÇADE FACING CROCKETT STREET

The ornate wooden front door contains a large panel of beveled glass which was restored by the owners. Above the door, there is a transom with a Victorian picket fence window pattern. There is a simple ledge molding above the transom. To the right of the front door, there is a sash window. The upper sash contains a Victorian picket fence window pattern. The lower sash has a single pane of plate glass. The window has a thin wood frame and simple wood surround with a simple ledge molding above the window.

Two tapered wooden, square columns on rusticated cast stone bases are on the right side of the porch. Between the two front-facing columns, there is wooden, bread loaf porch railing with a decorative pattern in the balustrade.

The porch gable contains a window with a Victorian picket fence window pattern. The window has a thin wood frame and simple wood surround with a simple ledge molding above the window. There are three Craftsman-style brackets under the eaves in the gable. The gable is covered in fish-scale shingles.

The current property owners, Bruce and Carole Boatner, have made significant efforts to restore the historic characteristics of 1918 Crockett, particularly the front porch.

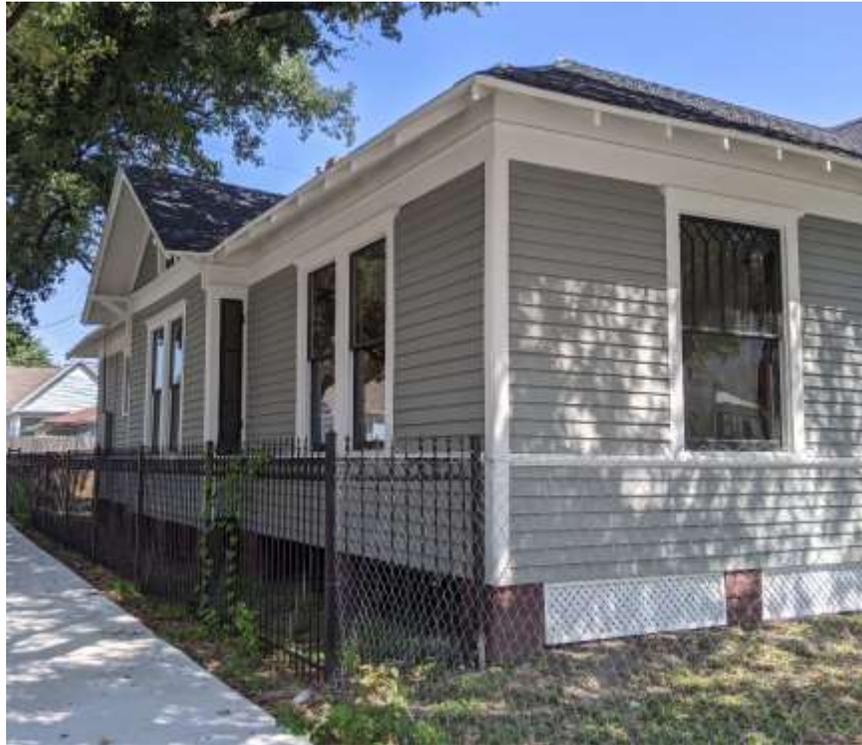
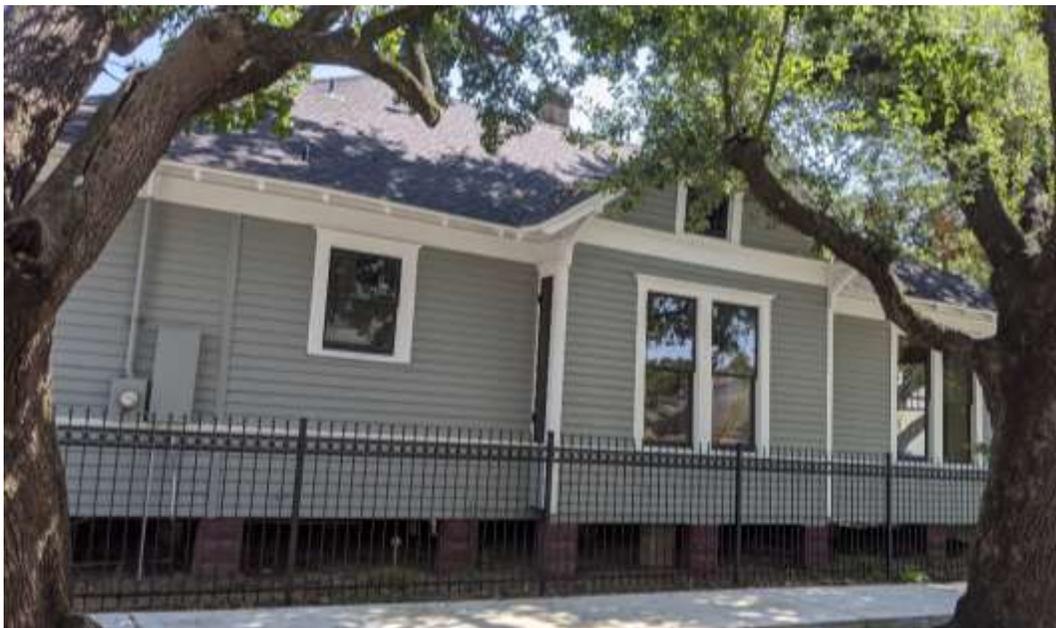
SIDE FAÇADE FACING WHITE STREET
PHOTOS BY PRESERVATION HOUSTON

The first (leftmost bay) contains one 1-over-1 sash window within a thin frame and simple wood surround. There is a simple ledge molding above the window.

The second (central bay) contains two 1-over-1 sash windows, each within a wood frame. There is a simple wood surround that contains both windows, with a simple ledge molding above. The wooden stringcourse separates the windows from the slightly projecting gable. Above the stringcourse, there is one window with a Victorian picket fence window pattern. The window has a simple wood surround with a simple ledge molding above the window. One Craftsman-style bracket is under the eaves at either end of the gable.

The third (rightmost bay) contains two 1-over-1 sash windows, each within a wood frame. There is a simple wood surround that contains both windows, with a simple ledge molding above.
