CERTIFICATE OF APPROPRIATENESS

Property: 1808 State Street, Lot 7, Block 441, Baker W R NSBB Subdivision. The property includes a historic 936 square foot, one-story wood frame single-family residence situated on a 5,000 square foot (50' x 100') interior lot.

Significance: Contributing gable front folk Victorian residence, constructed circa 1890, located in the Old Sixth Ward Historic District. An existing rear addition was constructed at an unknown date.

Proposal: Alteration – Revision. Replace the remaining original window (located under the porch (known as ‘Window G’)) with a 4-over-4 double-hung wood window (matching the exact dimensions and to previously installed new windows) and replace the existing non-original secondary front door with a custom wood door to match the original primary front door.

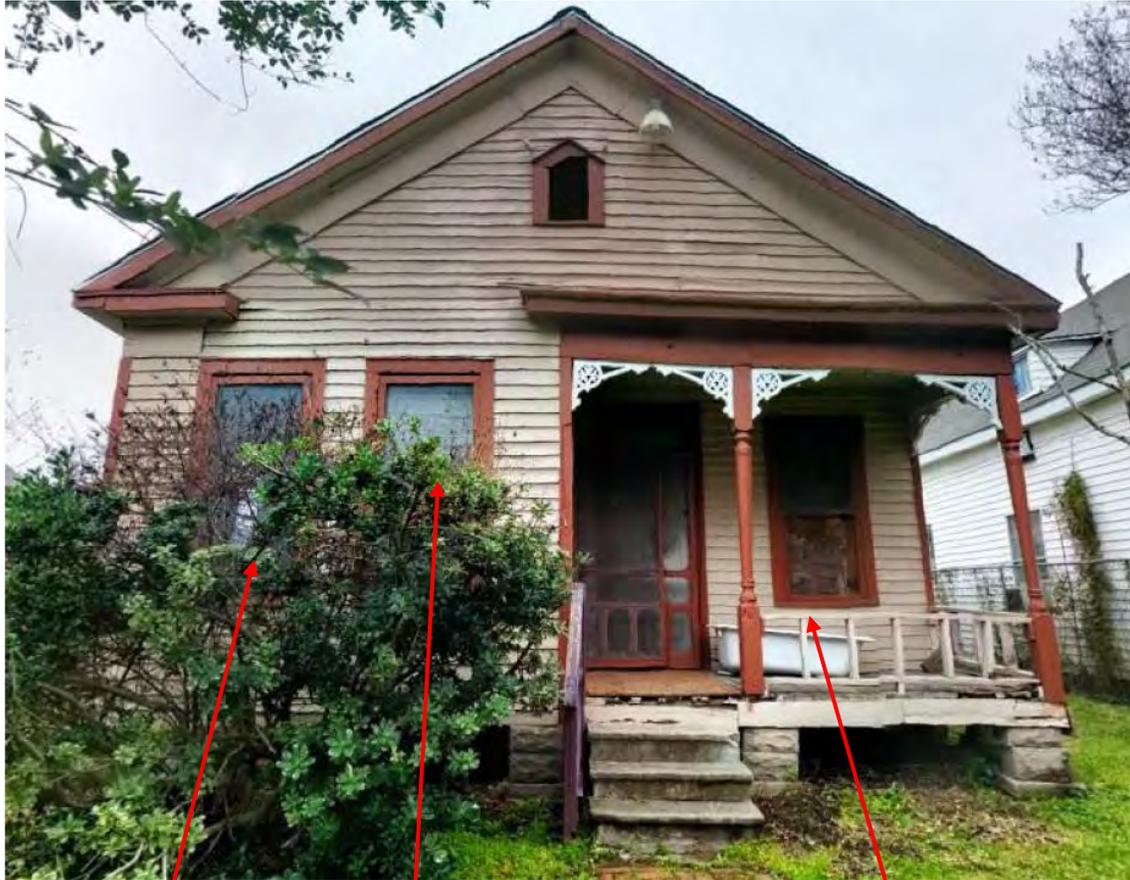
PREVIOUS APPLICATION WINDOW CHART

SOUTH ELEVATION – FRONT FACING STATE STREET

(NO CHANGE IN LITE PATTERN)

A

B

G – TO BE RETAINED

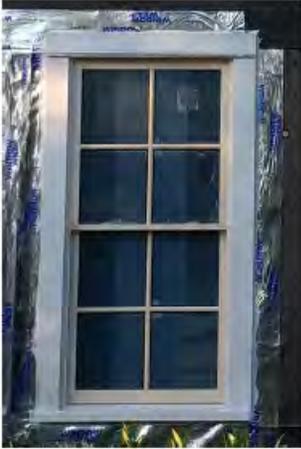
<ul style="list-style-type: none"> • 4-over-4 wood window • Damaged, rotted wood window • Trim is damaged, rotted

<ul style="list-style-type: none"> • Replace with double hung 4-over-4 wood window • Trim to reflect the same style from original home

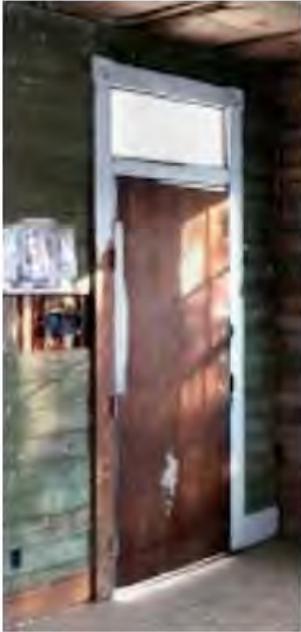
<ul style="list-style-type: none"> • Wood "door" is a flat piece of wood with a cut at the top

<ul style="list-style-type: none"> • Replace with Craftsman style wood door • All wood, no glass

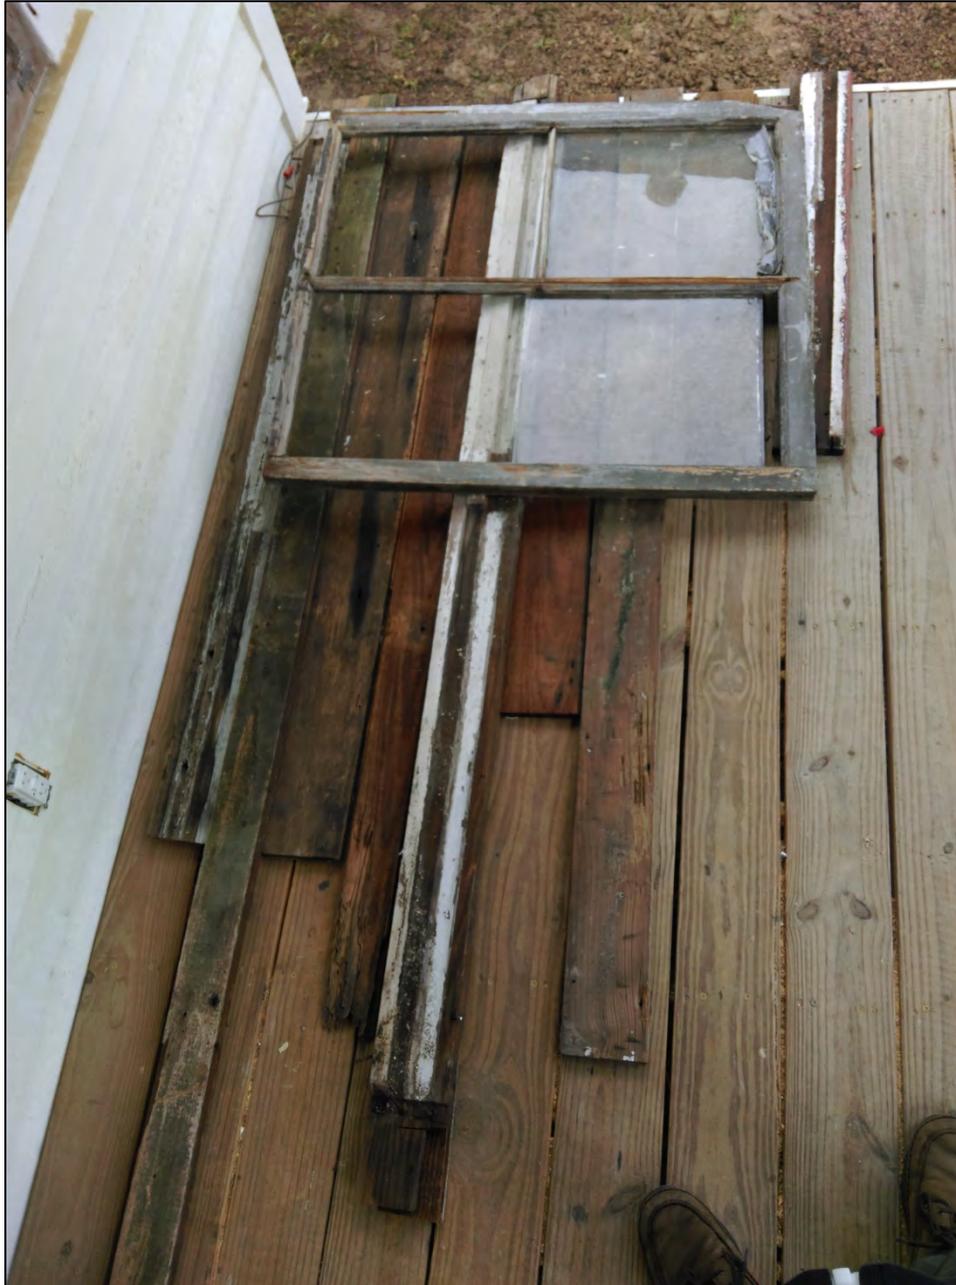
CURRENT WINDOW CONDITION

Proposed: The applicant seeks to replace the seventh, and last remaining original window (located under the porch (known as 'Window G')), with a new 4-over-4 wood sash window to match the previously installed new windows. The existing non-original secondary front door will be replaced with a custom wood door to match the original primary front door. Staff has now been granted access to assess the window and has determined that it is damaged beyond reasonable repair. See photos and drawings for more detail.

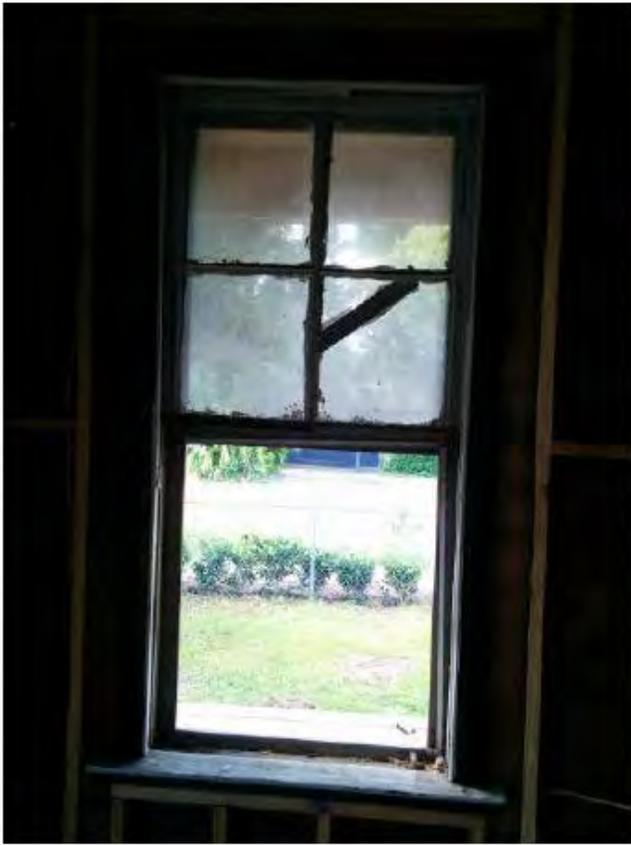
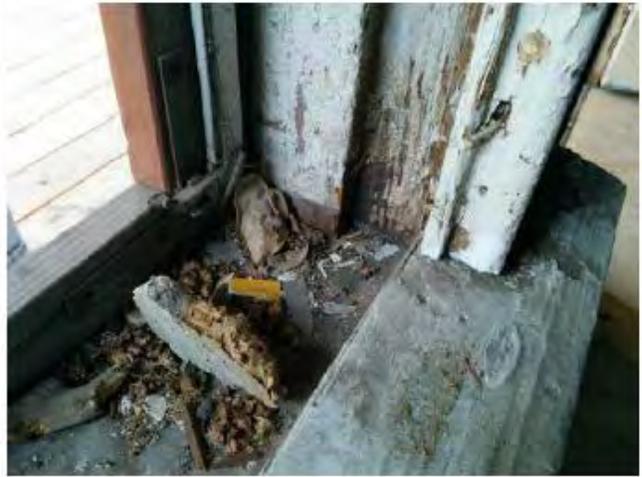
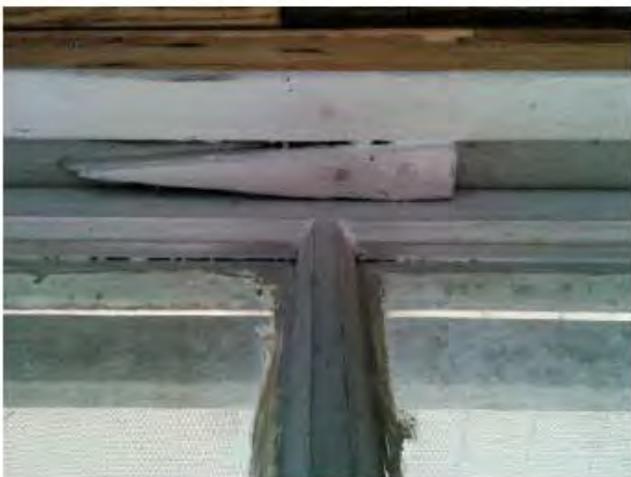
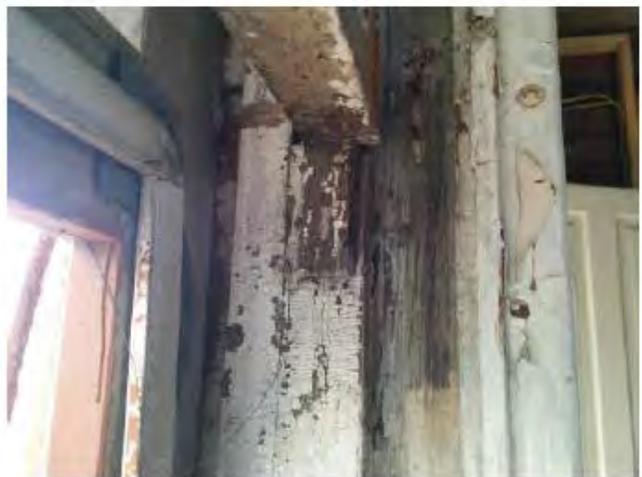
WINDOW G DETAIL

Now, the applicant would like to replace the lone, surviving, street-facing window. When the city and neighborhood inspected this window during the earlier application, we all noted that this front window was in better shape than the others. We now feel unsure why the applicant says this window's in irreparable shape. Is it the same window? During the earlier inspection, we noted that the front window and side windows were of slightly-different dimensions.

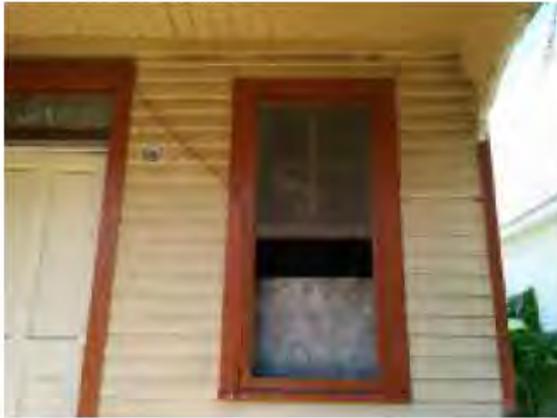
APPLICANT ASSESSED WINDOW DAMAGE

Window G

- 1-over-1 wood window
- Damaged, rotted wood window
- Trim is damaged, rotted

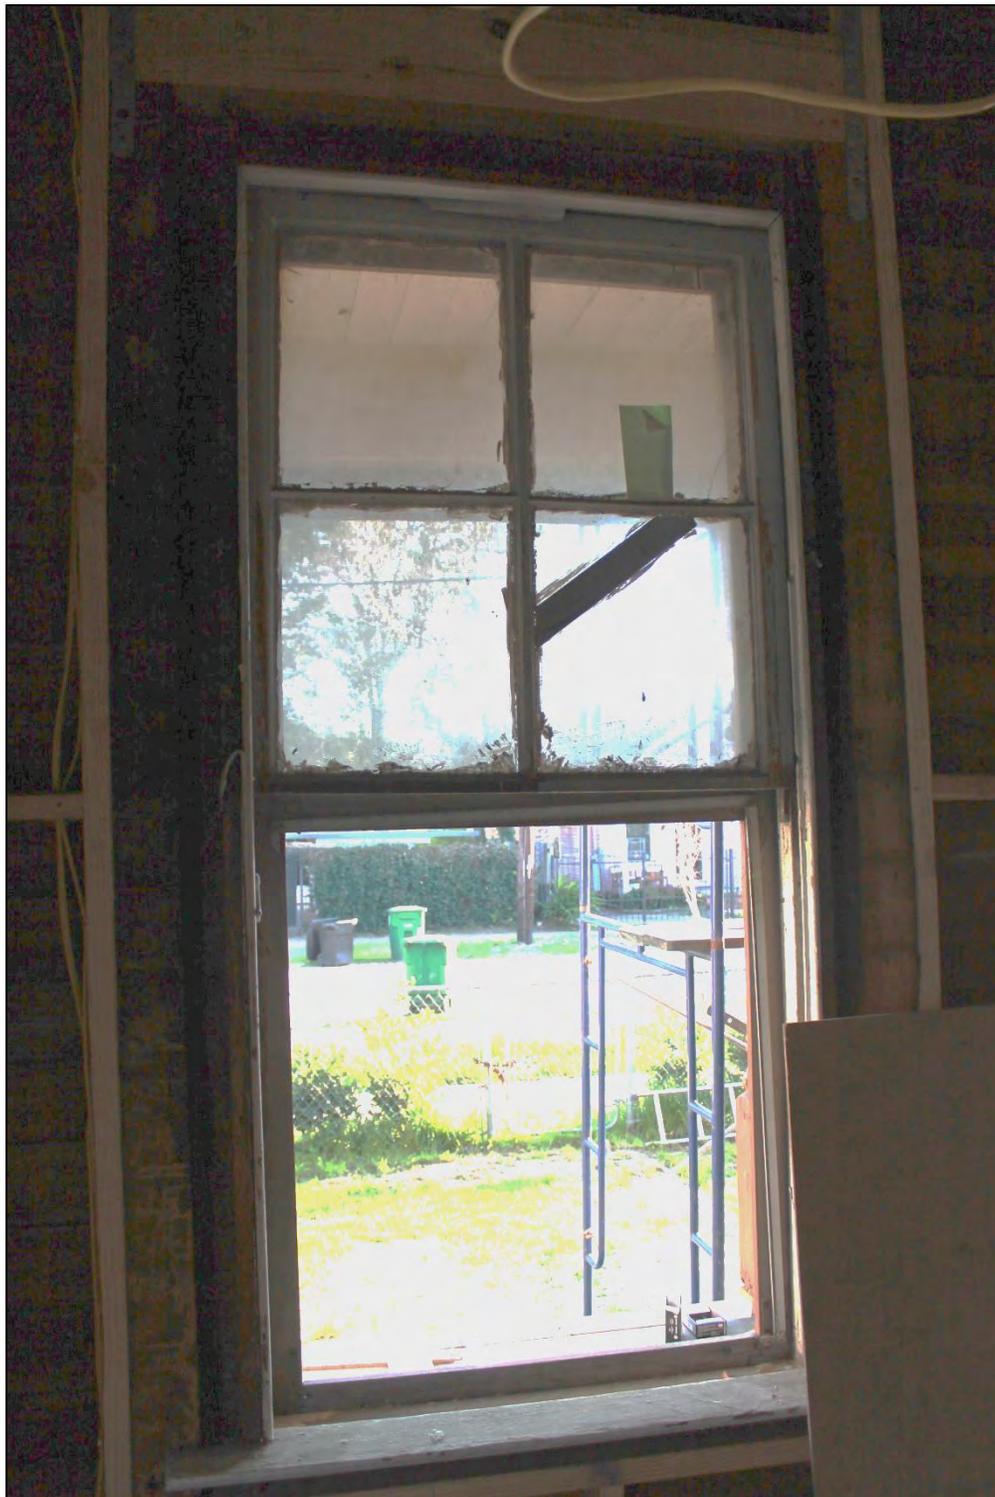
PREVIOUS STAFF PHOTOGRAPH

City inspection and our neighborhood site visit confirmed that existing windows were in rough shape, but repairable. Many windows lacked sashes, but we argued that the applicant could get duplicate matches made. Alternatively, the applicant could combine sashes and partial windows and produce at least a few fully-original, working windows.

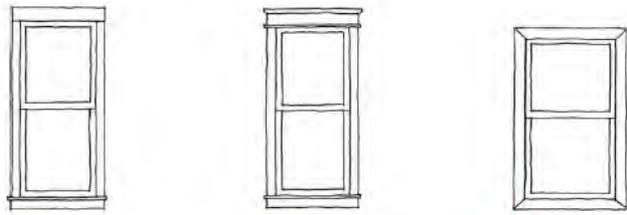
Figure V-9. Window and trim configurations.

Window trim should articulate a sill element, as well as a header that is deeper than the jambs.

Do not use mitered boards of the same width to trim an opening.

Windows shall be vertically proportioned, that is, taller than they are wide.

The horizontal trim elements should dominate at corners, so that the jambs appear to rest on the sill, and the header appears to rest on the jambs.
