CERTIFICATE OF APPROPRIATENESS

Property: 1808 State Street, Lot 7, Block 441, Baker W R NSBB Subdivision. The property includes a historic 936 square foot, one-story wood frame single-family residence situated on a 5,000 square foot (50' x 100') interior lot.

Significance: Contributing gable front folk Victorian residence, constructed circa 1890, located in the Old Sixth Ward Historic District. An existing rear addition was constructed at an unknown date.

Proposal: Alteration – *Revision*. Replace the remaining original window (located under the porch (known as 'Window G')) with a 4-over-4 double-hung wood window (matching the exact dimensions and to previously installed new windows) and replace the existing non-original secondary front door with a custom wood door to match the original primary front door.

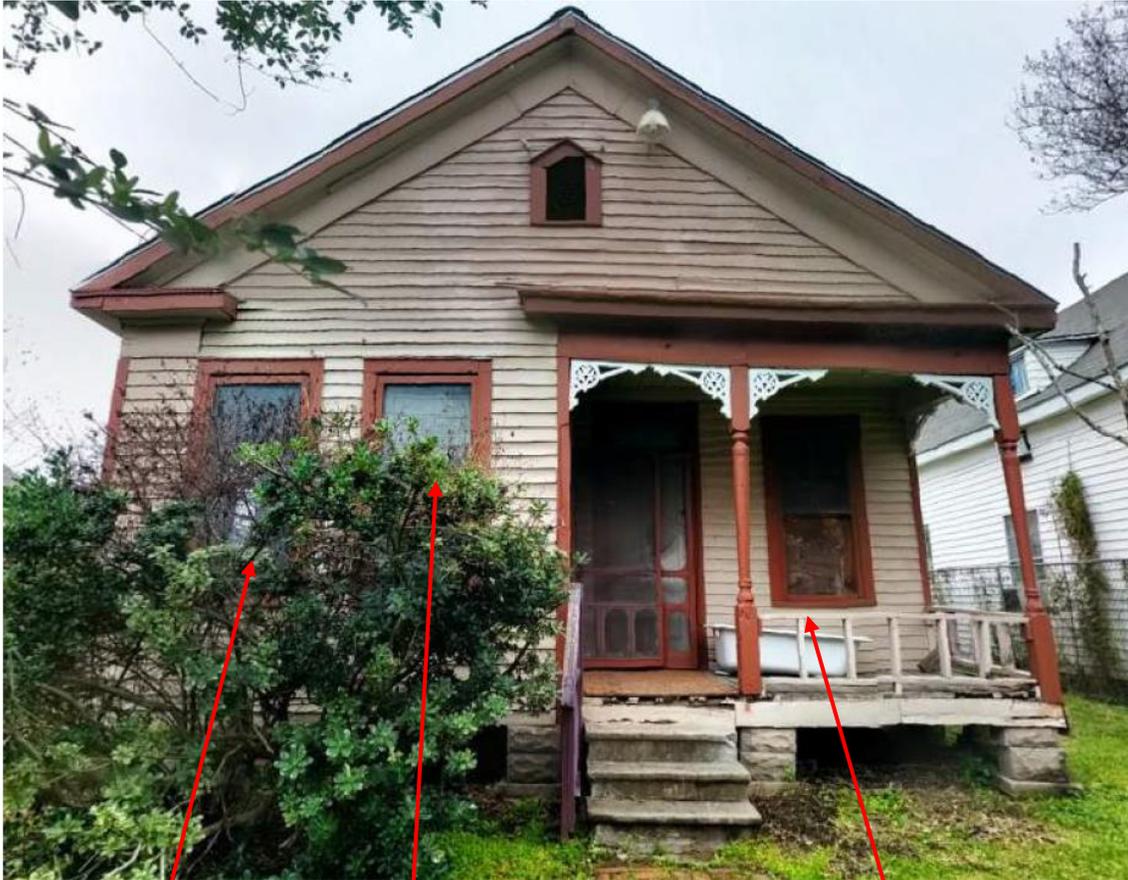
PREVIOUS APPLICATION WINDOW CHART
(NO CHANGE IN LITE PATTERN)

G – TO BE RETAINED

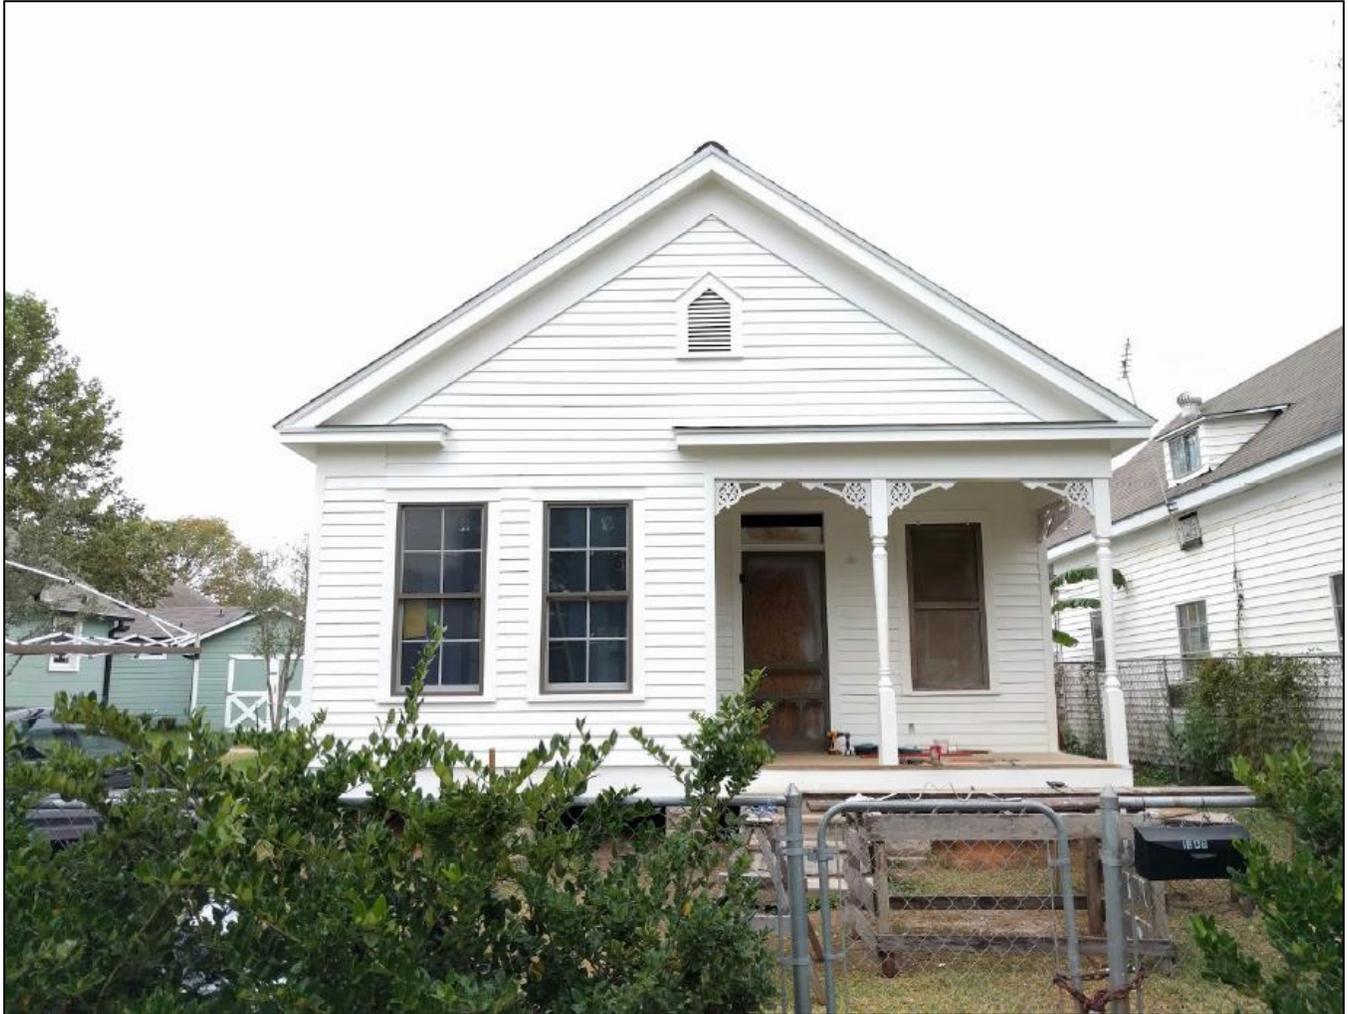
CURRENT PHOTO

SOUTH ELEVATION – FRONT FACING STATE STREET

Proposed: The applicant seeks to replace the seventh, and last remaining original window (located under the porch (known as 'Window G')), with a new 4-over-4 wood sash window to match the previously installed new windows. The existing non-original secondary front door will be replaced with a custom wood door to match the original primary front door. Staff has now been granted access to assess the window and has determined that it is damaged beyond reasonable repair. See photos and drawings for more detail.

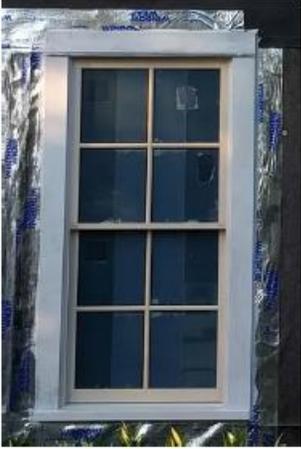
<ul style="list-style-type: none"> • 4-over-4 wood window • Damaged, rotted wood window • Trim is damaged, rotted

<ul style="list-style-type: none"> • Replace with double hung 4-over-4 wood window • Trim to reflect the same style from original home

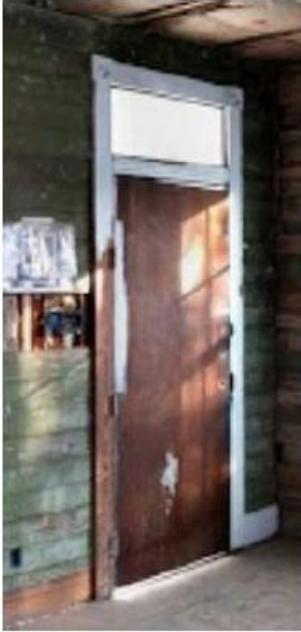
<ul style="list-style-type: none"> • Wood "door" is a flat piece of wood with a cut at the top

<ul style="list-style-type: none"> • Replace with Craftsman style wood door • All wood, no glass

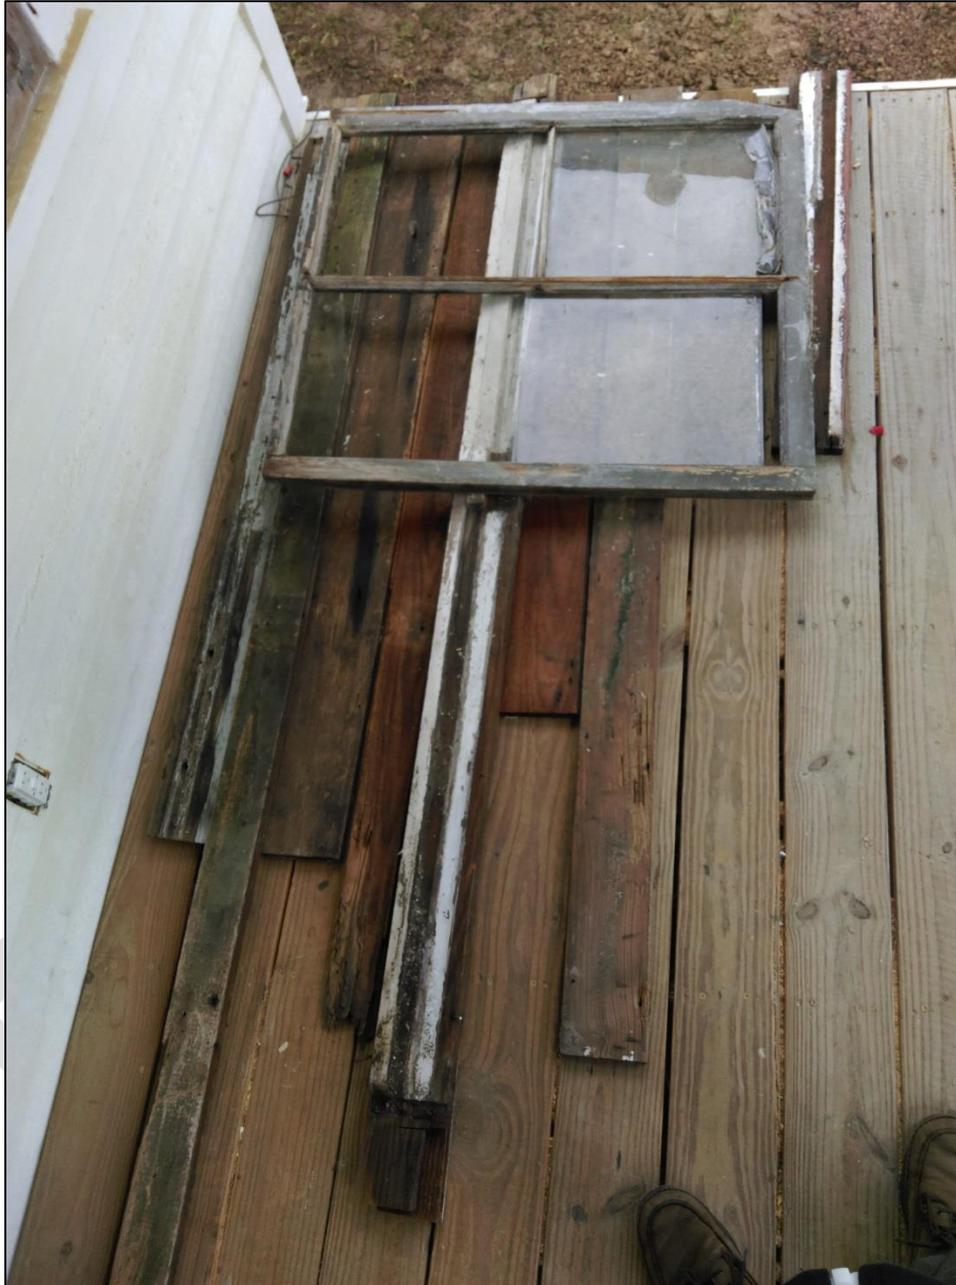
CURRENT WINDOW CONDITION

Replacement of the last original window of the historic structure was previously denied at the January 2016 HAHC meeting, due, in part, to staff not having access to the window for a proper evaluation of its condition. Staff has now been granted access to assess the window.

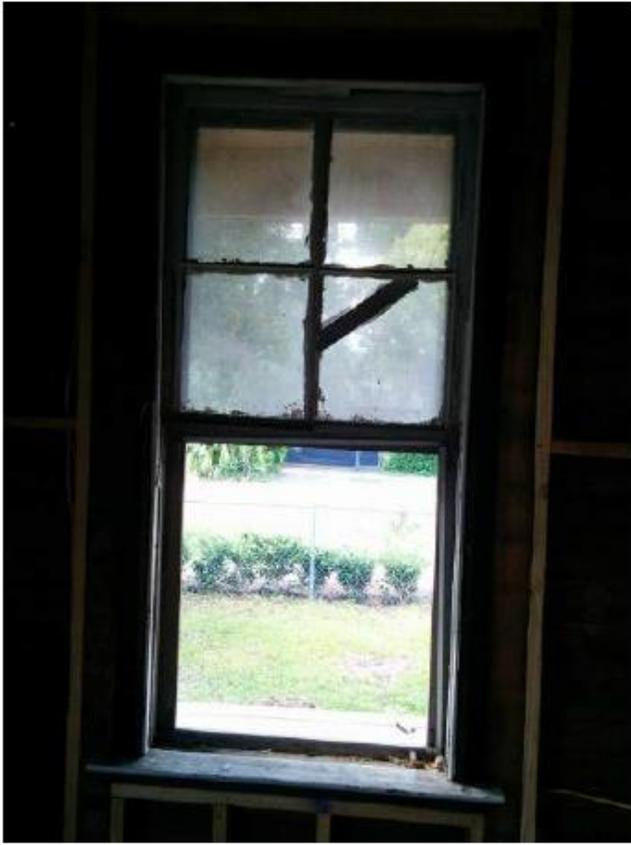
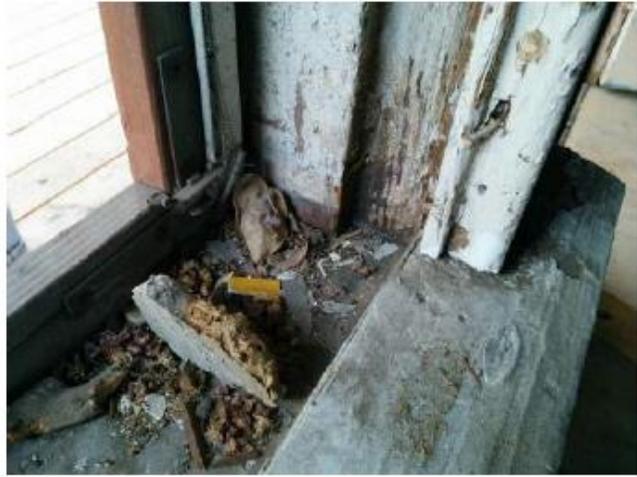
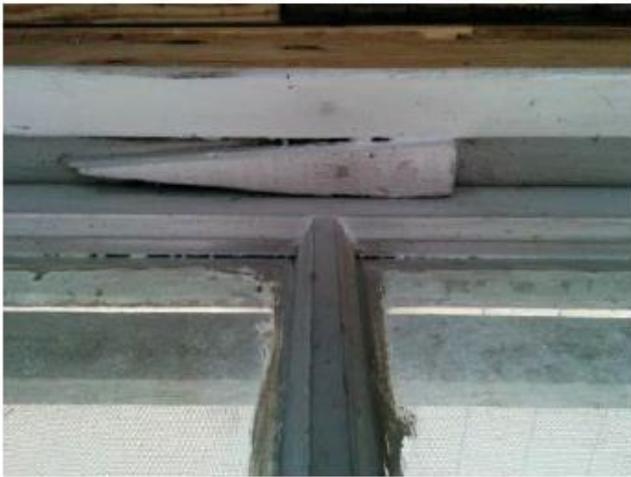
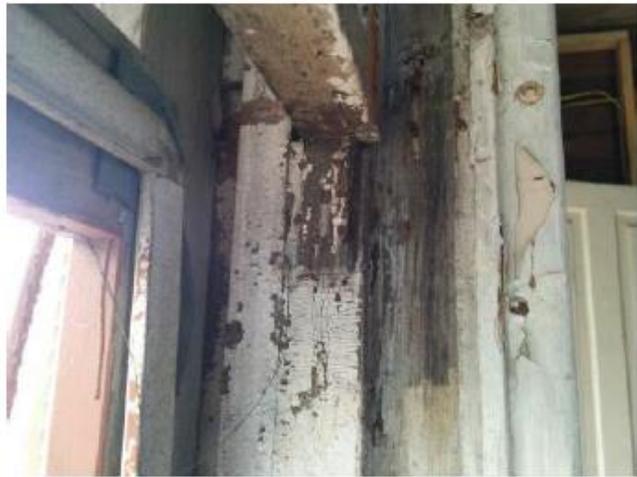
WINDOW G DETAIL

- 1-over-1 wood window
- Damaged, rotted wood window
- Trim is damaged, rotted

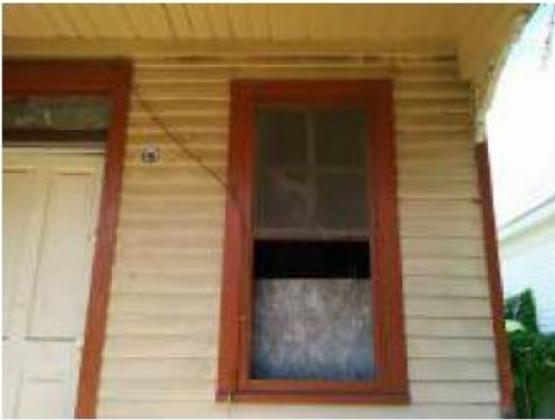
APPLICANT ASSESSED WINDOW DAMAGE

Window G
