CERTIFICATE OF APPROPRIATENESS APPLICATION FORM

Address 1719 CROCKETT STREET, HOUSTON, TEXAS, 77007
Historic District / Landmark _____ HCAD # 0051210000013
Subdivision BAKER NSBB Lot 129TR11A Block 298

A STRUCTURAL FOUNDATION INSPECTION REPORT

A SUPERSTRUCTURE INSPECTION REPORT

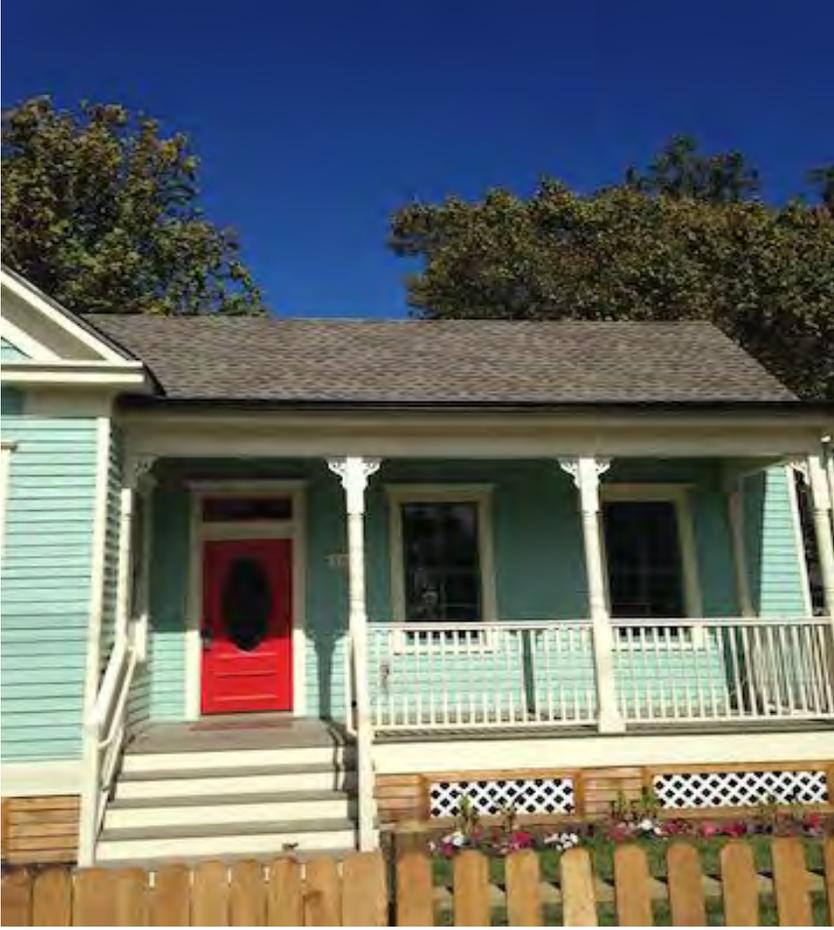
Figure 5

- Remove old asbestos siding and replace with authentic wooden siding that matches other Queen Anne historical homes in the neighborhood. The siding matches the neighbors.
- Remove old shingles and replace with new 30 year Driftwood, the same as renewed roofing on other historical homes in the area. (See figure 5)
- Remove dysfunctional aluminum windows and replace with premium grade, double hung, energy efficient windows. The existing openings and measurements shall be utilized.
