# 1932 South Blvd - Demolition Application Materials

### 1932 South Blvd (aka 5115 Hazard St) Demolition Application Materials

**EXHIBIT A**  
**PHOTOGRAPHIC RECORD**

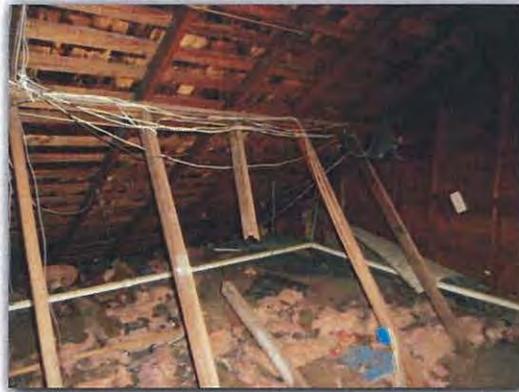
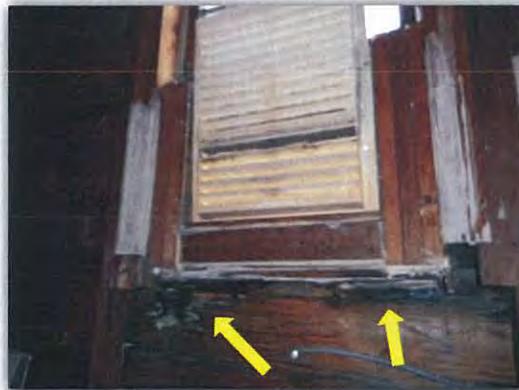
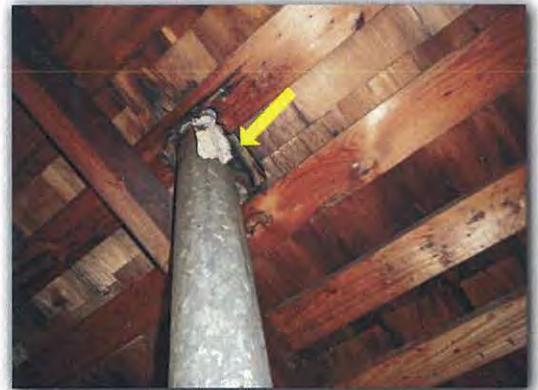
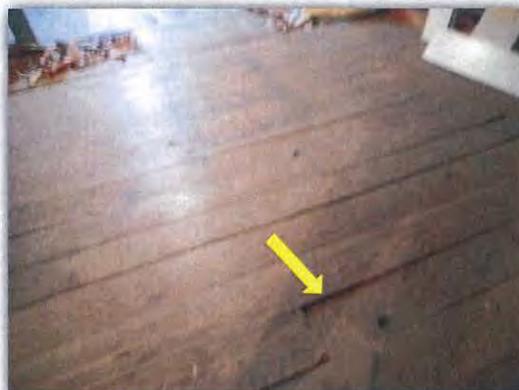
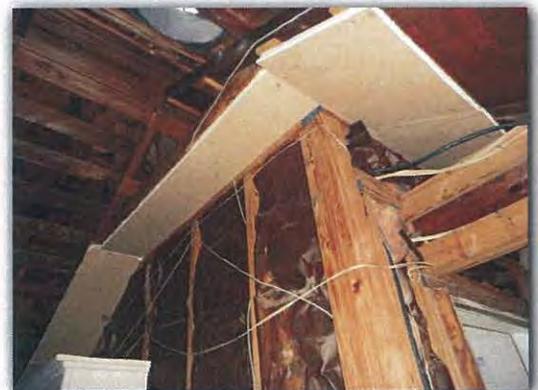
**X:** The flooring boards are loose/damage and unsafe in some areas. Repair flooring in order to have a safe and unobstructed service walk to the attic from the attic door.

**X:** Insulation depth in attic is less than currently recommended. At least 13-16 inches are recommended for maximum efficiency.

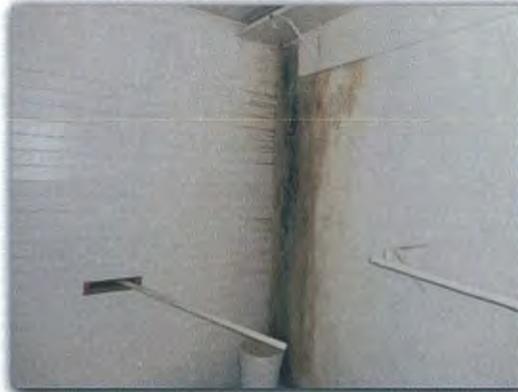
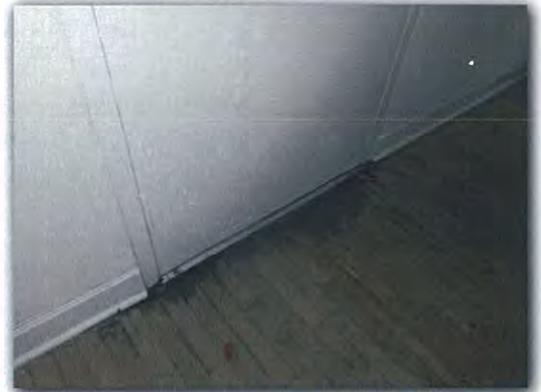
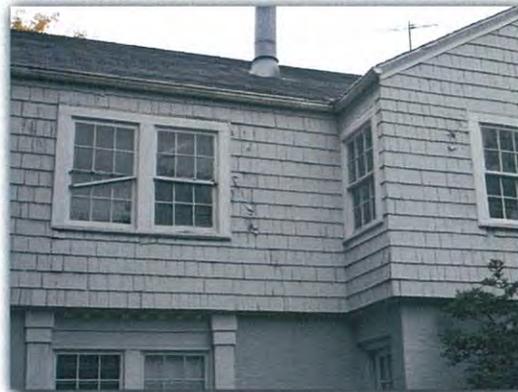
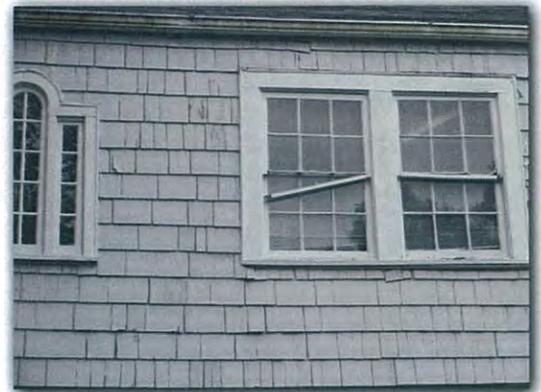
**Note:** We recommend that you contact an air quality specialist prior to closing to test and determine the health and safety levels of the air in the home due to black growth forming on the walls due to long term water penetration and damage. Additional remediation may be required based upon the findings of the environmental engineer or air quality specialist, Proper Lead abatement procedures are required to be followed when removing/repairs drywall .

**X:** Keep heavy vegetation off of walls. Vegetation restricts visibility, traps moisture and attracts insects

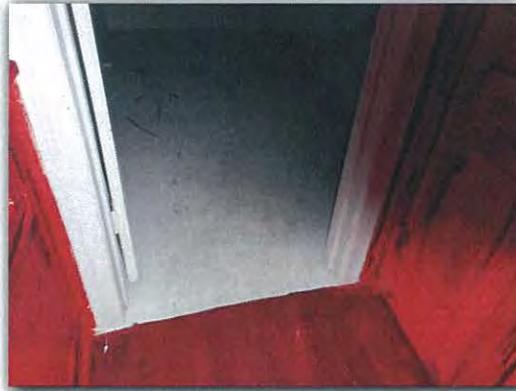
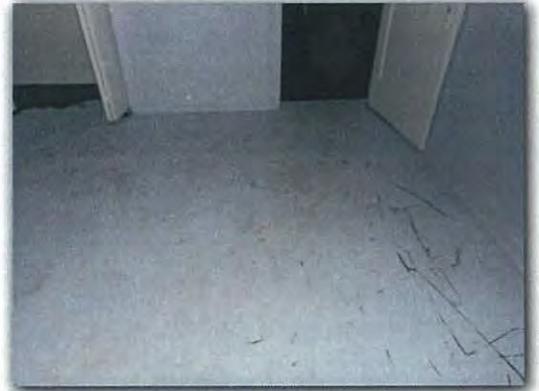
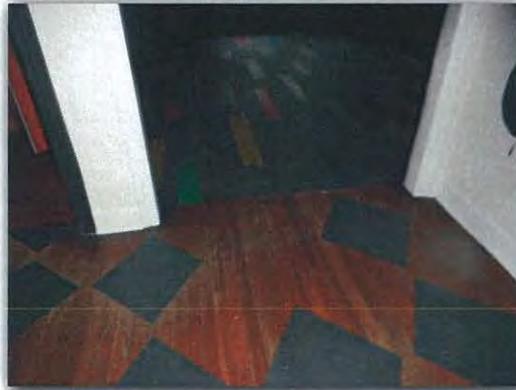
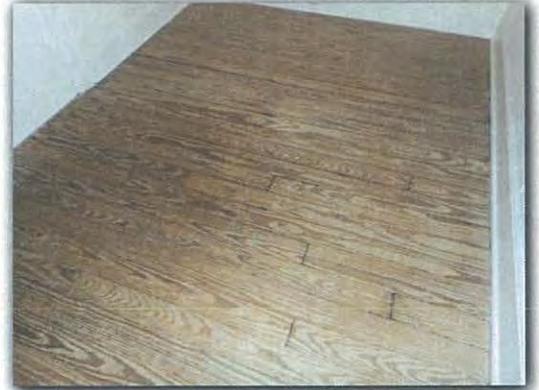
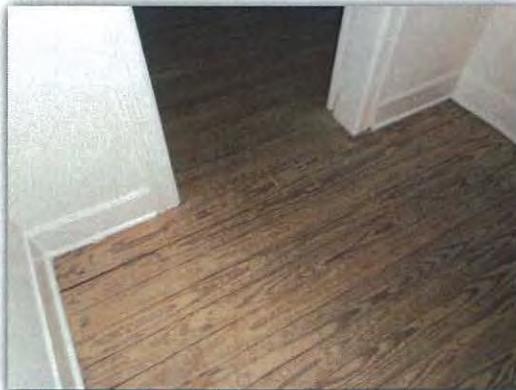
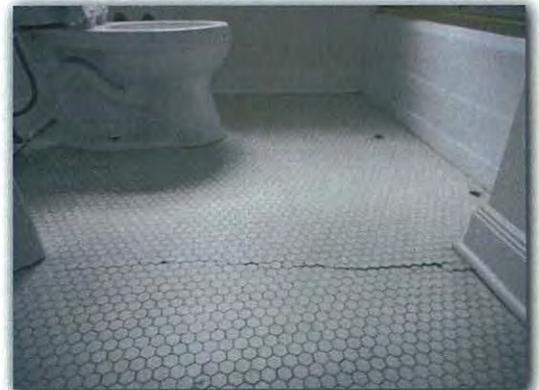
**X:** The floors need extensive repairs to replace and refinish damaged floor sections. Tiles are cracked and missing in bathrooms. The floors are loose, unlevelled and splitting. The wood floors are worn, warped, painted on, scuffed and scratched throughout. Separated and swollen planks noted upstairs in kitchen, breakfast area and living room due to water penetration. Floors are water damaged and rotted at back door.

**X:** Signs of water penetration were observed at the ceilings. The source of water penetration was not determinable at the time of inspection. Repair the source the ceiling and any hidden

water damage as needed.

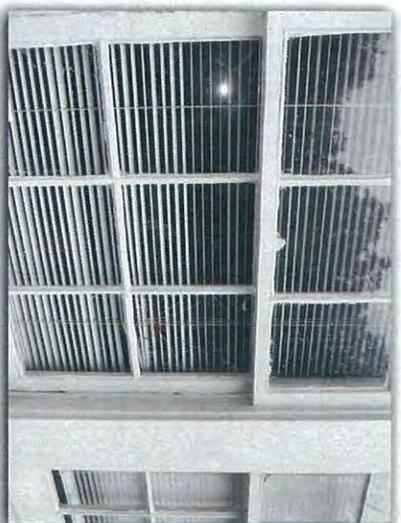
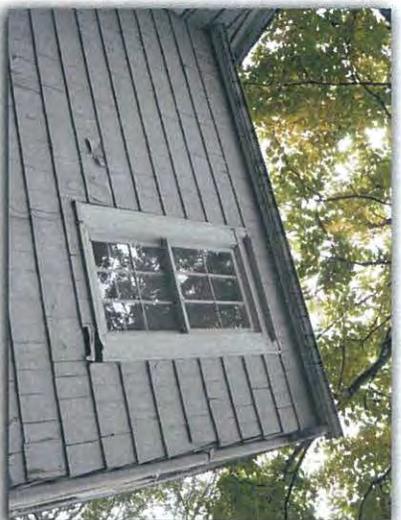
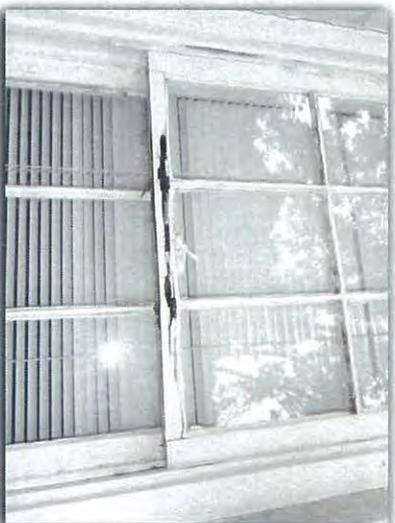
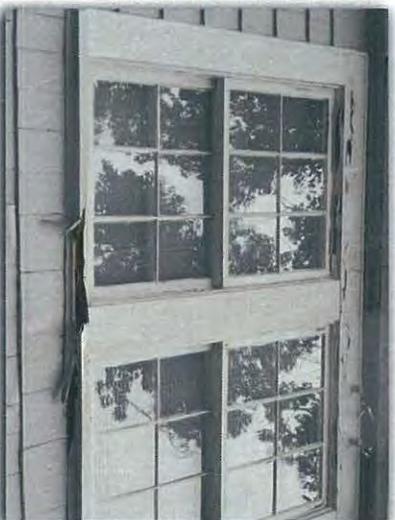
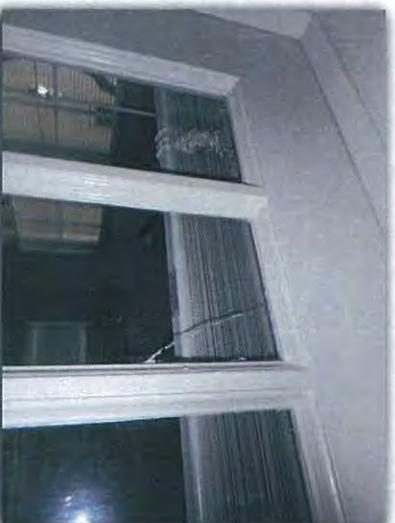
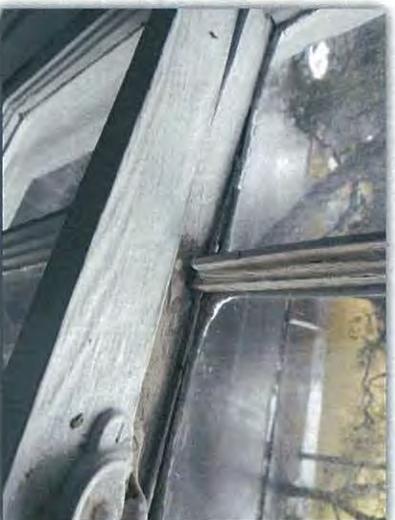
- X:** Safety glass is not present in the required areas. This was not a requirement at the time of construction. However, all windows must meet current safety glass requirements if home is rehabed in the future.
- X:** Windows are in poor condition. Window frames and sills are rotted/deteriorated or swollen. Several windows have separated from the their frames. The wooden window frames are stuck or painted shut and have damaged ropes/pulleys and latches. Windows in bedrooms must be functional for egress in the event of an emergency. All windows should be checked by a window specialist for repairs and safe and normal operation.
- X:** 3 cracked/broken windows found.
- X:** The windows are missing screens.
- X:** Caulking around exterior windows is deteriorating and missing in several areas.

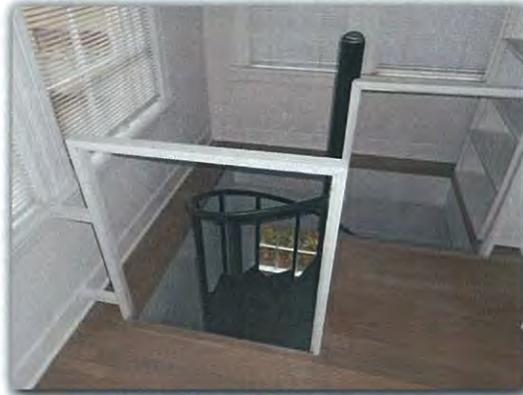
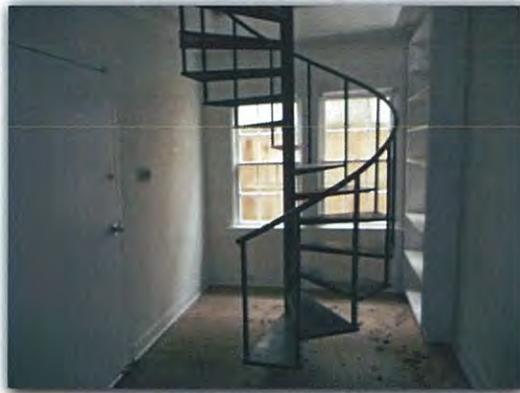
**X:** The baluster are missing at the upstairs living room and are too wide at spiral stairs. The current standard is that the gap along handrails and barristers may not exceed 4 inches. Also, modern handrails should have closed tapered ends to prevent injury and garments from snagging.

**X:** The spiral stair case is loose, wobbles and needs to be secured by quaffed contractor. Also, the stair steps appear to be too tall and inconsistent in height. Current standards dictate that steps (risers) be a maximum of 7 3/4 inches tall & that the tallest riser may not be 3/8 inch greater than the shortest riser. This is a trip hazard.

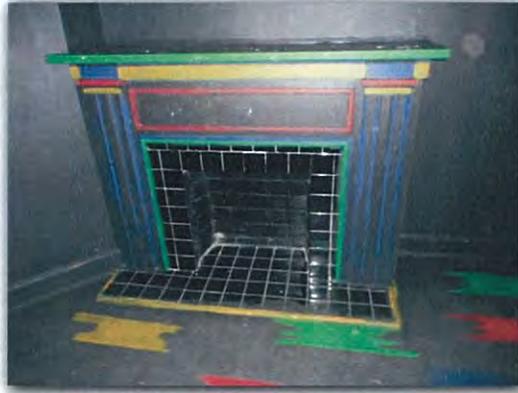
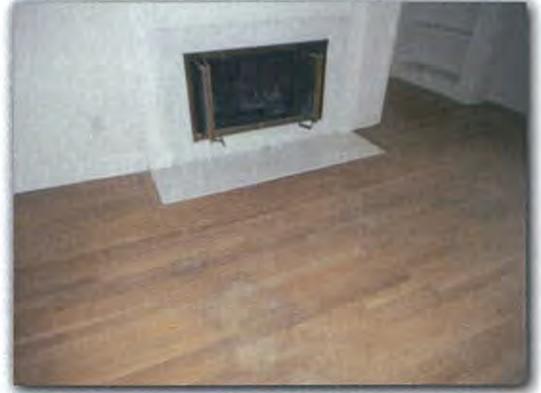
**X:** The upstairs firebox is dirty and heavy creosote build up was noted in flue. Recommend the chimney flues be swept and checked for safe operation prior to use.

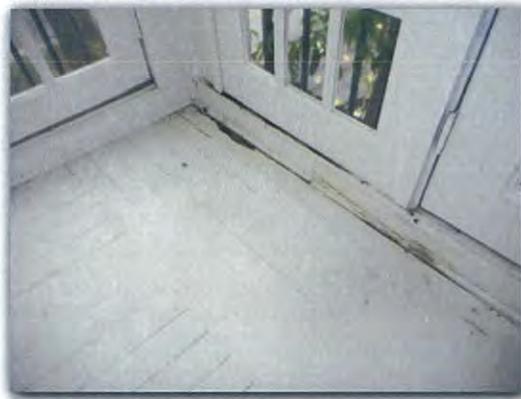
**X:** The closed-in balcony is deteriorated at the floor/decking boards, from water penetration. The sub-floor structure under this area was not visible for inspection. Balcony is leaking and needs extensive repairs to prevent water penetration and structural failure. The closed-in balcony is unsafe for use at this time.

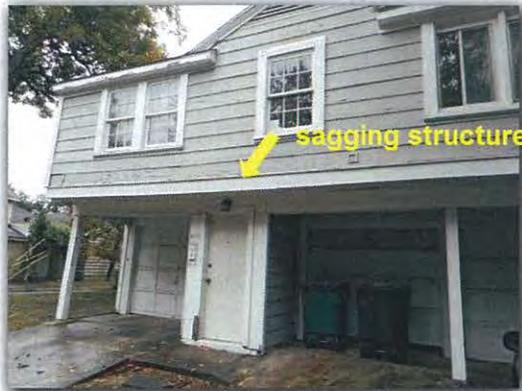
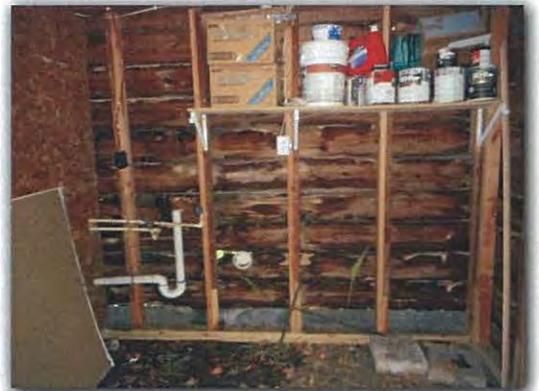
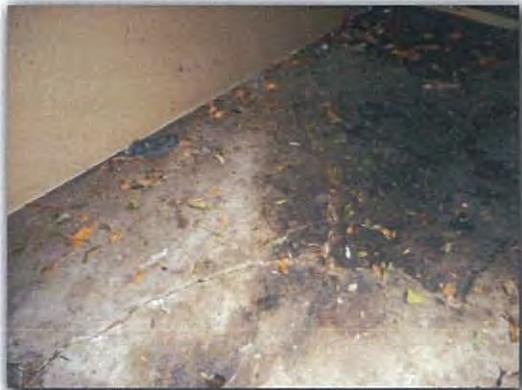
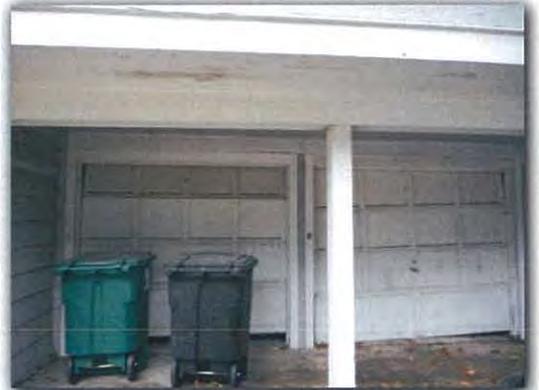
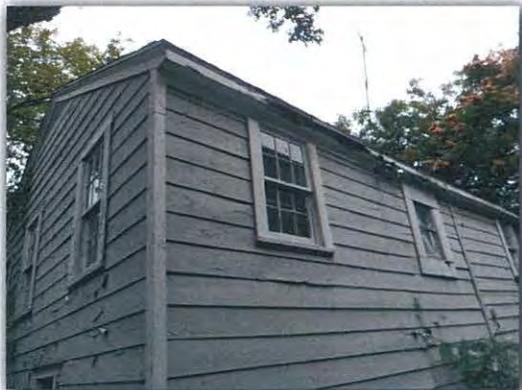
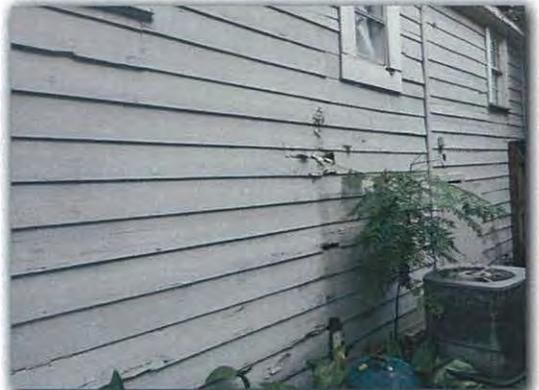
**X:** The garage structure is in overall very poor condition, is not structurally safe and is not habitable at this time. The unit has no power and the upper level was not safe for entry. The foundation is severely cracked, heaved and splitting. The front of the structure is sagging and the building shows signs of deflection and excessive structural movement. The garage doors are misaligned out of square and inoperable. The siding & trim is deteriorated, rotted, and the electrical system is on poor and unsafe condition. Plumbing & AC could not be tested at this time. Structural engineer or specialist is needed to further evaluate the garage structure.

**X:** Evidence of rodent activity/droppings observed in the attic. If they have not been controlled then a pest control expert should be consulted for treatment plan.

**X:** The kitchen and bathroom cabinets are water damaged in some areas and show significant signs of wear and tear.

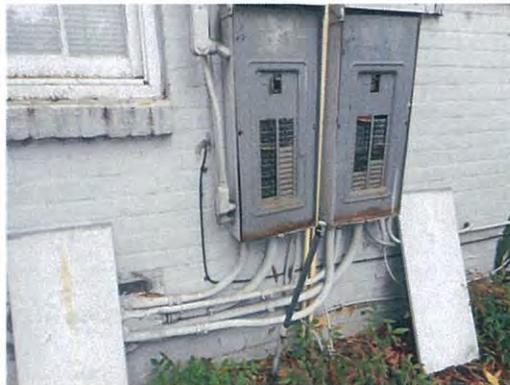
**X:** These are older boxes and service. The service has been tapped into some existing knob and tube wiring which is not allowed. Active knob and tube wiring was found in the attic and under the house. It is likely that an electrician may need to disable the knob and tube wiring, upgrade the boxes, and/or service prior to performing any other major electrical repairs.

**X:** The electrical panel is not fully labeled any labeling present is not checked for accuracy.

**X:** Knock outs missing on panel box cover plates and doors are damaged and fall off when opened.

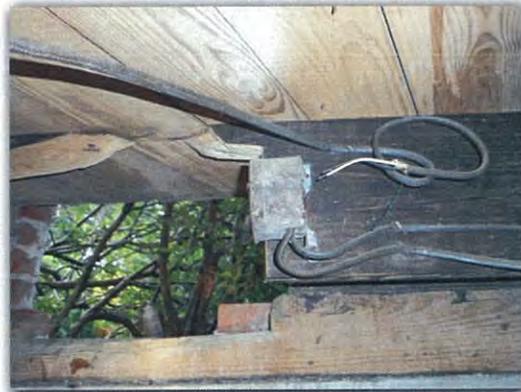
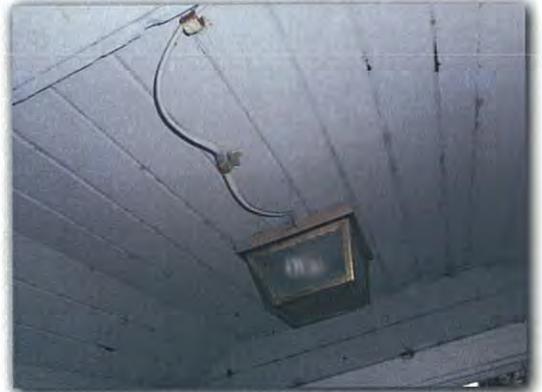
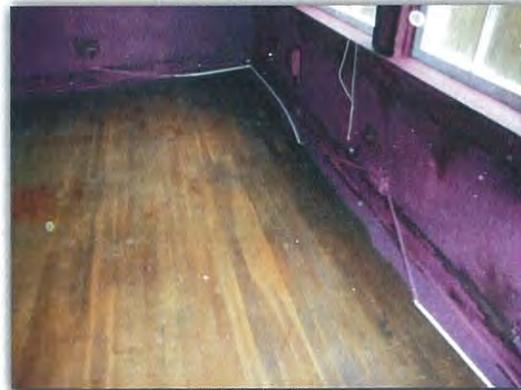
**X:** The first floor bathroom GFCI is improperly wired with reverse polarity. It did not trip when tested.

**X:** The ceiling fan in the upstairs bedroom is loose and wobbles during operation.

**X:** There is loose conduit and improper wiring in the bedrooms.

**X:** Exposed wiring connections in crawlspace, in the attic and missing conduit at exterior fixtures.

**X:** Lights out/inoperable around the house. Replace bulbs and test again.

**X:** Smoke detectors are missing in the bedrooms, & hallways adjoining bedrooms. Recommend they be installed in all sleeping rooms and other areas as currently recommended. The detectors are not interconnected as currently required.

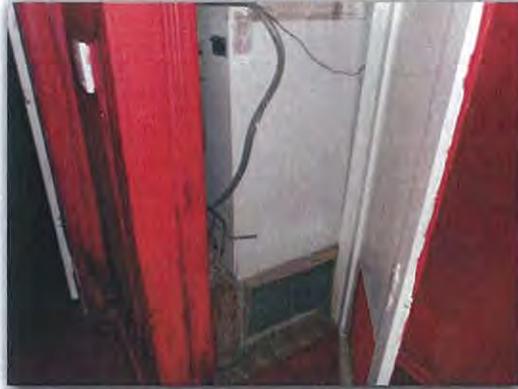
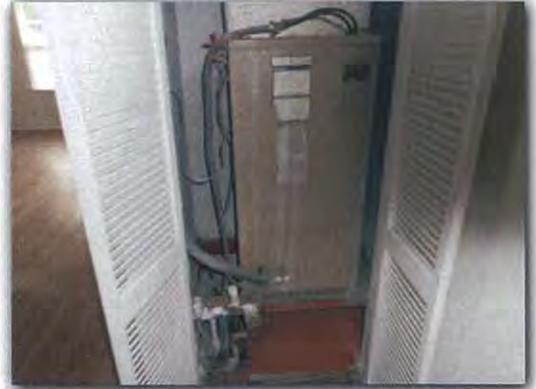
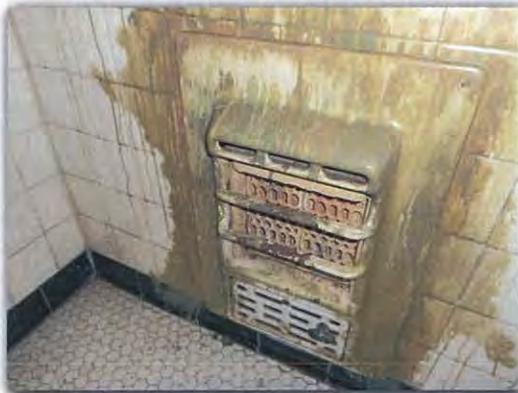
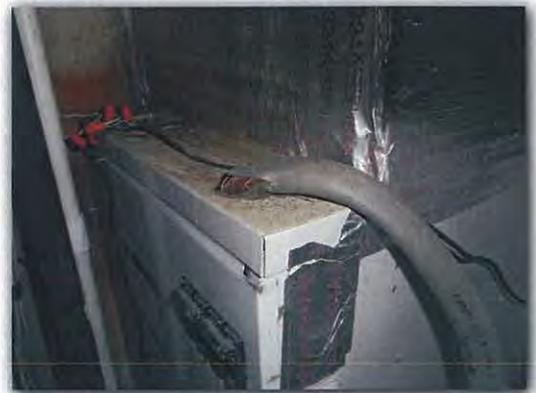
- X:** The conduit is loose at exterior exposing the wire. Properly secure/seal loose conduit.
- X:** The downstairs condenser is inoperable and did not respond when tested. A low temperature differential was noted on the upstairs unit indicating that the system is not cooling at this time. These are both old systems and should be maintained and serviced annually. Recommend a qualified HVAC specialist be consulted for a full evaluation to determine what equipment needs replacement, to check refrigerant levels, check for leaks, and for any other repairs needed at that time.

- X:** The conduit is loose at exterior exposing the wire. Properly secure/seal loose conduit.
- X:** The large coolant line is not fully insulated as required for system efficiency and to keep condensation from dripping below.

- X:** Condensing unit is older and cooling fins are deteriorated from corrosion and plugged with debris. Damaged, deteriorated cooling fins will prevent air circulation across coils and reduce system. The average life span of this type of equipment is 10-15 years, these units are 20 and 30 years old and well beyond their average life for this type of equipment.

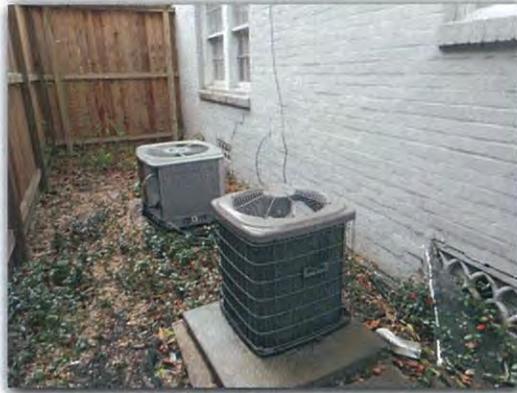
**X:** Repair/replace loose and damaged ducts. Grey ductwork has been known to be inefficient and prematurely deteriorate. Recommend they replaced in the near be future since the interior of the ducts cannot be inspected.

**X:** Ducts are not all suspended off of attic floor and are some ducts are touching. Recommend ducts be properly suspended and any ducts that touch should have insulation between them.

**X:** Air leaks noted at openings, and connections at HVAC units.

**X:** Filters are dirty and should be changed regularly. Recommend a qualified HVAC specialist be consulted to clean and service the coil and system and for any other repairs needed at that time.

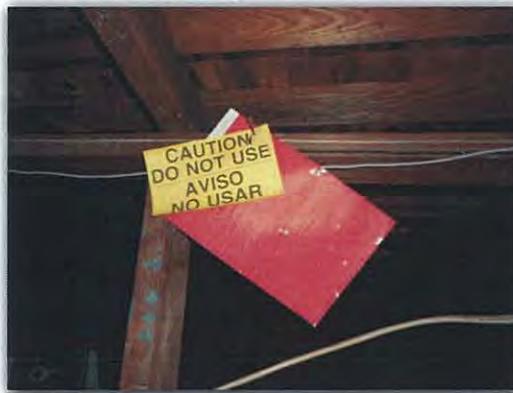
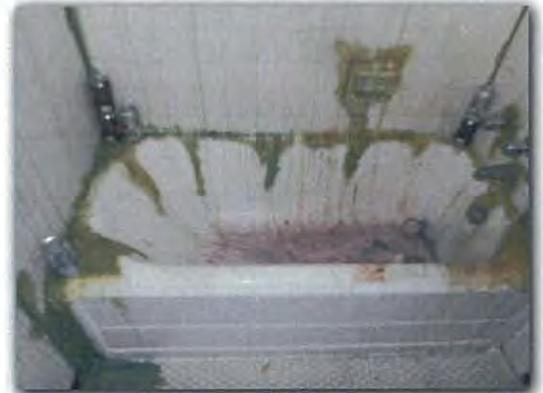
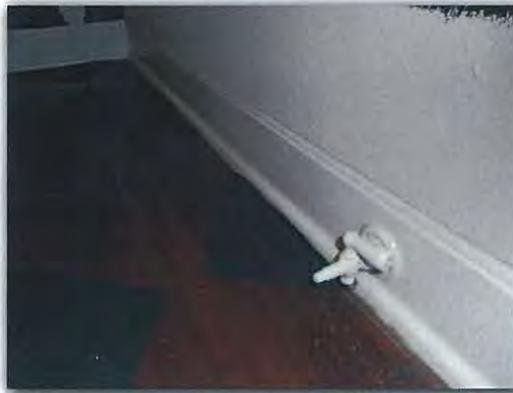
**X:** The house is plumbed with the majority of the original galvanized plumbing. Signs of previous pin-hole leaks and repairs were present. A leak was found at the water heater at the time of inspection. The water heater has been red-tagged.

**X:** Tile, caulk and grout repairs are needed along the tile joints in bath tub enclosures.

**X:** The kitchen sink handle is leaking.

**X:** Shower diverter in upstairs bath leaks.

**X:** Anti siphon device/vacuum breaker not installed at hose bibs around perimeter of dwelling.

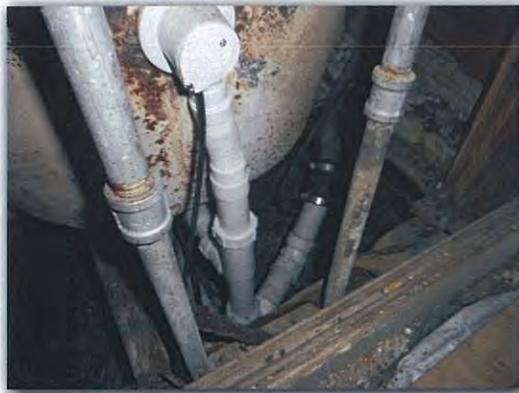
**^:** The condition of underground cast iron drain lines cannot be determined. If you desire a hydrostatic test it should be performed by a qualified leak detection company of your choosing.

**X:** The upstairs tub is slow to drain indicating a possible obstruction in the drain line. Clear and retest the drain line.

**X:** The downstairs tub is missing a p-trap as required and has an improper connection.

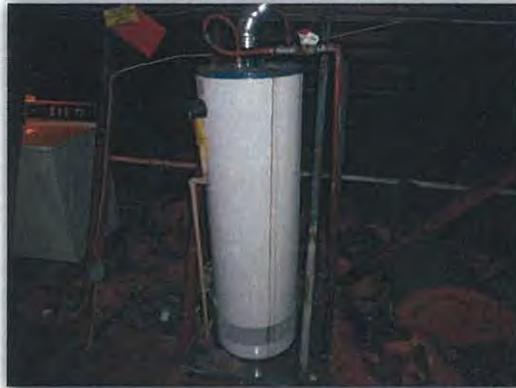
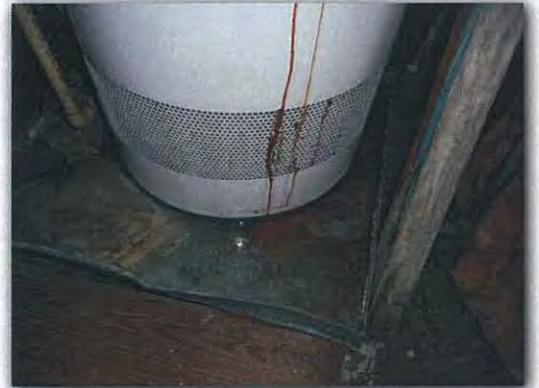
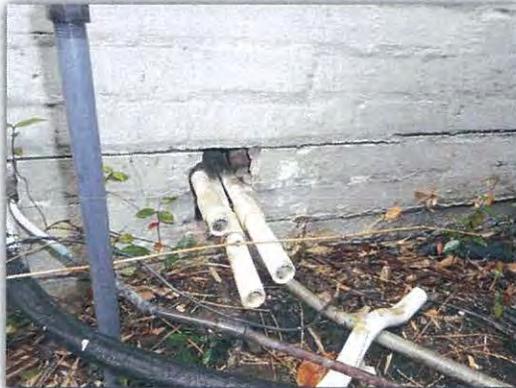
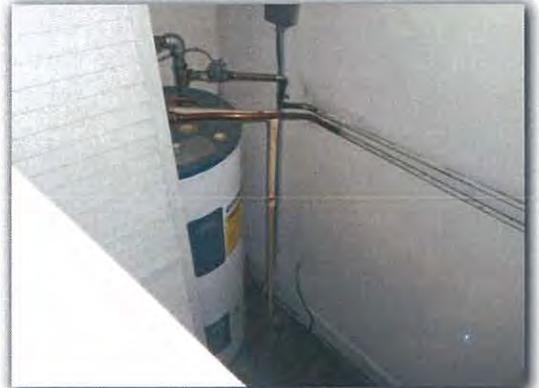
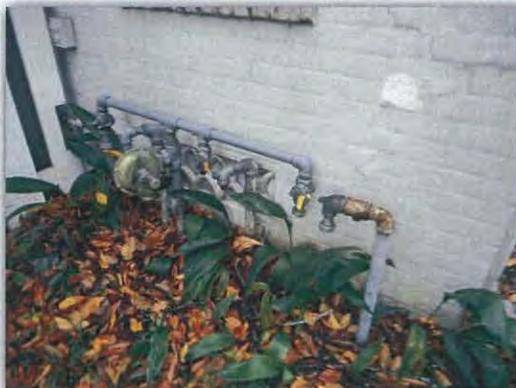
**X:** Water leak at supply connection. Corrosion and rust was noted on the water heater and pan is full of water.

**X:** The water heater in the downstairs kitchen is trapped behind the refrigerator, is not accessible and was not fully visible. Unit needs to be relocated so that it is accessible for service and inspections.

**X:** A 90 degree fitting should be installed at the end of T&P exhausts to safely divert exhaust to ground.

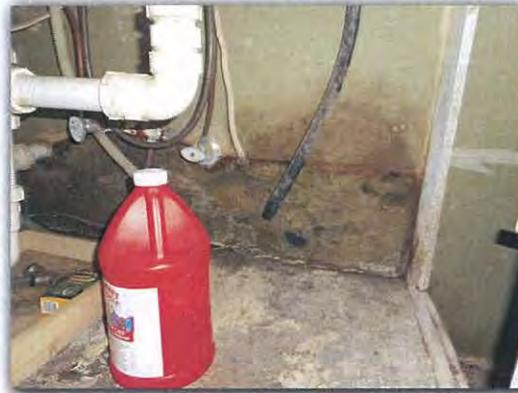
**X:** Water damage under the kitchen sink, replace damage and hidden damage as needed.

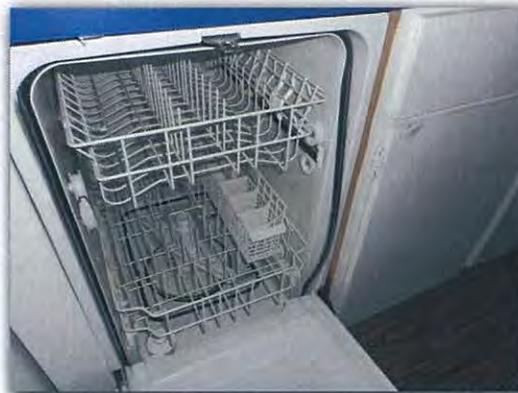
**X:** Door gasket is damaged at upstairs dishwasher unit.

**X:** No suspended loop in drain line or anti siphon device installed to prevent the back flow of contaminated water from sink drain to dishwasher.
