CERTIFICATE OF APPROPRIATENESS APPLICATION FORM

Address 1846 Harvard St.

Historic District / Landmark Houston Heights East /HHWC Clubhouse HCAD # 0201010000035

Certificate of Appropriateness Application

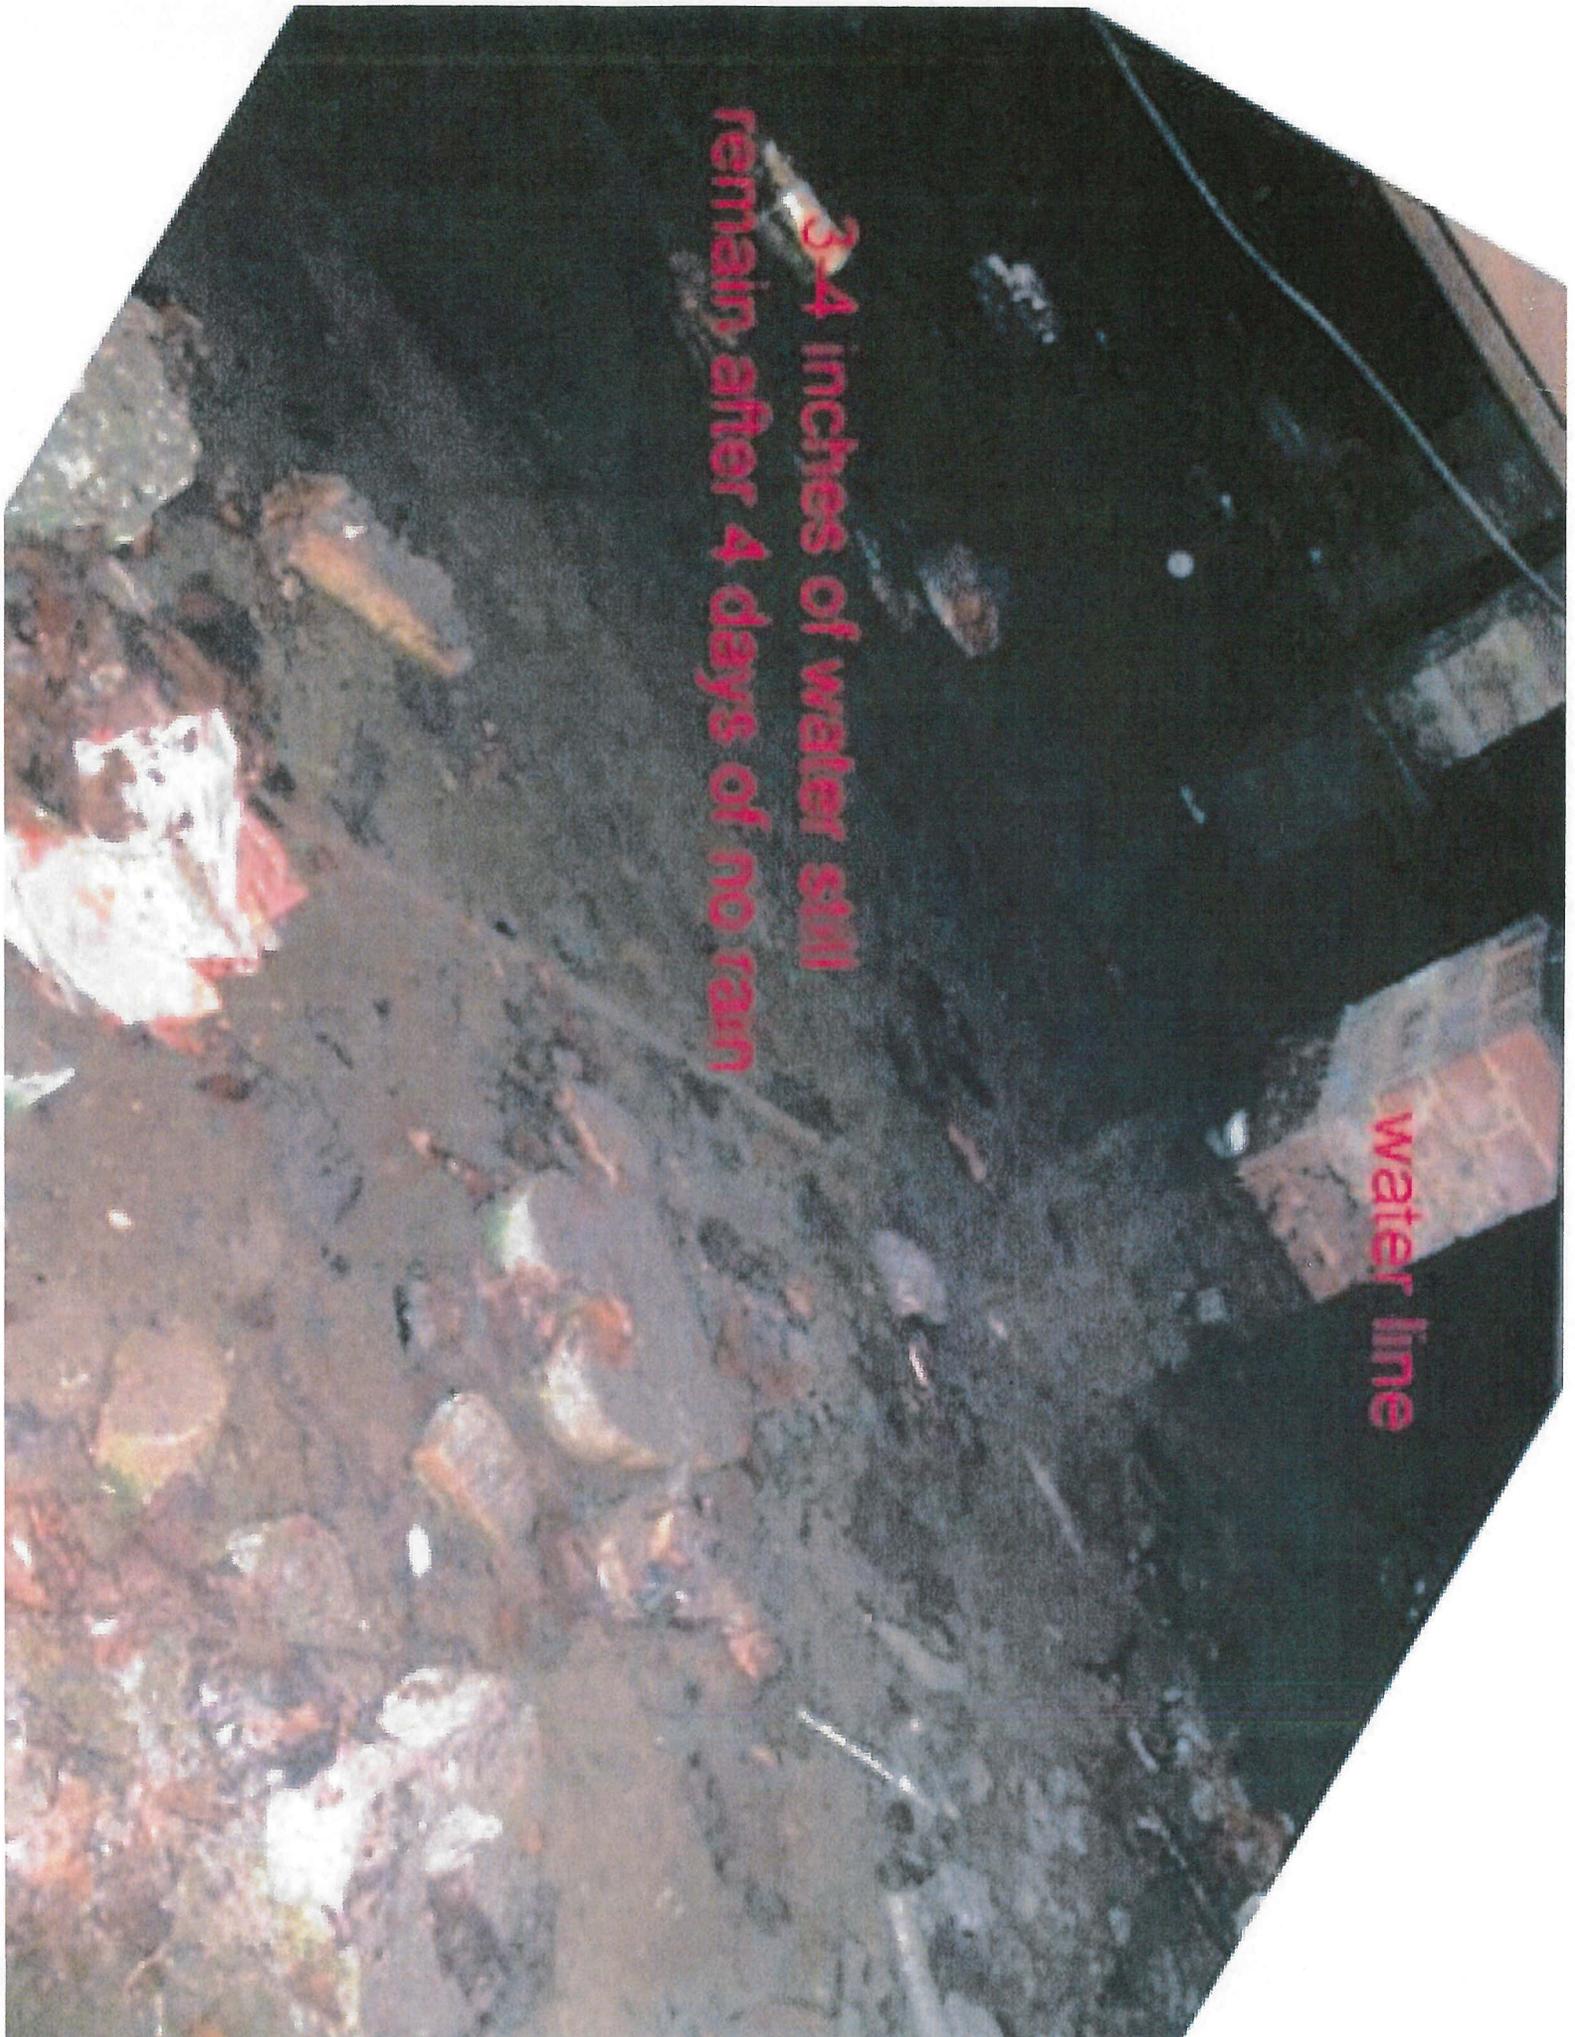
Water damaged beam touching the soil.

Soil has been pushed from under the house from the poor water drainage and it has rested against the beam, creating a dam-effect and traps more water and more erosion causing house to sink more.

water line

3-4 inches of water still
remain after 4 days of no rain
