**CERTIFICATE OF APPROPRIATENESS**

**Property:** Lot 6, Block 289, Houston Heights Subdivision, City of Houston, Harris County, Texas. The site includes a 1,370 square foot contributing residence situated on a 6,600 square foot (50 x 132) interior lot.

**Proposal:** Alteration – Addition – *Revision* The applicant was granted a COA on December 12, 2013 to construct a two-story addition.

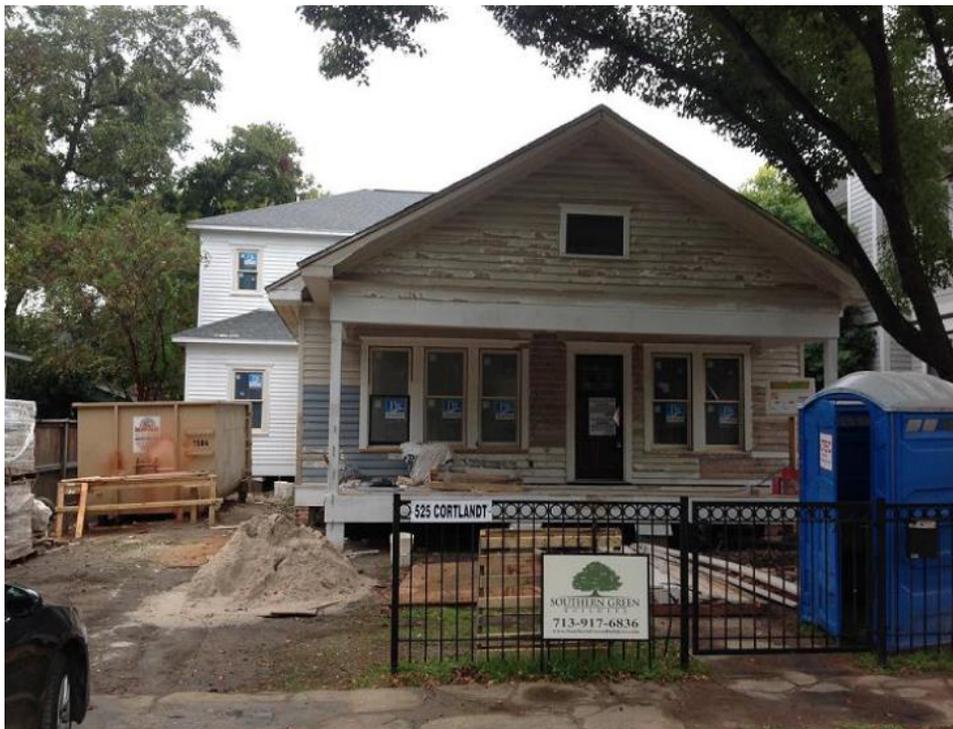
CURRENT PHOTO

**November 3, 2014** – City Structural Inspector notes that all of the historic windows were replaced with new sash pack windows. The Inspector directs the builder to apply for a COA for the exceeded scope of work at the next HAHC meeting in December. The builder applies for a COA for new windows on November 5, 2014.

**Staff finds that the application would likely meet all applicable criteria if they replaced their new windows for historic salvaged wood sashes.**

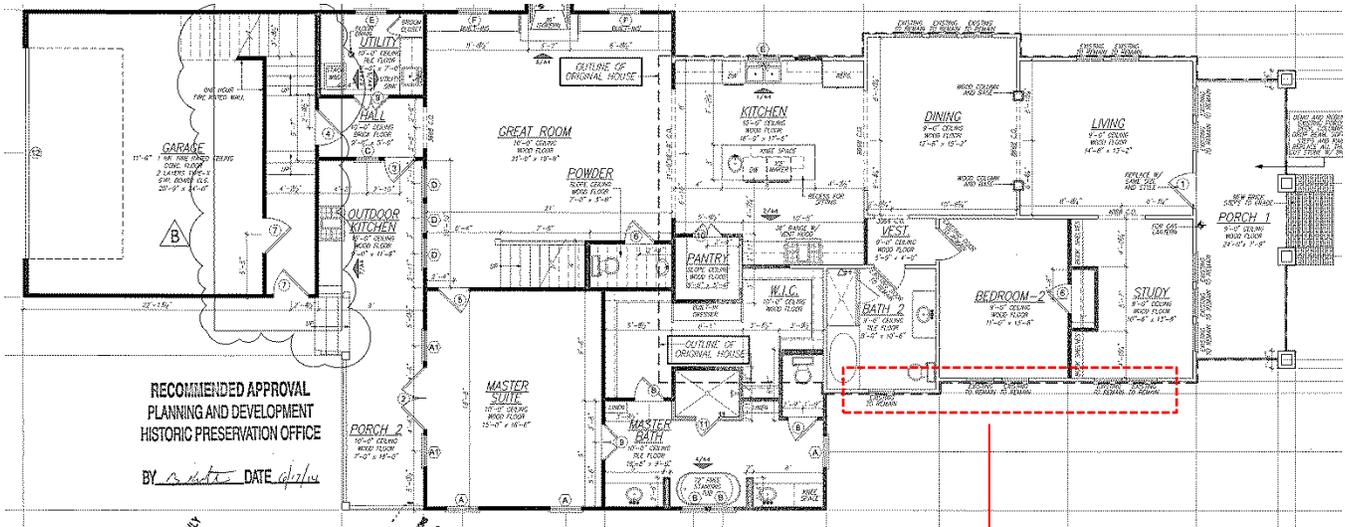
### FIRST FLOOR PLAN

Existing to Remain notes by each  
 window

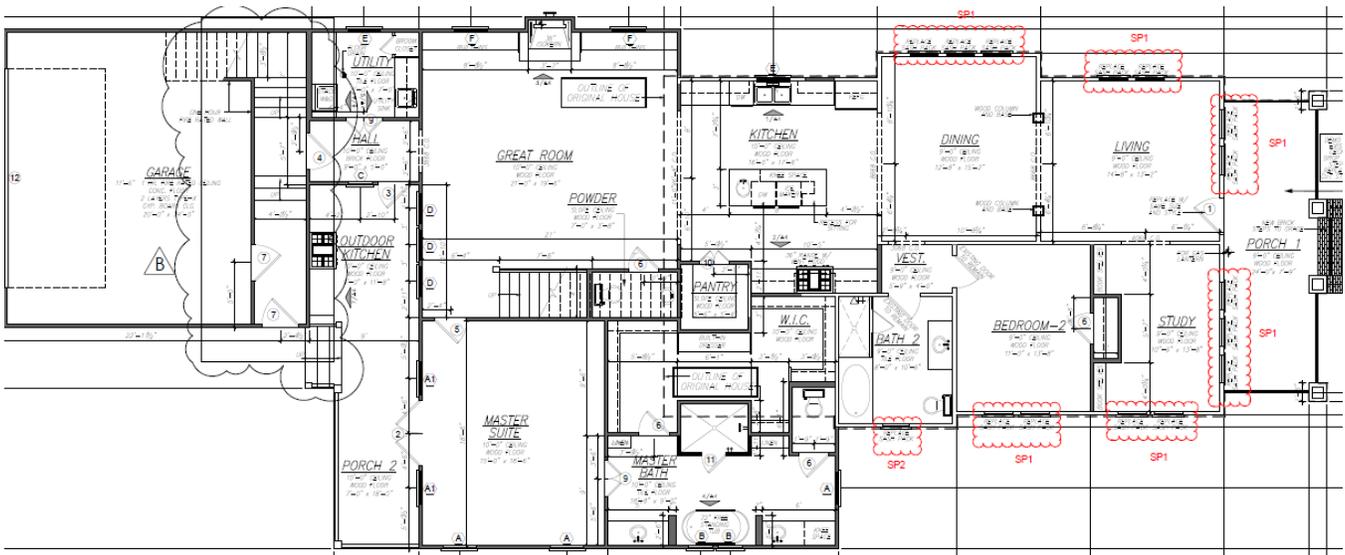
### PROPOSED

<b>Sash Pack Replacement Schedule</b>					
<b>Tag</b>	<b>Location</b>	<b>Qty</b>	<b>Width</b>	<b>Height</b>	<b>Description</b>
SP1	Dining Room	3	2'-4"	5'-2"	Double Hung
SP1	Living Room	4	2'-4"	5'-2"	Double Hung
SP1	Study	5	2'-4"	5'-2"	Double Hung
SP1	Bedroom2	2	2'-4"	5'-2"	Double Hung
SP2	Bath 2	1	2'-4"	3'-2"	Double Hung Tempered

**Windows/Doors:** Remove 15 original windows and replace with matching wood 1 over 1 interior mounted sash pack windows. These window sashes retain the existing window frames.

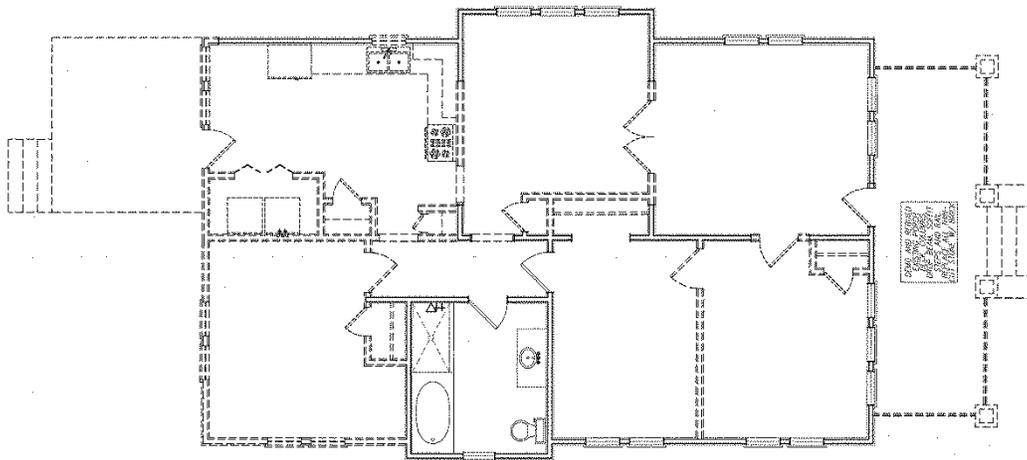
**DEMOLITION PLAN**

Existing wall at kitchen had to be re-framed due to the kitchen window being relocated 2' towards the back of the home. Additional support for window and second floor framing were needed for structural integrity.

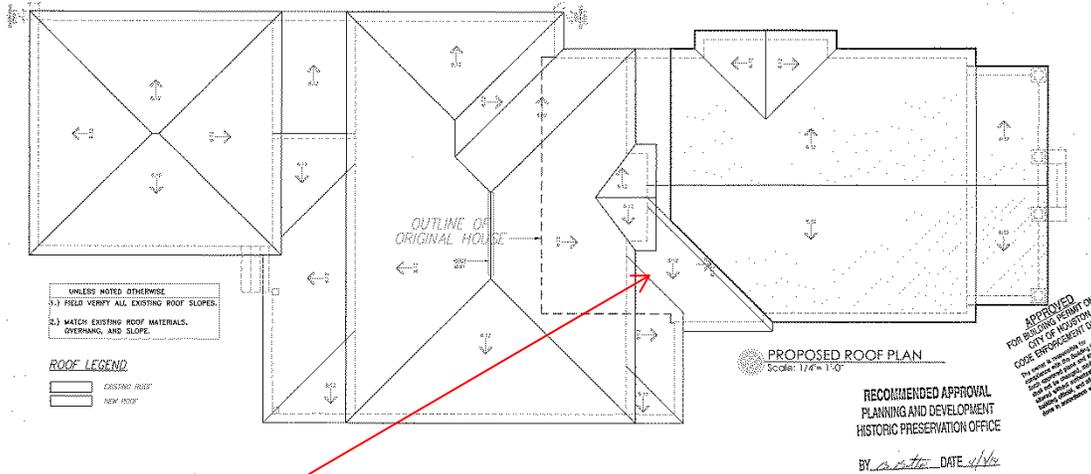
**ROOF PLAN**

- Proposed hipped roof above the existing structure's south facing bump out was not built as proposed. Instead, the applicant incorporated the bump out within the existing roof structure.
- A 16' deep section of exterior wall material and cladding were removed and replaced with new matching material.

Approved hipped roof over south facing bump out

**Roof:** The existing south facing bump out originally featured a side facing gable. The applicant was approved to remove this gable and replace it with a hipped roof. The applicant now proposes to eliminate the hipped roof over the bump out and instead extend the existing roof structure to the rear to cover the bump out.
