**CERTIFICATE OF APPROPRIATENESS**

**Application Date:** August 4, 2014

**Property:** 528 Highland Street, Lot 8 & Tract 7, Block 20, Woodland Heights Subdivision. The property includes a historic one-story residence situated on a 7,500 square foot (75' x 100') corner lot.

**Proposal:** Alteration – Request for HAHC approval of completed and partially completed alterations that have exceeded the scope of work approved in two previous COAs.

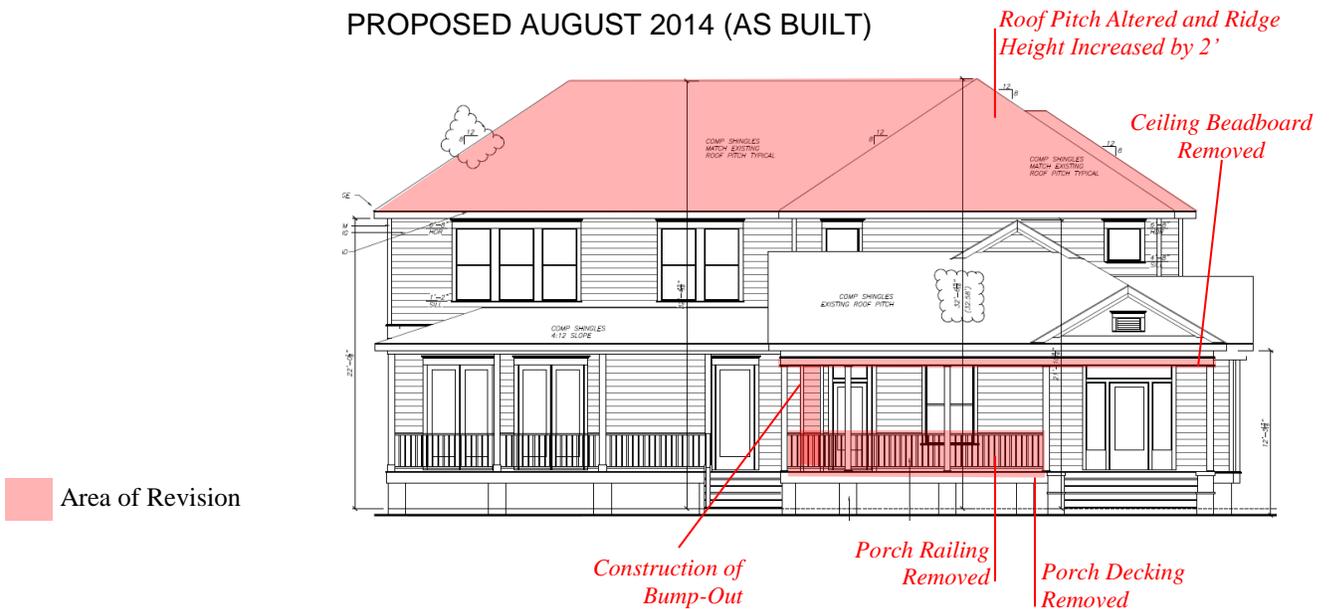
PROPOSED AUGUST 2014 (AS BUILT)

- Roof pitch of the addition was increased from 6:12 to 8:12.
- Ridge height as constructed is 2' taller than approved (32'-6" rather than 30'-5").
- Second story addition encroaches an additional 18" into the original structure.
- Construction of a bump-out approximately 3' wide by 11' long on east elevation of original structure that resulted in the removal of an additional 11' of the original exterior wall and required a change to the approved roof shape.
- Removal of all original wood siding behind the bay window on the west elevation and replacement with cementitious siding.
- Removal of the front porch decking, railing, and ceiling beadboard.
- Installation of a window on the rear portion of the east elevation of the addition.

*Staff recommends that the owner be required to build in accordance with the earlier approved COA, to remove all unapproved work already performed, and to make repairs with in-kind materials.*

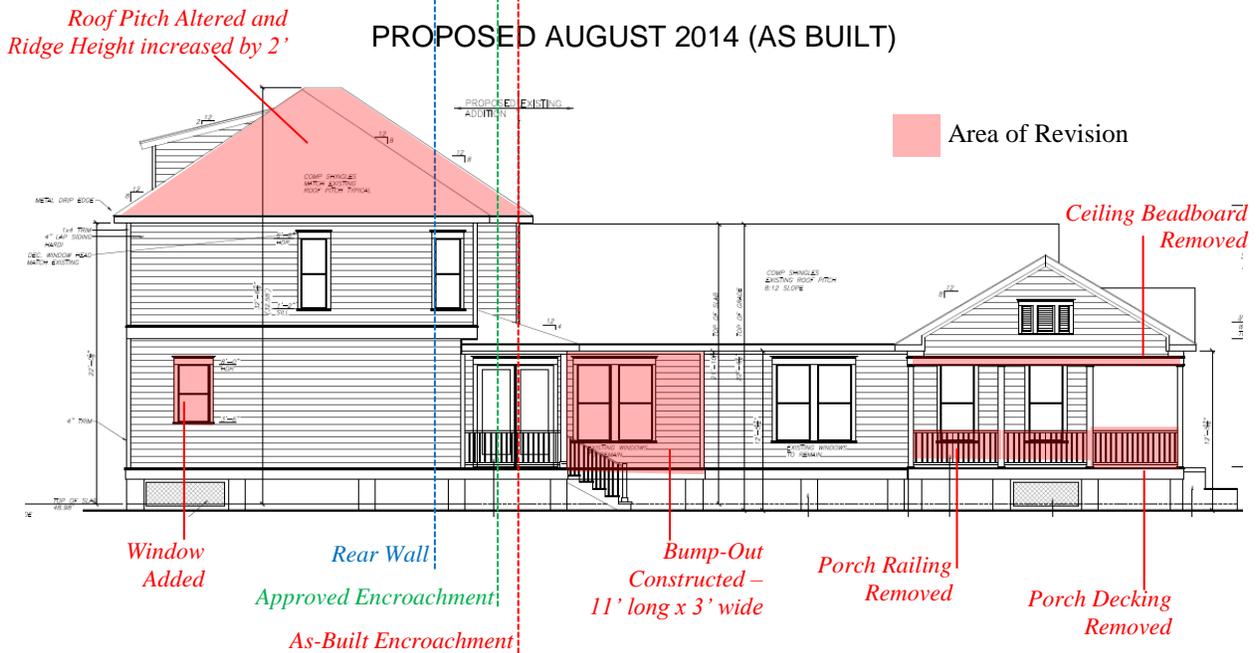
PROPOSED AUGUST 2014 (AS BUILT)

- Bump-out on east elevation. A 2'-10" wide by 10'-9" deep bump-out on the first-story of the original structure was constructed. In order to bump out the existing wall, historic material was destroyed. Fortunately, the original windows from this location, which were removed, were later installed in the bump-out. According to the applicant, the foundation company installed the piers based on the "bid set" of plans which included this portion of the addition. The final COA approved plans did not include this portion. The framer continued on with the error and it was not realized until the framing was complete.

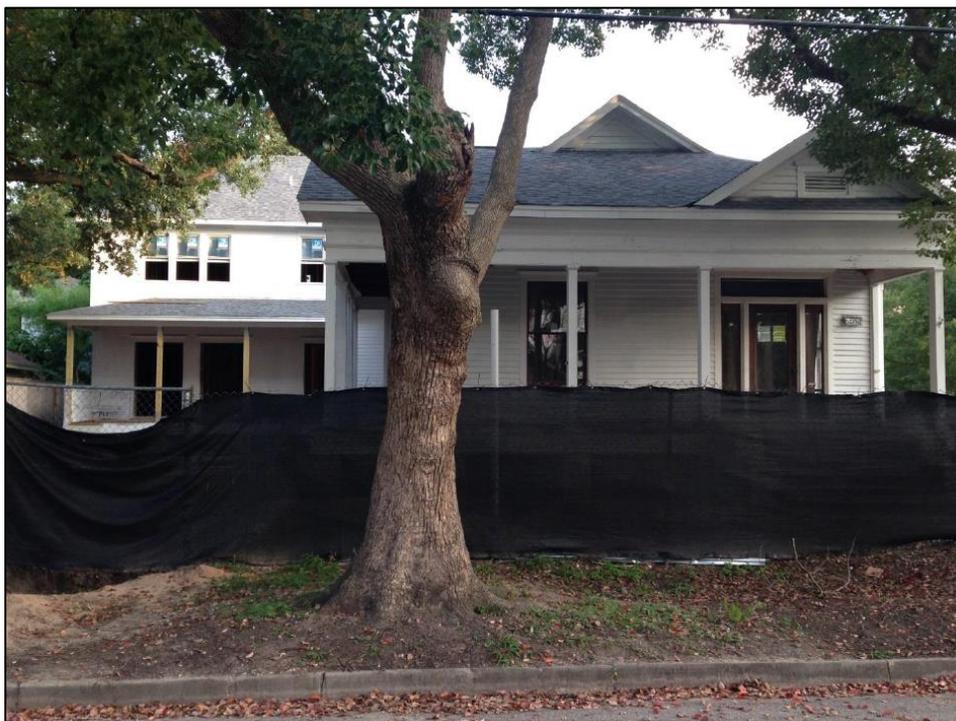
Applicant Photo; Gable removed (hipped)
