CERTIFICATE OF APPROPRIATENESS

Property: 504 Avondale St, Lot 2, Tract 3A, Block 6, Montrose Subdivision. The property includes a historic 3,124 square foot two-story residence and detached garage on a 7,800 square foot (60' x 130') interior lot.

Proposal: Alteration – Replace 22 historic wood 1-over-1 windows on both side elevations of the structure with wood 1-over-1 windows to fit within existing openings.

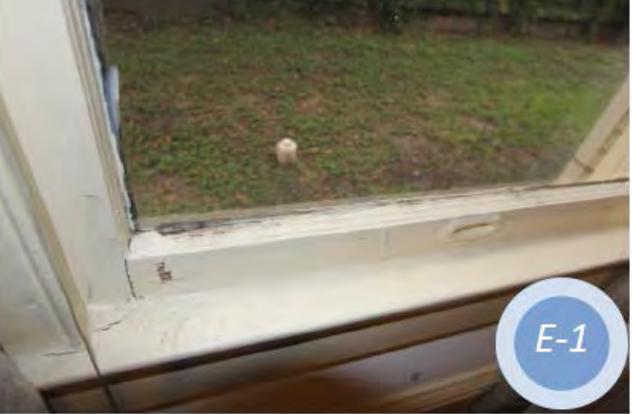
Broken window sash
E1b

<p>Painted shut; flaking paint; meeting rail slipping slightly.</p> <p>Wood under flaking paint is solid.</p>	<p>Repair.</p> <p>The 'broken sash' as indicated by the applicant appears to refer to the visible joint between the rail and stile, not to actual damage.</p>
<p>E2</p>	<p>Glass Block</p>	<p>Not historic material</p>	<p>Okay to replace</p>

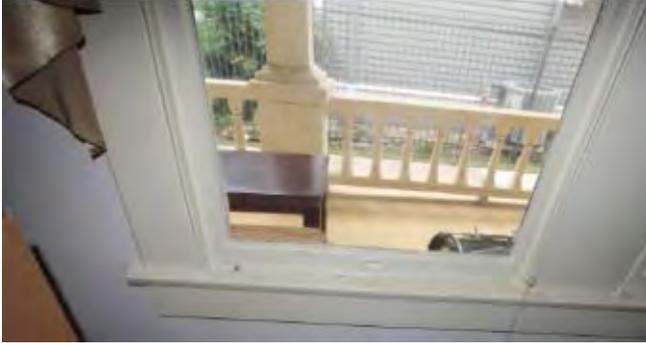
E6a

<p>Painted shut; flaking paint</p>	<p>Repair</p>
<p>E6b</p>

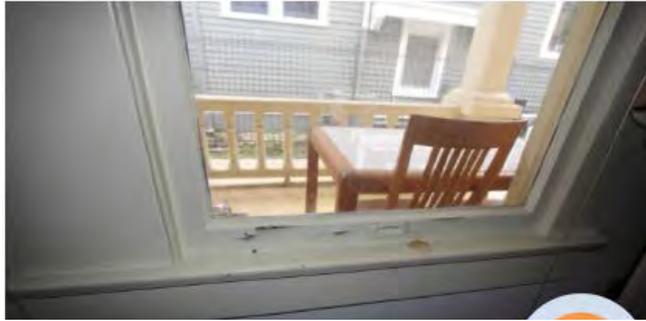
E6b

<p>Painted shut; flaking paint; lower sash bottom rail slightly out on left side</p>	<p>Repair and reconnect bottom rail</p>
<p>E7a</p>

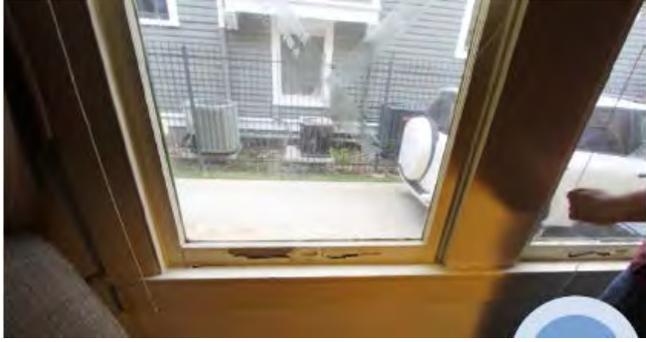
E7a

Rotten window sash
E7b		Rotten window sash

<p>Painted shut; flaking paint, wood is solid underneath.</p> <p>No evidence of 'rotten window sash' as stated by applicant.</p>	<p>Repair</p>

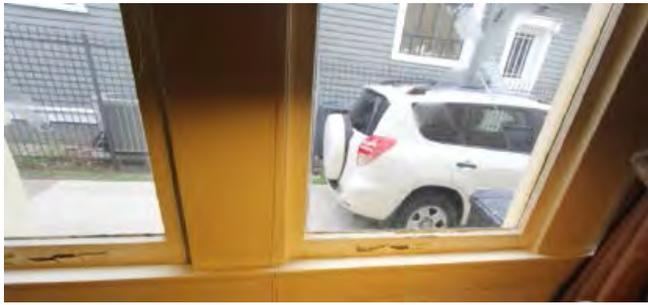
<p>Rotten window sash</p>
<p>E8</p>

<p>Painted shut; flaking paint, wood is solid underneath.</p> <p>No evidence of 'rotten window sash' as stated by applicant.</p>	<p>Repair</p>
<p>E7c</p>		<p>Painted shut; flaking paint, wood is solid underneath.</p> <p>No evidence of 'rotten window sash' as stated by applicant.</p>	<p>Repair</p>

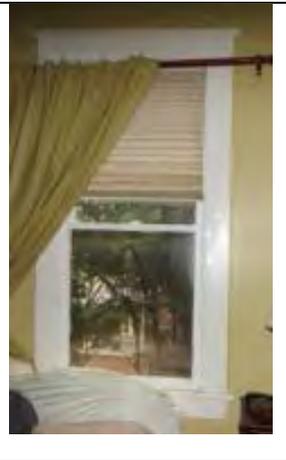
Broken window sash
E11		Fixed	
E12		Fixed

Painted shut; flaking paint; tiny softness on bottom rail of lower sash	Repair, possibly wood filler on bottom rail of lower sash

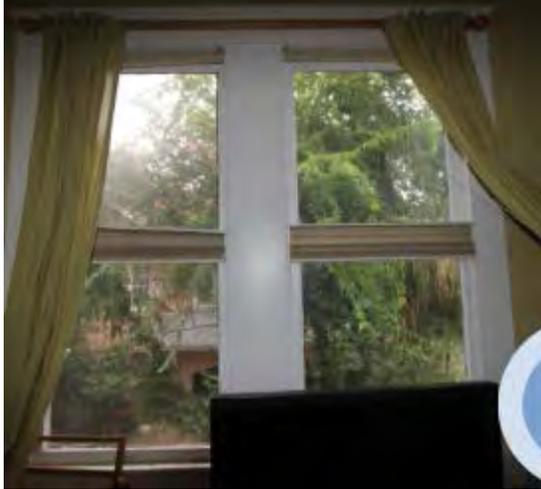
E13a

Damaged window sill
E13b

Painted shut. No damaged sill as stated by applicant.	Repair

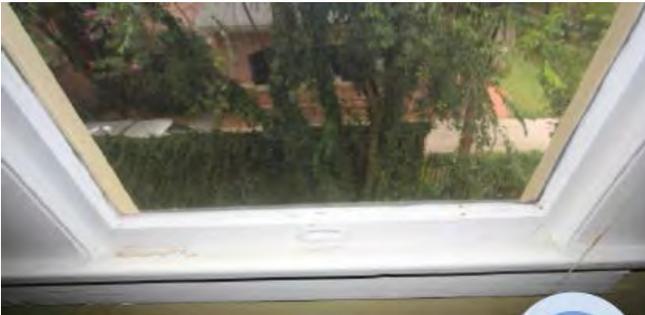
Damaged window sill
E16a

Painted shut; loose glass. No damaged window sill as stated by applicant.	Repair and re-glaze
E16a

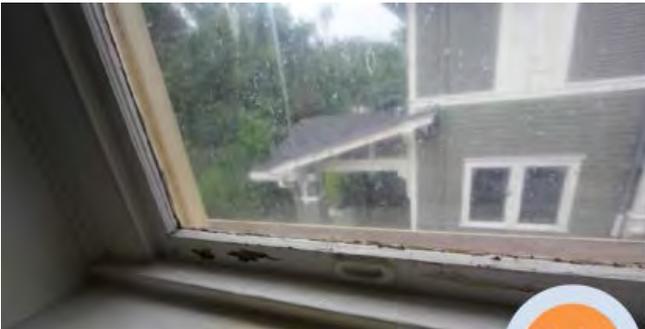
Rotten window sash

Painted shut; flaking paint; meeting rail slipping slightly but solid. Sash is not rotten as stated by applicant.	Repair, reattach bottom rail of upper sash

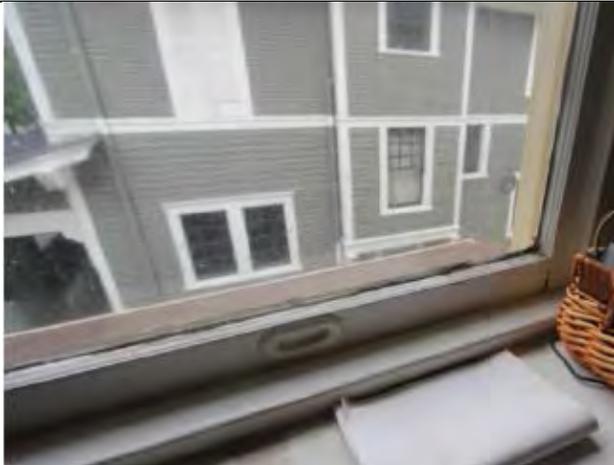
E16b

Rotten window sash
E17a

Painted shut; glass slipping. Sash is not rotten as stated by applicant.	Repair and re-glaze
E17a

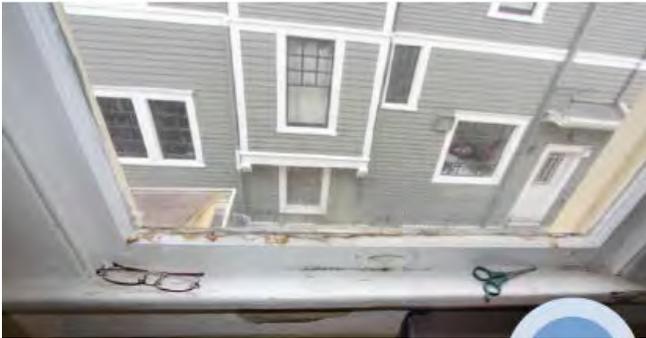
Rotten window sash; Damaged window sill
E17b

Painted shut; no cord; bottom rail of lower sash tiny bit soft. No damage seen on window sill, as stated by applicant.	Replace cords, possibly wood filler for rail or replacement rail

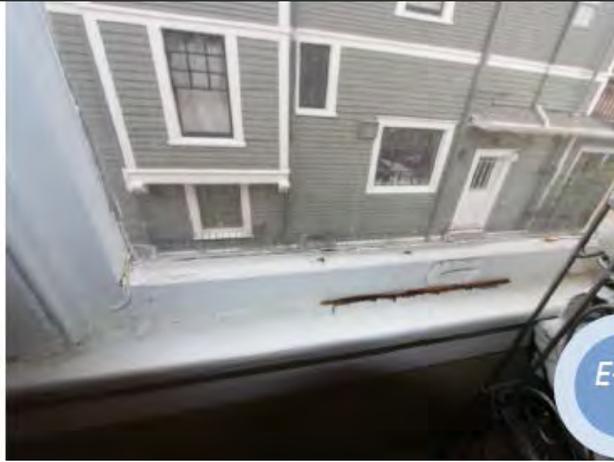
Rotten window sash; Damaged window sill

<p>Painted shut. Sash and sill do not appear to be damaged as stated by applicant. Flaking paint is over solid wood.</p>	<p>Repair</p>
<p>E18</p>

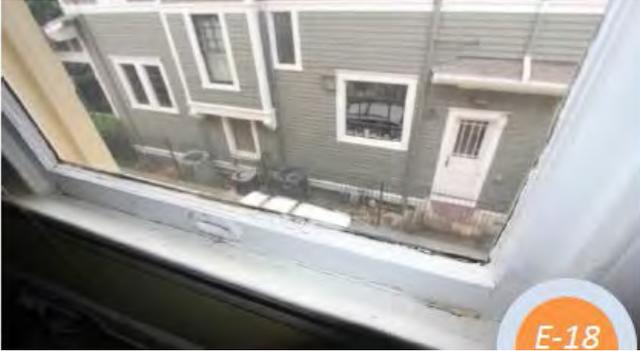
E18

Damaged window sill
E19a

<p>Partially rotten sill; Painted shut; upper sash bottom rail bowing</p>	<p>Possibly replace bottom rail of upper sash, repair sill</p>

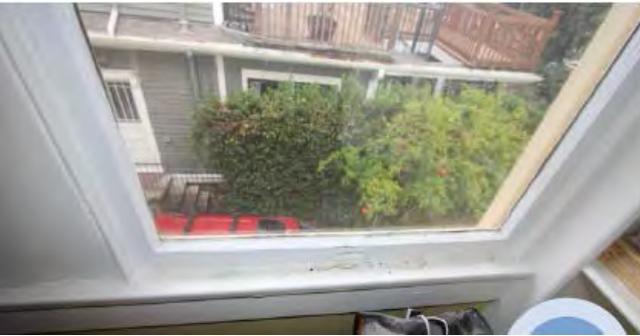
Damaged window sill

<p>Painted shut; upper sash bottom rail slipping, slightly soft; bottom rail lower sash soft on edges; loose glass</p>	<p>Re-glaze, possibly replace bottom rail of lower sash, reattach upper sash bottom rail</p>
