CERTIFICATE OF APPROPRIATENESS

Property: 504 Avondale St, lot 2, tract 3A, block 6, Montrose Subdivision. The property includes a historic 3,124 square foot two-story residence situated and detached garage on a 7,800 square foot (60' x 130') interior lot.

Proposal: Alteration – Changes to the foundation, windows and porch

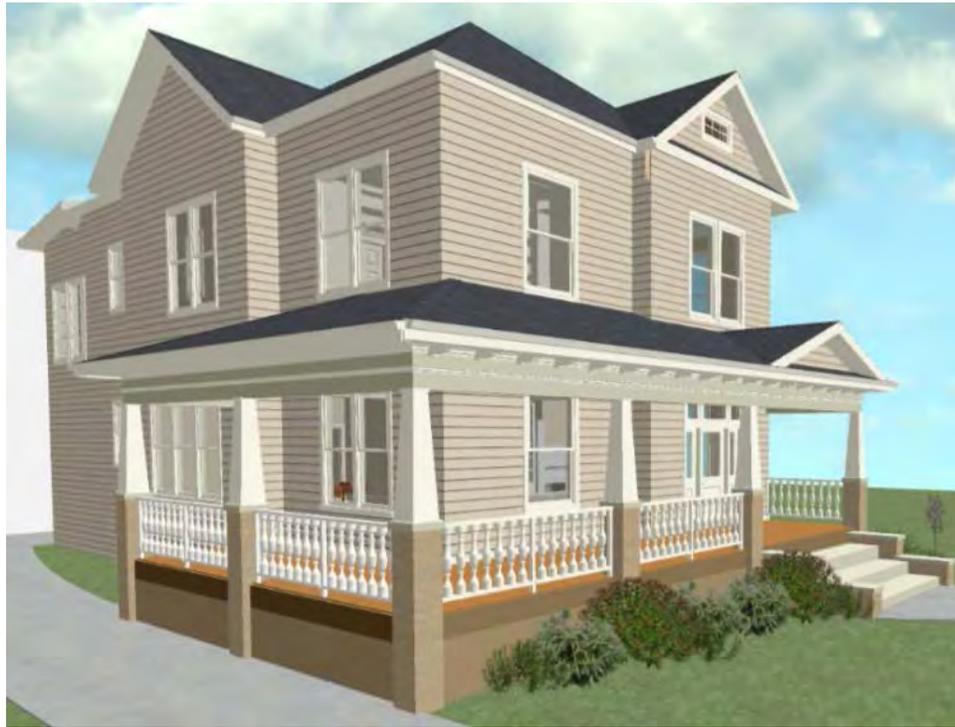
NORTH ELEVATION – FRONT FACING AVONDALE
EXISTING

Front Elevation: The residence contains four wood 1-over-1 windows and four brick piers with wood tapered columns at the front porch and corbels under the gable portion of the porch roof. The alteration replaces all windows with vinyl 1-over-1 windows and raises the porch piers by 6". The piers are failing and need to be rebuilt. The stairs will be raised through re-grading so another step will not be needed and corbel wills be installed on the rest of the front porch.

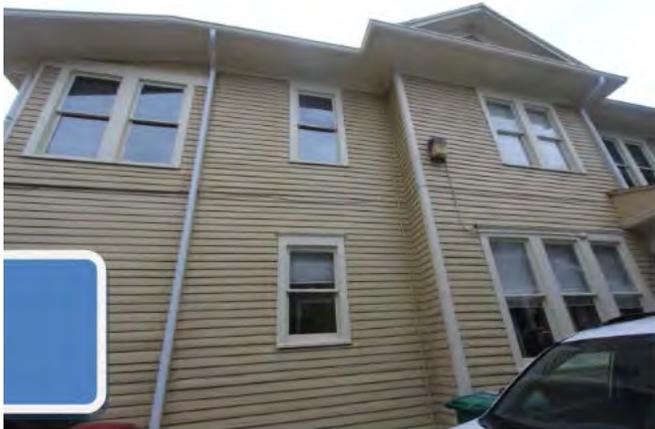
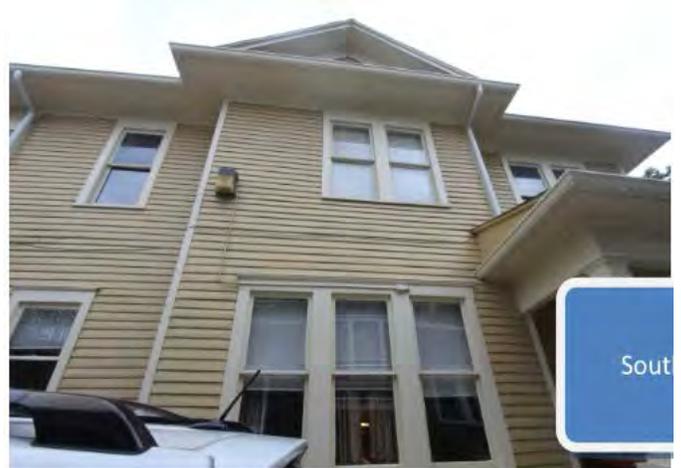
EAST SIDE ELEVATION

Side Elevation: The residence contains 13 wood 1-over-1 windows and three brick piers with wood columns at the front porch. The alteration replaces all windows with vinyl 1-over-1 windows and rebuilds the brick piers.

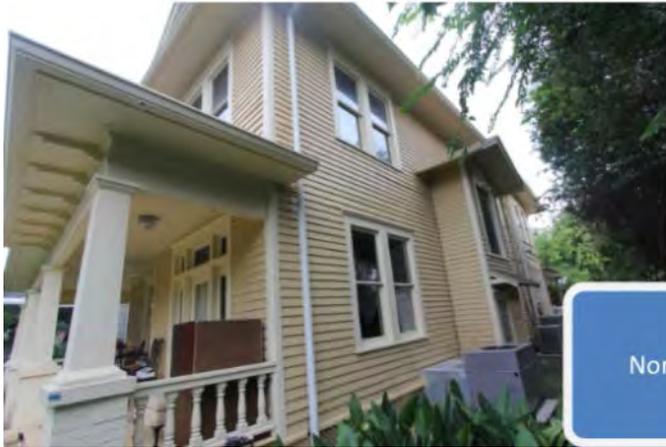
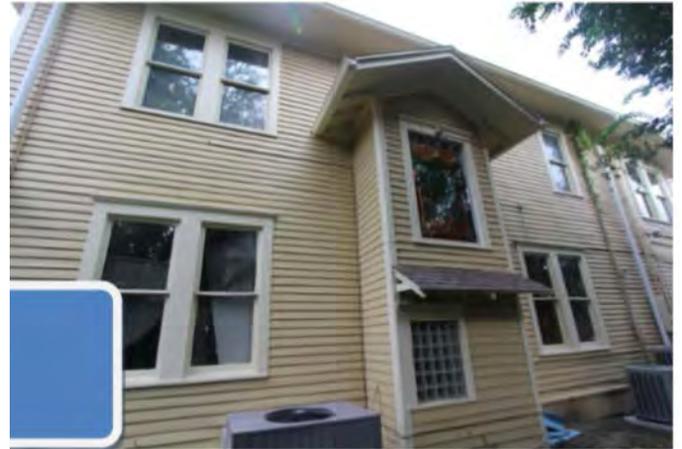
WEST SIDE ELEVATION

Side Elevation: The residence contains nine wood 1-over-1 windows and one brick pier with a wood column at the front porch. The alteration replaces all windows with vinyl 1-over-1 windows and rebuilds the brick piers.

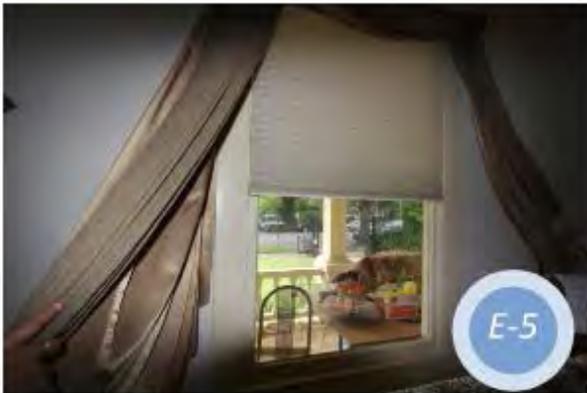
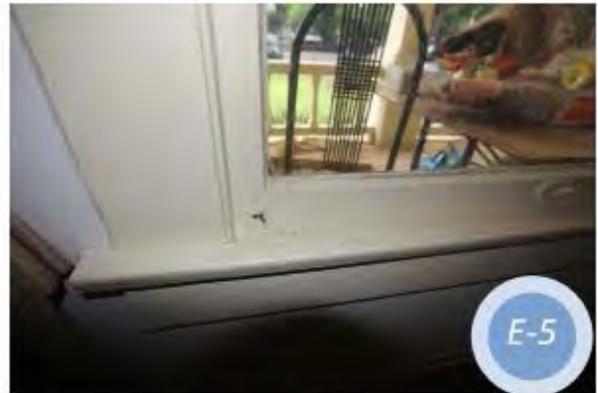
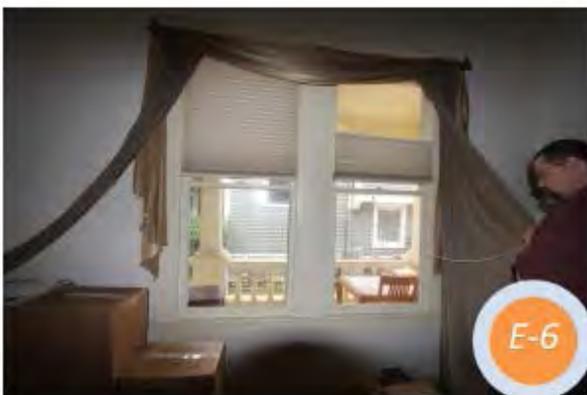
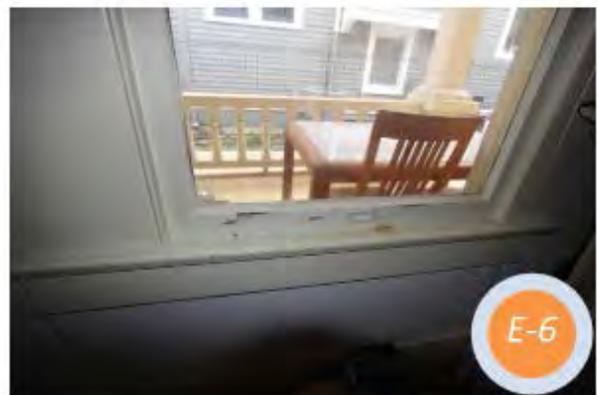
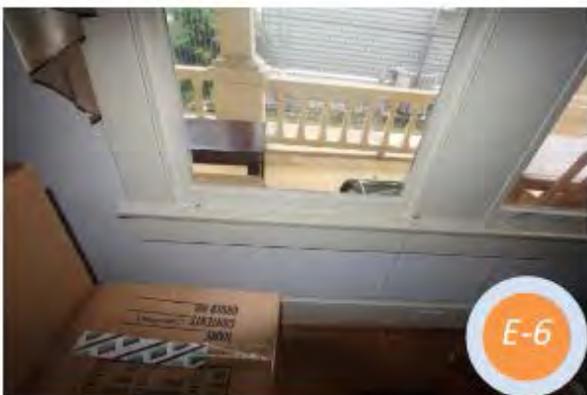
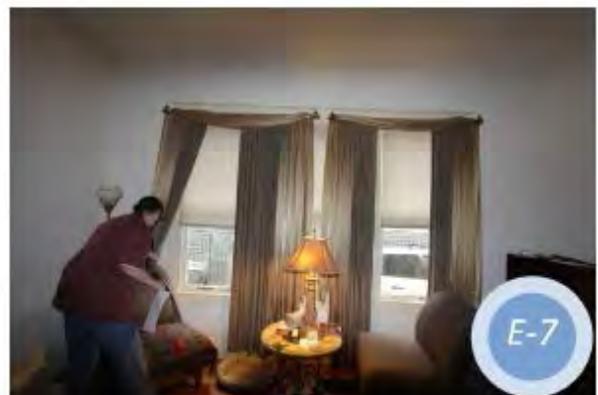
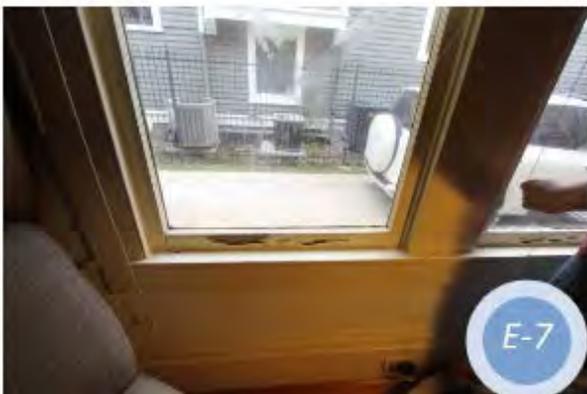
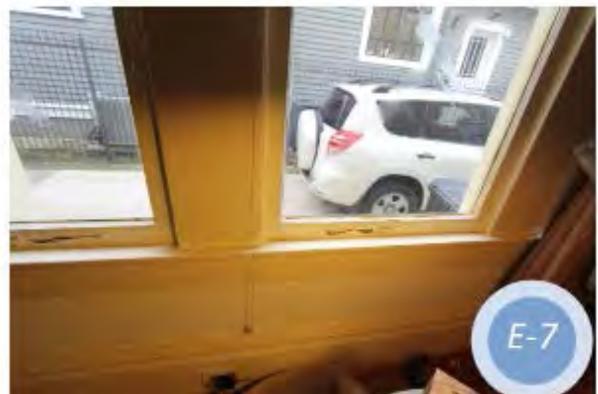
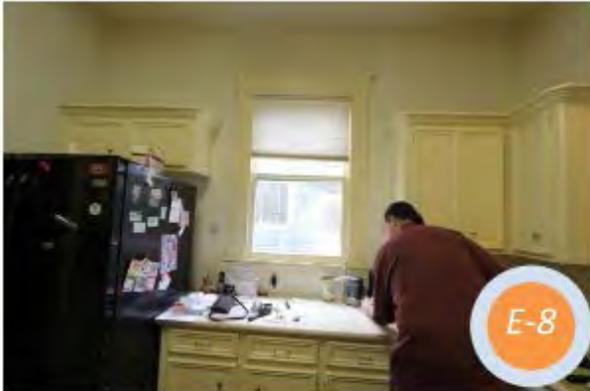
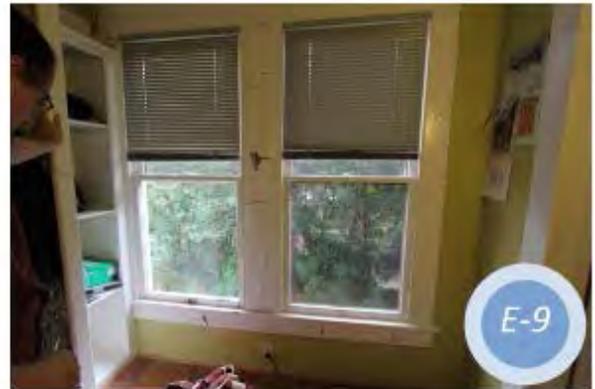
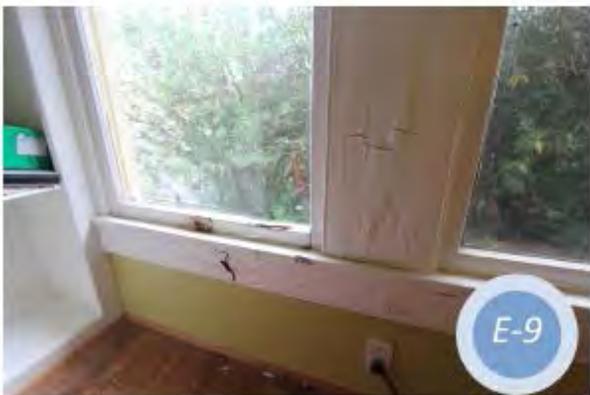
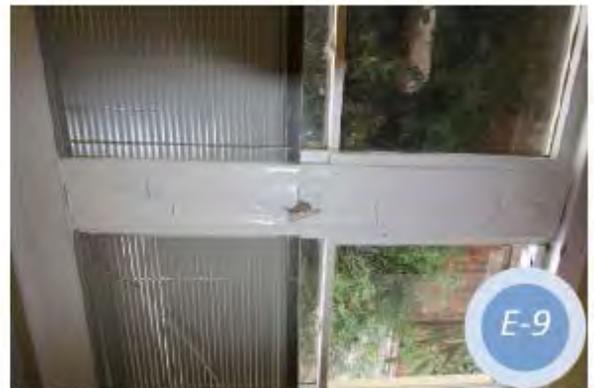
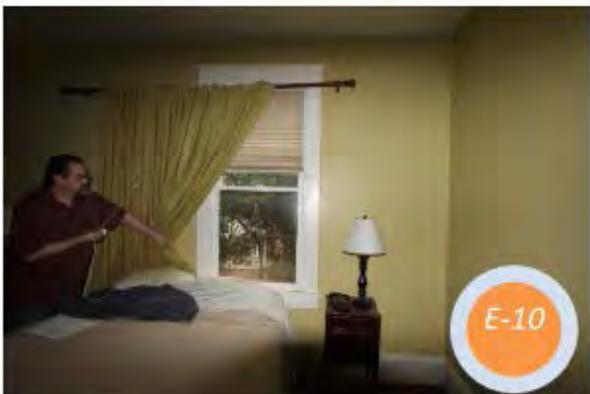
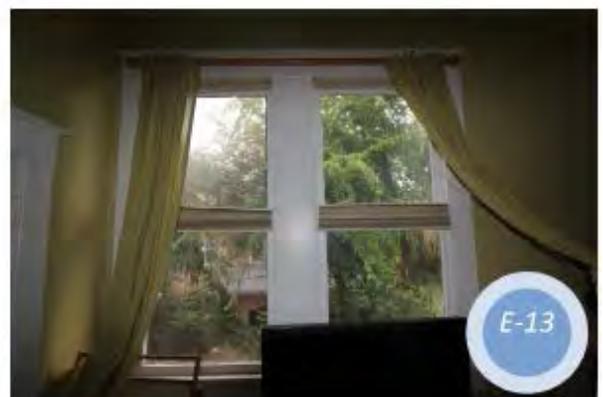
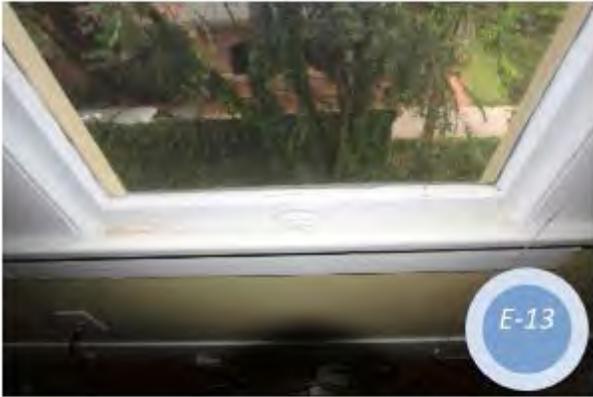
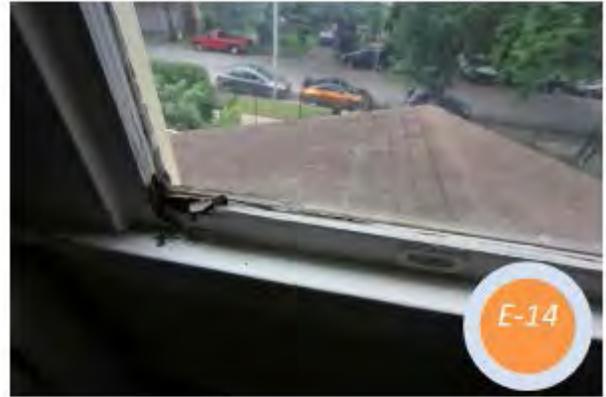
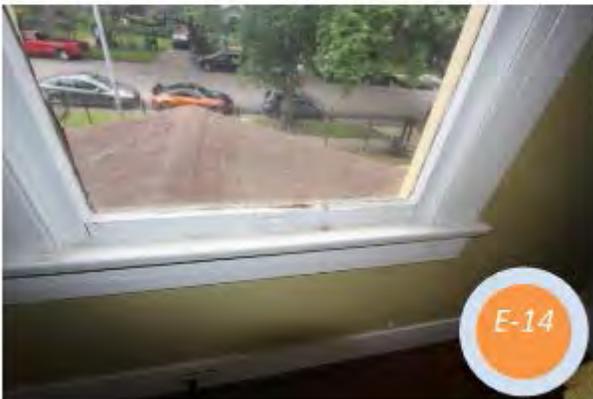
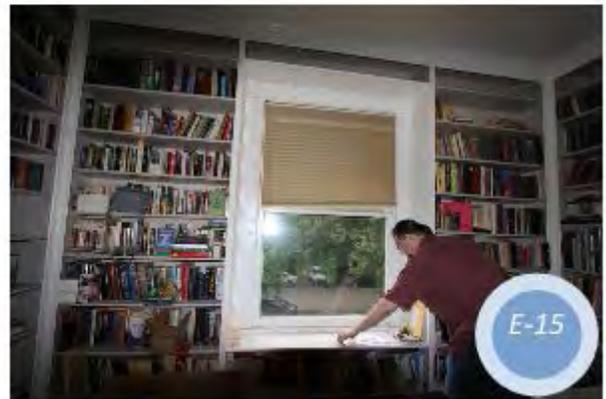
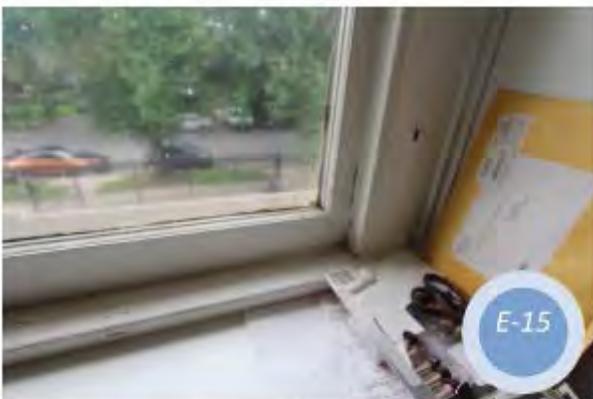
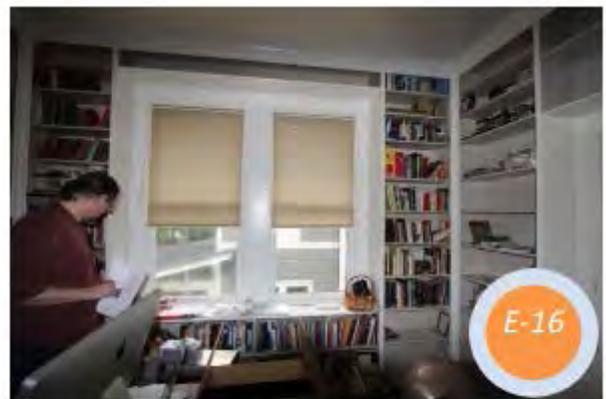
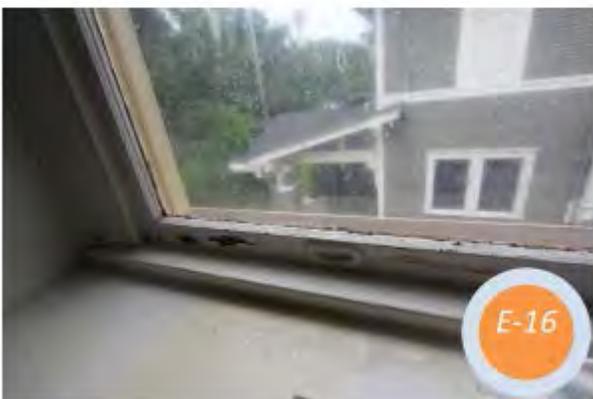
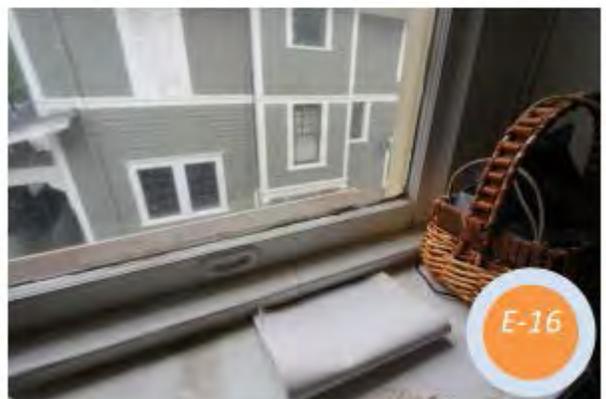
Description of Damages by Applicant

<i>The original wood windows are a distinguishing feature of the property and should be retained. Staff confirmed some damage of the original windows but believe they are not beyond reasonable repair.</i> | |

Broken window frame E-1, E-3, E-5, E-8, E-10, E-13, E-15, E-18, E-19

Damaged window sill E-9, E-13, E-14, E-17, E-18, E-19

Denial to replace all wood windows with vinyl windows.

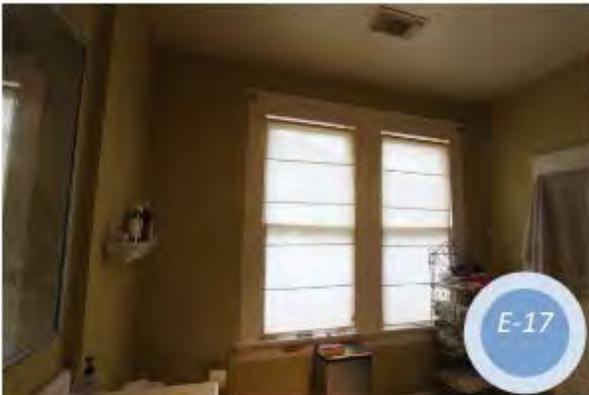
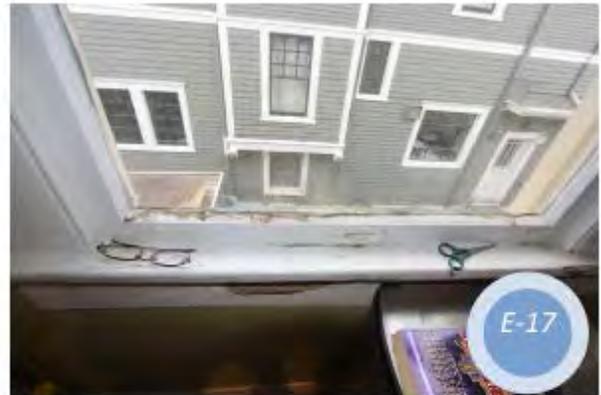
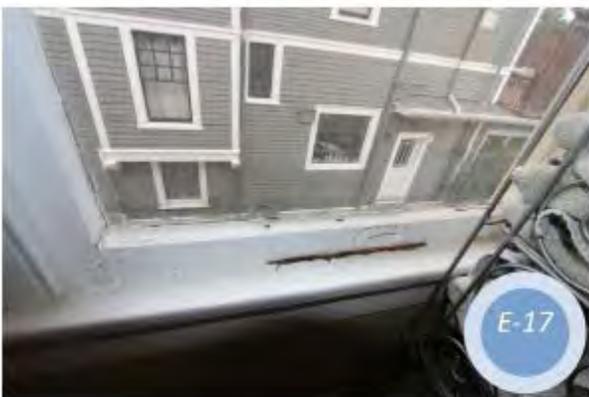
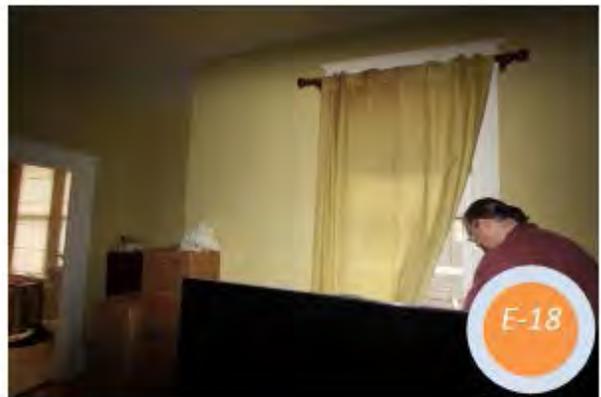
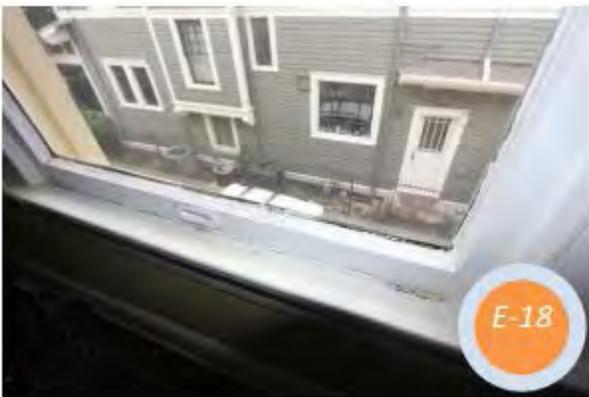
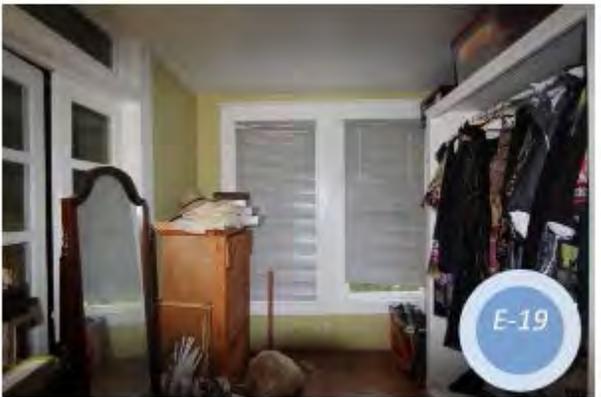
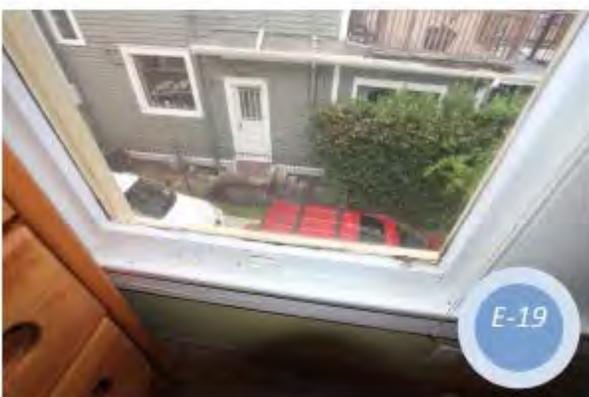
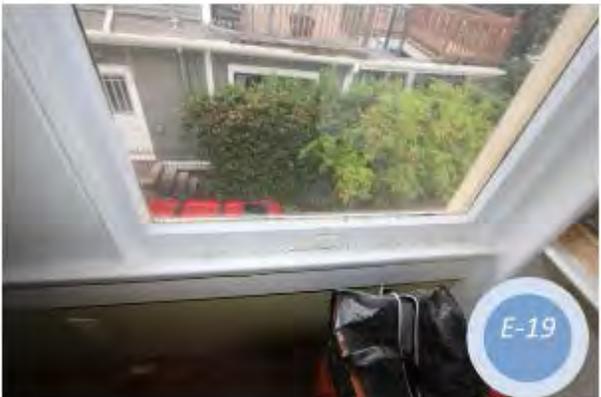
WINDOWS

<i>The original wood windows are a distinguishing feature of the property and should be retained. Staff confirmed some damage of the original windows but believe they are not beyond reasonable repair. The replacement windows are compatible in size, scale, and character with the existing windows.</i> | |
