CERTIFICATE OF APPROPRIATENESS

Property: 1031 Le Green Street, Lot 13, Block 110, North Norhill Subdivision. The property includes a historic 1,190 square foot one-story wood frame single-family residence and detached garage situated on a 5,000 square foot interior lot.

Proposal: Alteration – Alter the fenestration of the existing south (front) and east elevations of the historic residence.

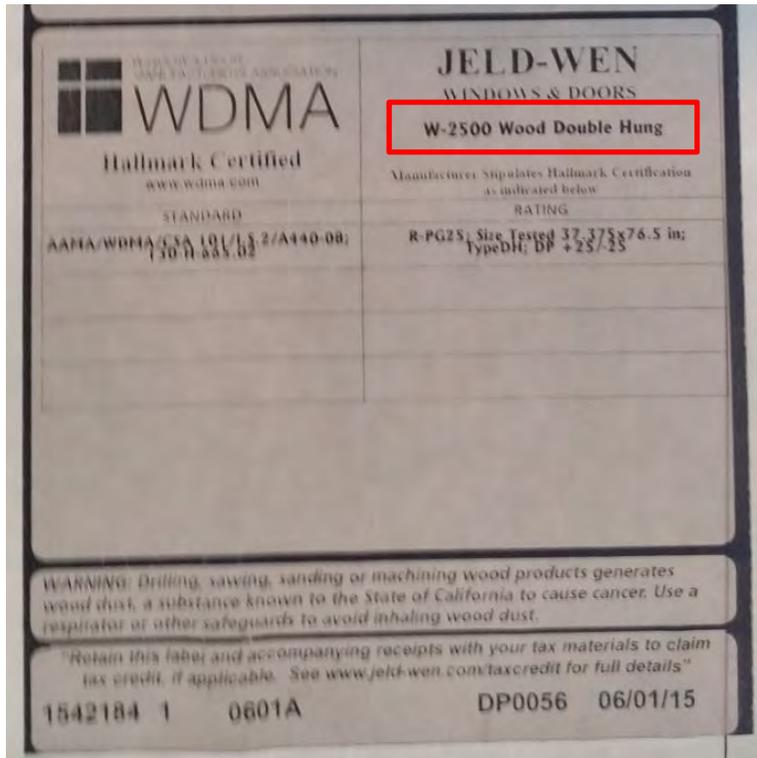
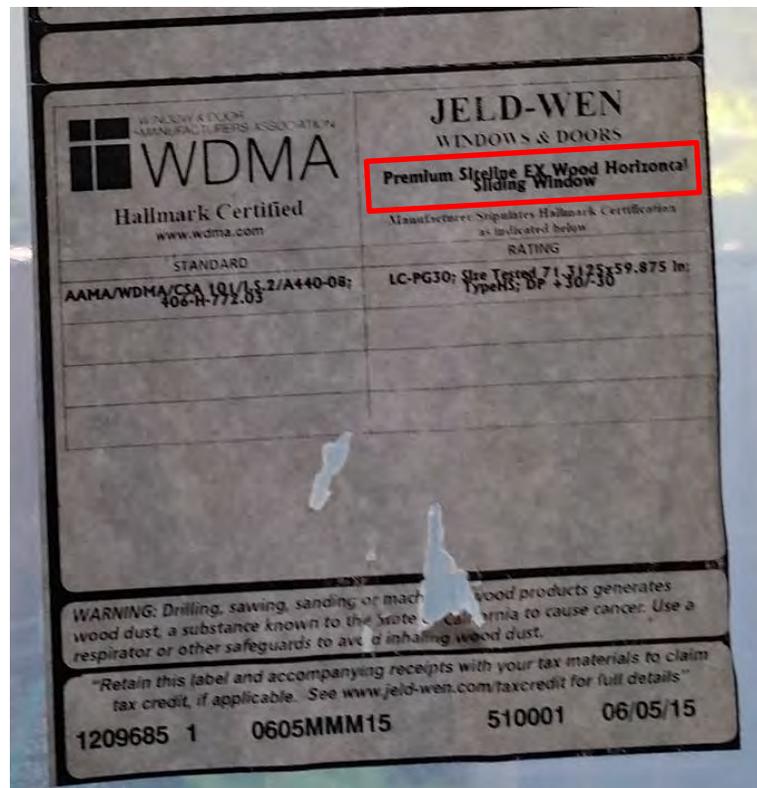
WINDOW / DOOR SCHEDULE

The two existing windows on the front elevation were removed. The existing openings were then expanded 1.5' on either side and two new pairs of 3' x 5' 1-over-1 wood double hung windows were installed. On the east elevation, the third window (from the street (after the pair)) was removed and replaced with a 3' x 2' wood slider window. The remainder of the opening was patched with new 117 wood siding to match existing. See photos, window/door schedule, and drawings for more detail.
