**CERTIFICATE OF APPROPRIATENESS**

**Property:** 1212 Tulane Street, Lot 27, Block 183, Houston Heights Subdivision. The property includes a historic 1,580 square foot, 1½-story wood frame single-family residence situated on a 4,400 square foot (33' x 132') interior lot.

**Significance:** Contributing Dutch Colonial residence, constructed circa 1915, located in the Houston Heights Historic District West.

**Proposal:** Alteration – Revision. The applicant was granted a COA in January 2015 for a rear two-story 1,621 square foot addition beginning at the rear wall of the historic house. All existing original 1-over-1 wood windows and original 117 wood siding were to be retained and repaired.

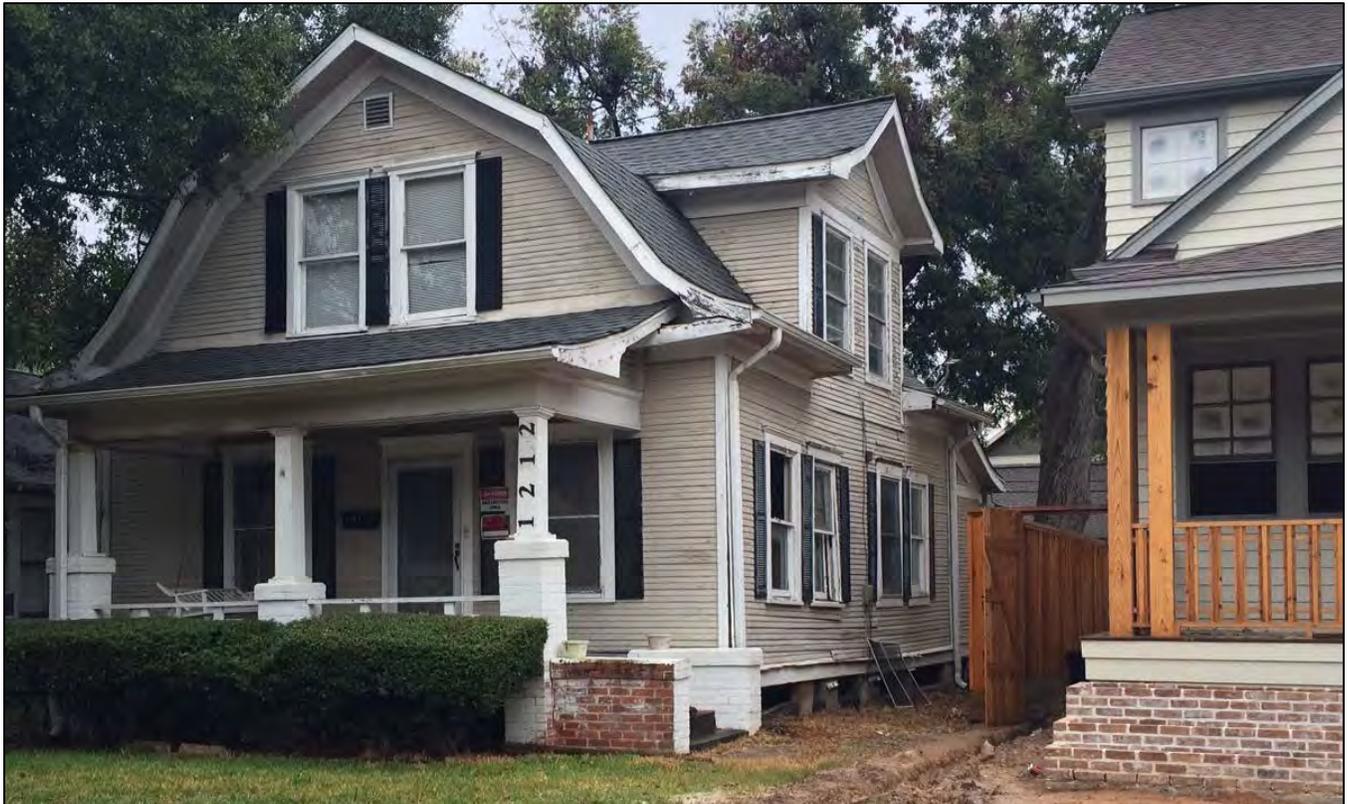
CURRENT PHOTO

- Altered, resized and shifted original window openings.
- Replaced all original wood windows with flush-mounted vinyl windows of a smaller size.
- Removed substantial portions of the original 117 wood siding, including the entire south wall, part of the front west wall, and approximately 50% of the north wall.
- Removed all original wood trim.
- Raised the foundation 8", which caused damage to existing porch elements.
- Removed interior shiplap from exterior walls.
- Extended the addition an additional 1'-0".

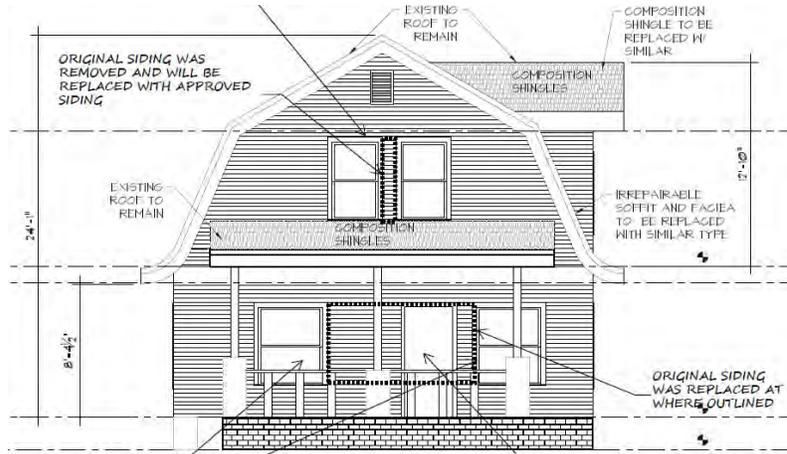
EXISTING

- Removed Siding
- Reinstall Original Windows
- Install Composite Replacements
- Vinyl Windows

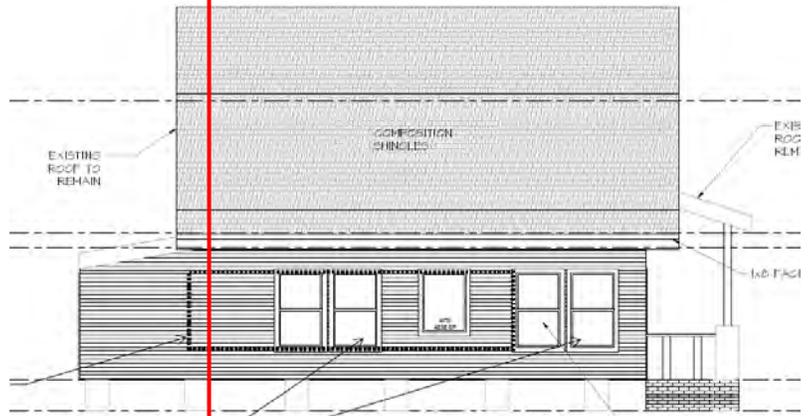
EXISTING

- Removed Siding
- Reinstall Original Windows
- Install Composite Replacements
- Vinyl Windows

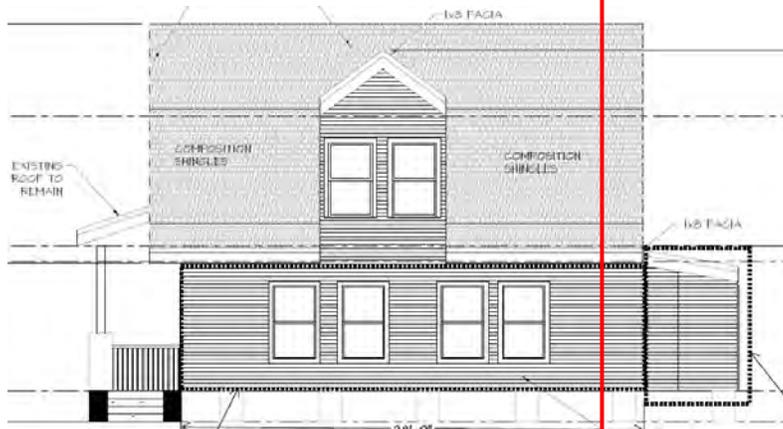
EXISTING

- Removed Siding
- Reinstall Original Windows
- Install Composite Replacements
- Vinyl Windows

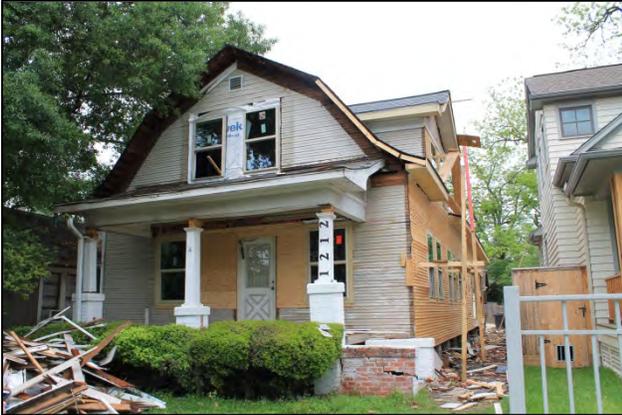
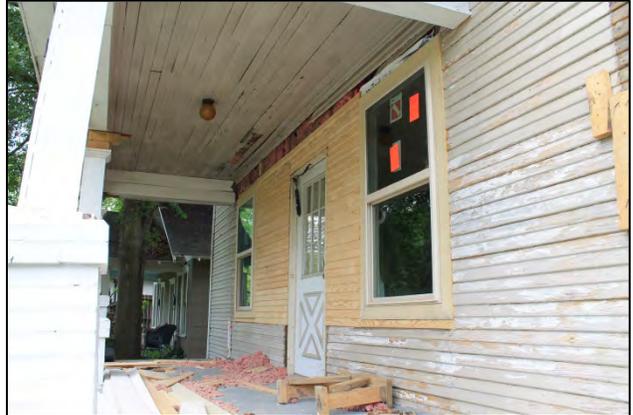
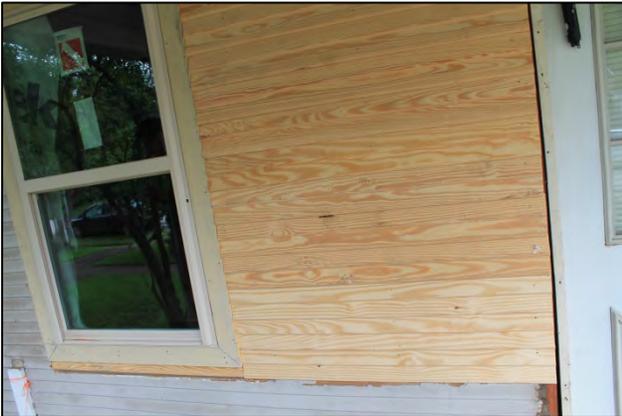
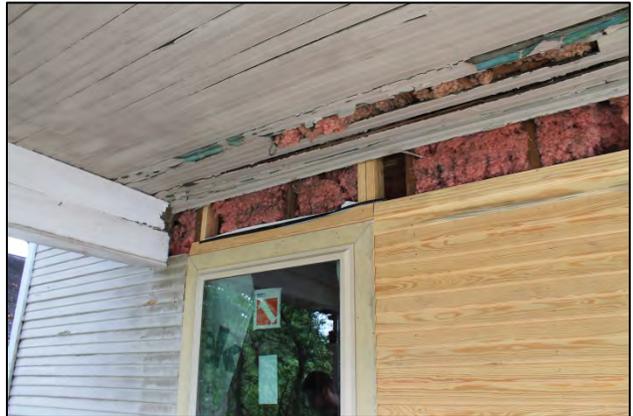
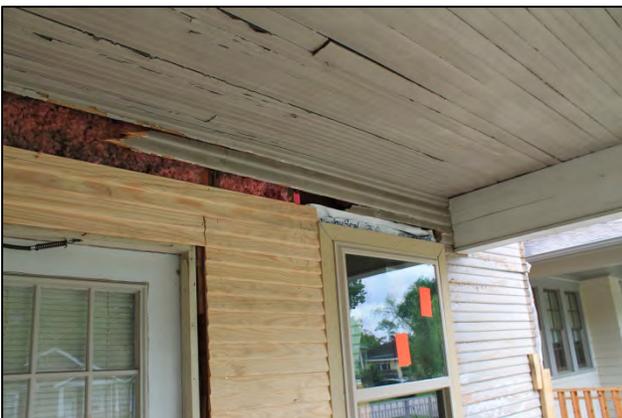
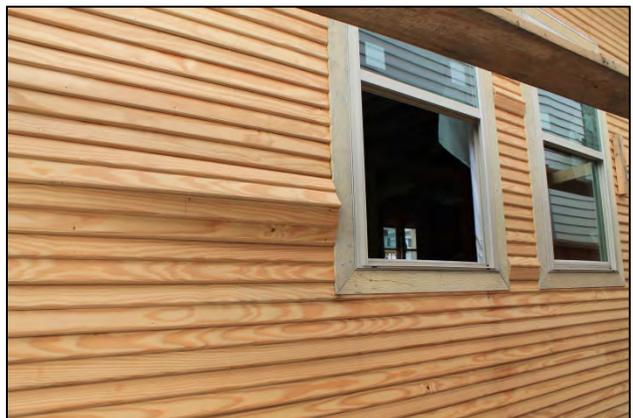
CURRENT PHOTOS OF UNPERMITTED WORK

June 2015: All historic windows have been removed and replaced with flush mount vinyl windows. Additionally, all historic window openings have all been reframed, with the two front windows on the first story reduced in width by half a foot. On the north elevation, one window has been shifted 1'-7" to the east, one window has been eliminated, and the window located at the stairs has been altered. Altogether, 13 original wood windows were removed, along with two non-original aluminum windows. The applicant proposes to reinstall 7 of the original wood windows that have been found on site. The remaining original windows have been destroyed. For the balance of the existing window openings, five new composite windows are to be installed and one window will be eliminated. The two non-original windows will be replaced with vinyl windows. Seven additional windows have been installed in the addition. The addition will retain the vinyl windows already installed. The existing door will be retained and repaired. See drawings, window/door schedule, and photos for more detail.

June 2015: All original siding has been removed on the south elevation along with sections of siding on the first and second stories of the front (west) elevation and sections of the north elevation. New replacement 117 wood siding has been installed. All historic trim has been removed and destroyed. Existing soffit and fascia has been damaged. Removed trim, soffit, and fascia will be replaced with new cementitious material to match the profile of the removed material. Wood lattice skirting will wrap the foundation. See drawings and photos for more detail.

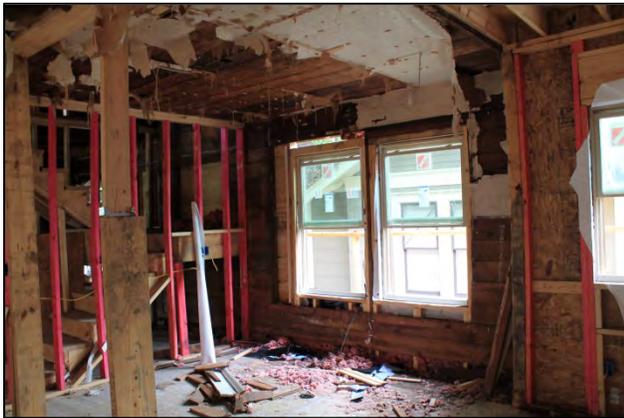
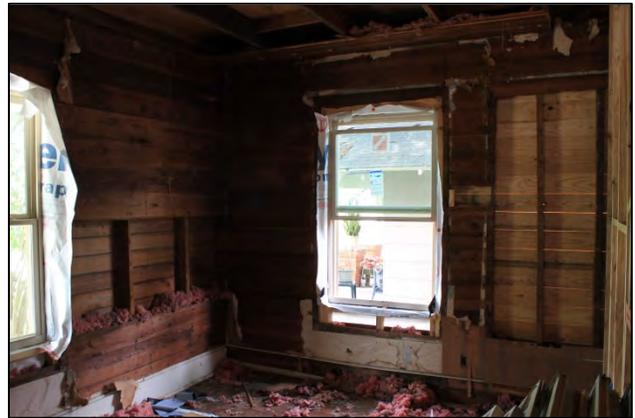
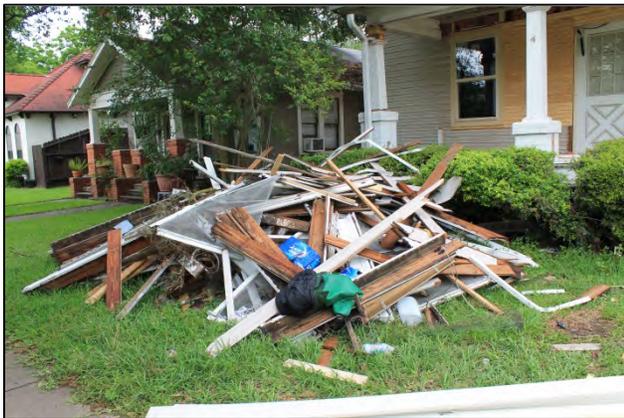
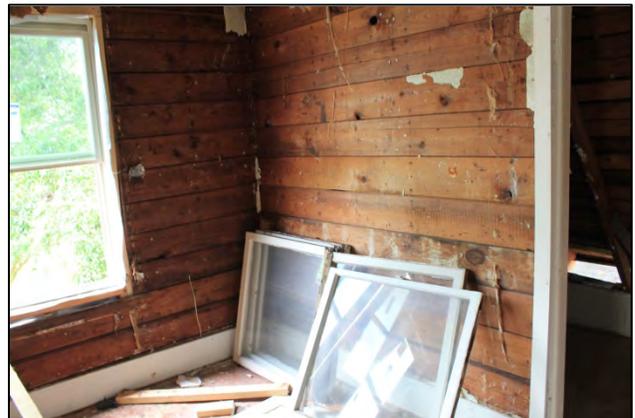
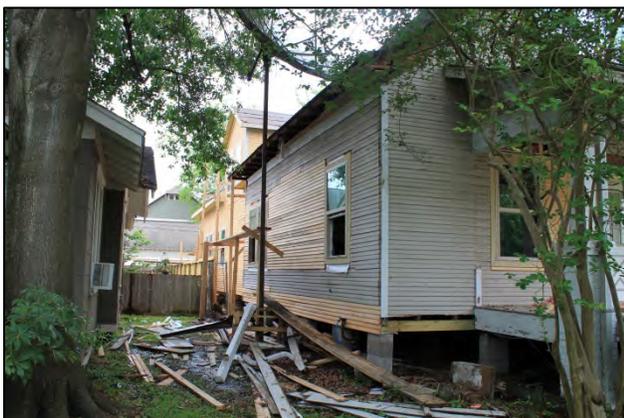
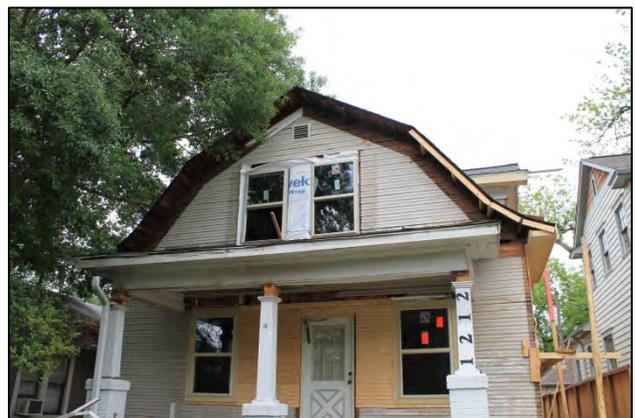
CURRENT PHOTOS OF UNPERMITTED WORK

June 2015: The applicant has exceeded the approved scope of work. Significant portions of the original siding have been removed and replaced, especially on the first story. All trim has been removed. All original windows have been removed and replaced with flange mounted vinyl windows. The two front windows were also reduced in width. The original portion of the house was raised 8" separating the porch roof from the columns (which are now topped by blocking). See drawings and photos for more detail.

June 2015: The applicant has exceeded the approved scope of work. The original portion of the house was raised 8" separating the porch roof from the columns (which are now topped by blocking). Significant portions of the original siding have been removed and replaced. All original windows have been removed and replaced with flange mounted vinyl windows. The westernmost pair of windows has also been significantly altered. The western window of this pair has been shifted to the west while the eastern window has been removed altogether. The addition now has three pairs of windows, five more windows than originally approved. See drawings and photos for more detail.

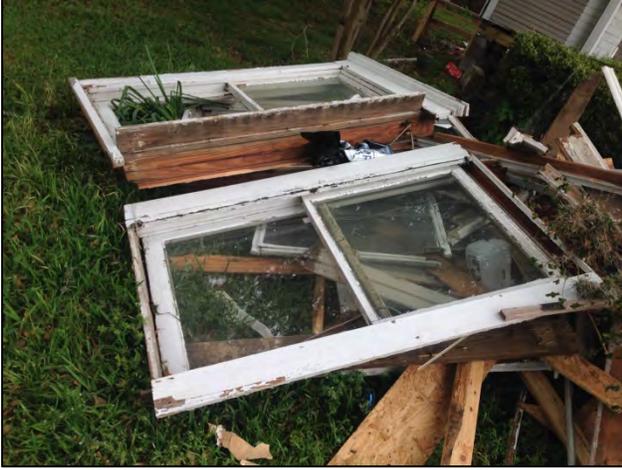
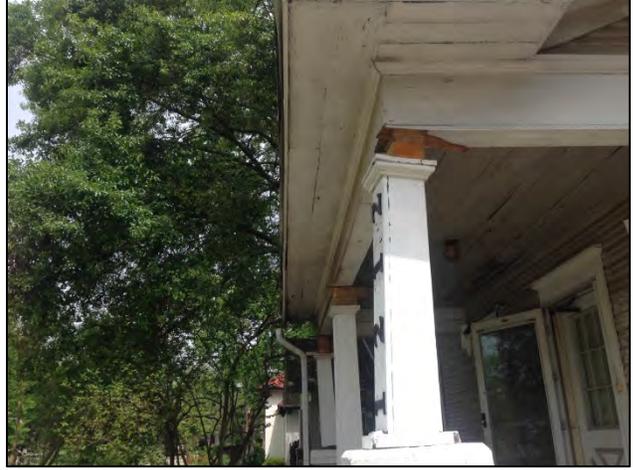
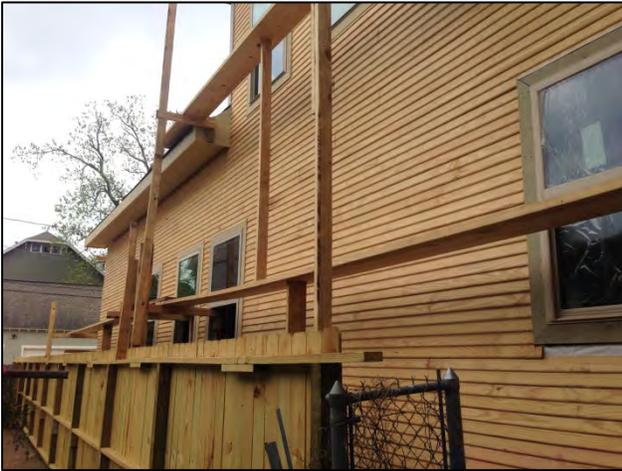
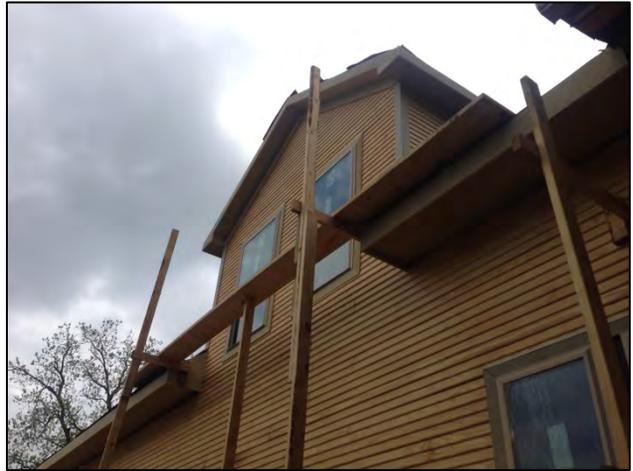
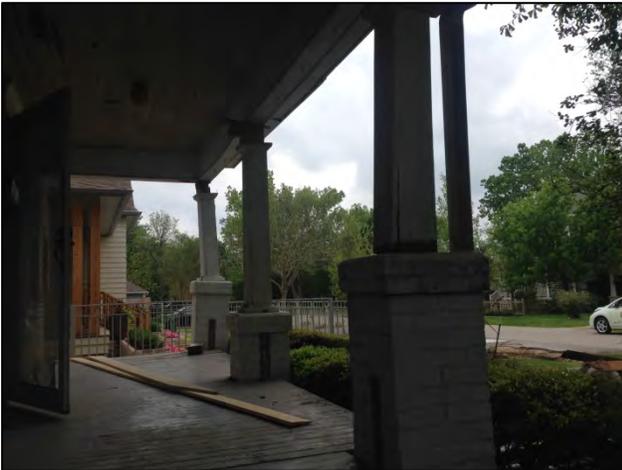
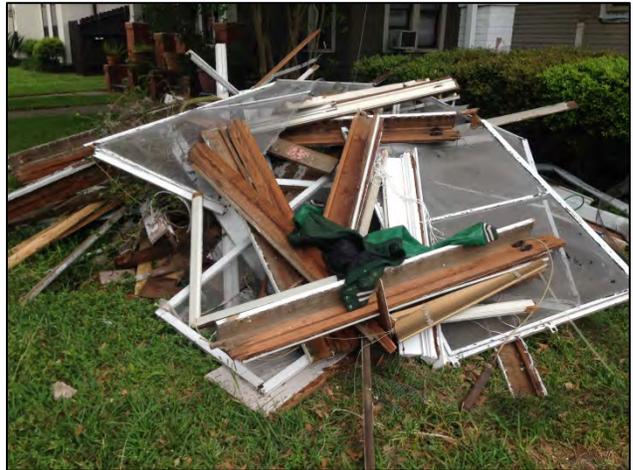
CURRENT PHOTOS OF UNPERMITTED WORK

June 2015: The applicant has exceeded the approved scope of work. The original portion of the house was raised 8" separating the porch roof from the columns (which are now topped by blocking). All original siding has been removed and replaced. All original windows have been removed and replaced with flange mounted vinyl windows. The addition now includes two more windows than originally approved. The rear inset portion is now a porch with five columns and a railing system. The proposed additional dormer was never constructed. See drawings and photos for more detail.
