CERTIFICATE OF APPROPRIATENESS

Property: 638 Heights Boulevard, Lot 22, Block 277, Houston Heights Subdivision. The property includes a historic 1,108 square foot, one-story wood frame single-family residence situated on a 7,500 square foot (50' x 150') interior lot.

Proposal: Alteration – Revision

The property received a COA for foundation repair and brick stabilization on June 19, 2014 and a COA for a rear two-story addition on October 23, 2014. All original materials were to remain as stipulated in the previously approved COAs.

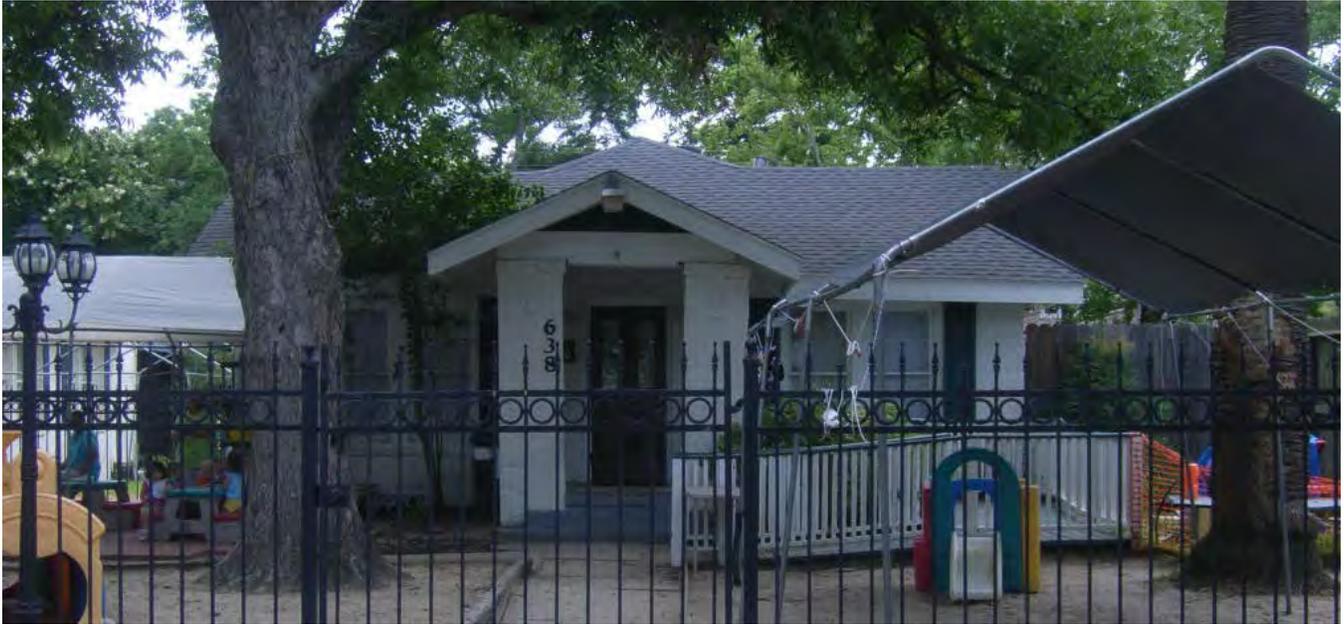
STAFF PHOTO – 4/26/2015

- Removed the original brick veneer
Removed a portion of the original roof
Reframed removed portion of roof at an increased height
Removed original windows (retained on site)
Removed structural shiplap and reframed exterior walls

- Reinstall the original windows
Reinstall the original brick veneer to be supplemented with antique brick to match existing
Reconstruct original roof to original configuration

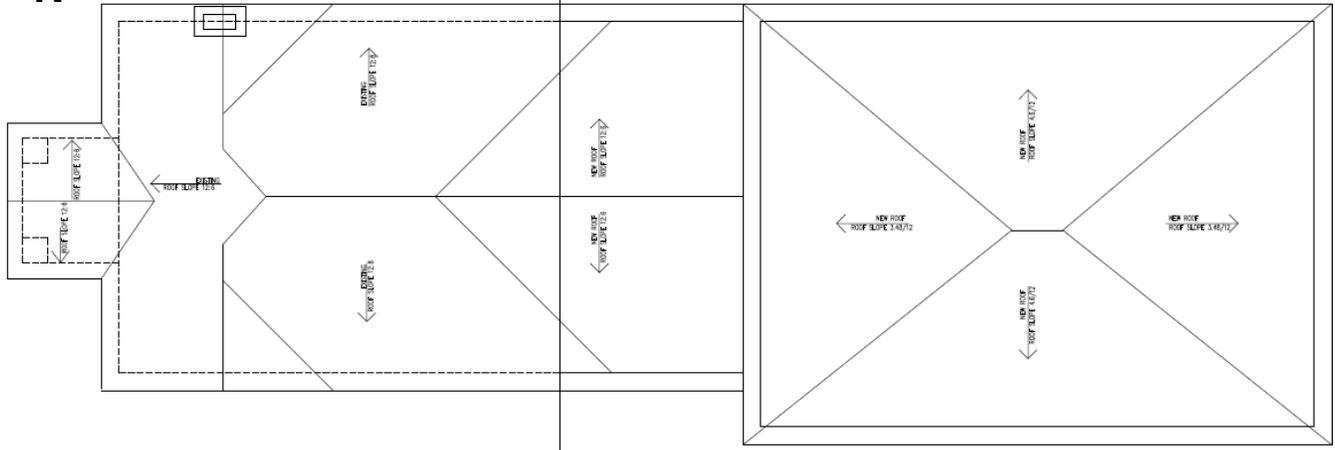
APPROVED – 10/23/14

The current roof, not built to plan, will be removed and replaced with a roof that matches the original height and configuration. The raised roof of the addition will now begin 1'-0" behind the original rear wall of the house on the north elevation and 4'-9" behind the original rear wall on the south. See drawings for more detail.
