CERTIFICATE OF APPROPRIATENESS

Property: 511 Arlington Street, Lot 10, Block 288, Houston Heights Subdivision. The property includes a historic 1,158 square foot, one-story wood frame single-family residence and a detached garage situated on a 6,600 square foot (50' x 132') interior lot.

Proposal: Alteration – *Windows Revision*

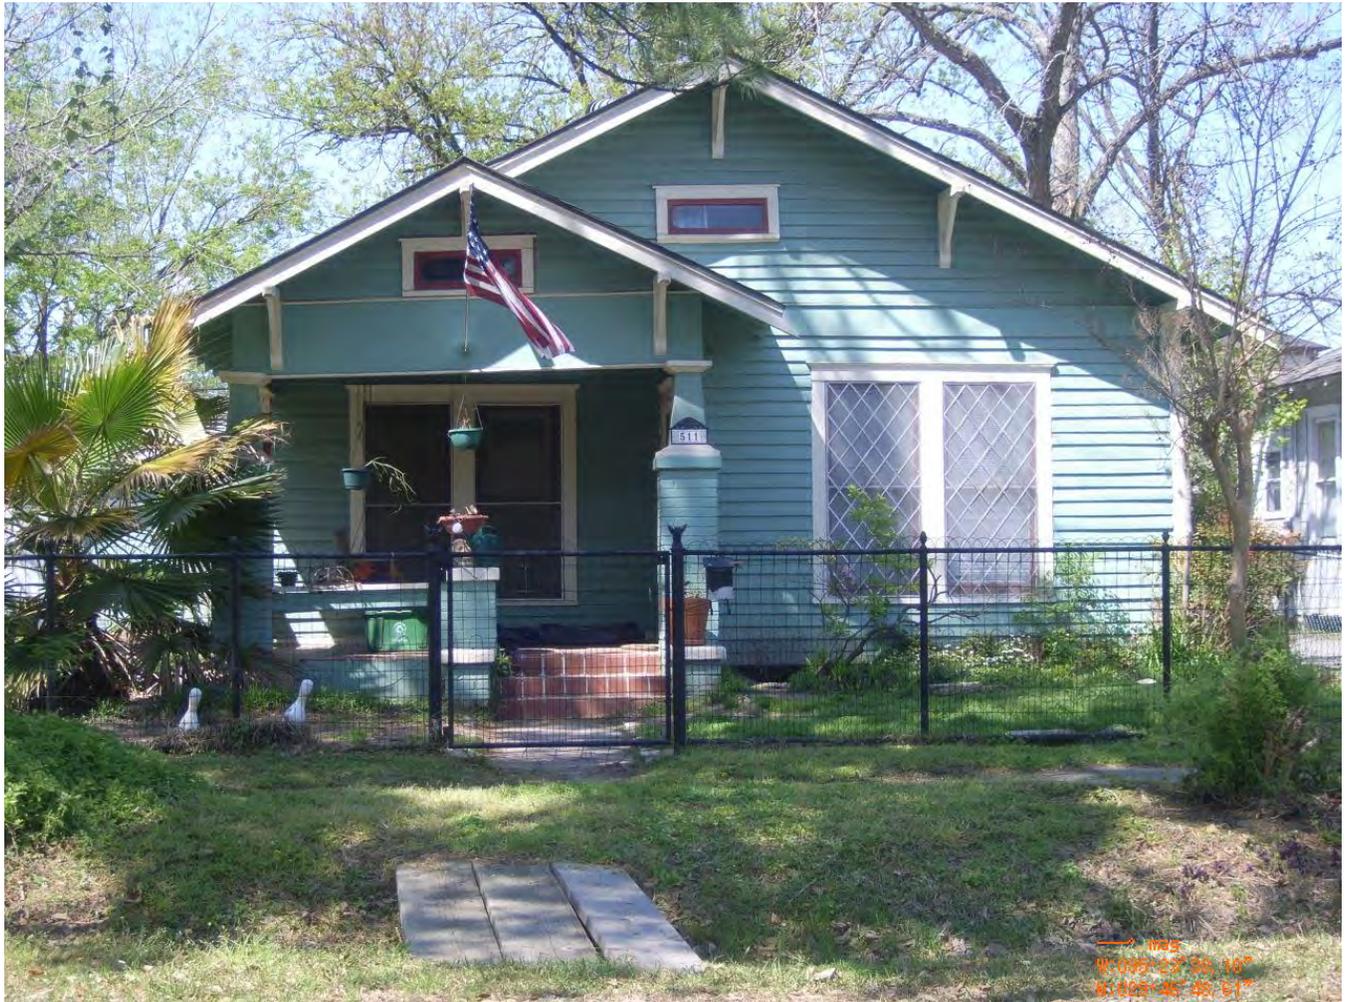
WINDOW REFERENCE KEY

WINDOWS PROPOSED TO BE REPLACED ARE HIGHLIGHTED

6 of the existing windows feature a 2-over-2 divided lite configuration. Window-2 features a 2-over-1 lite pattern.

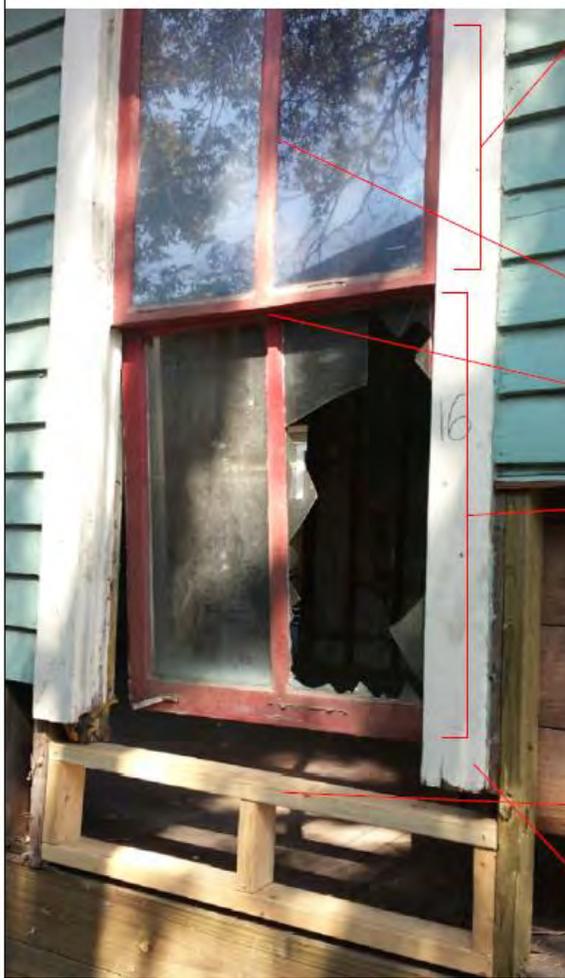
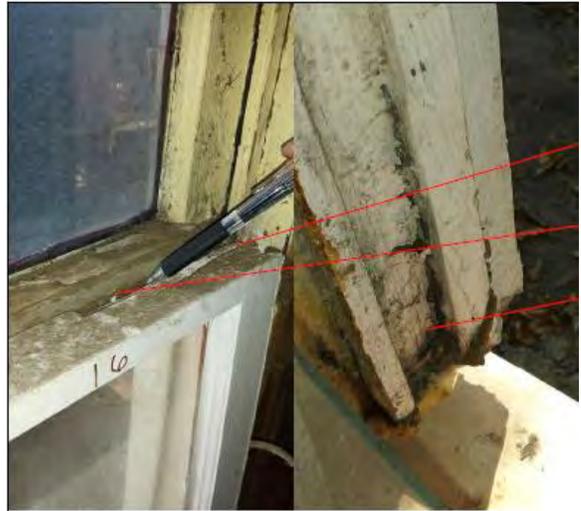
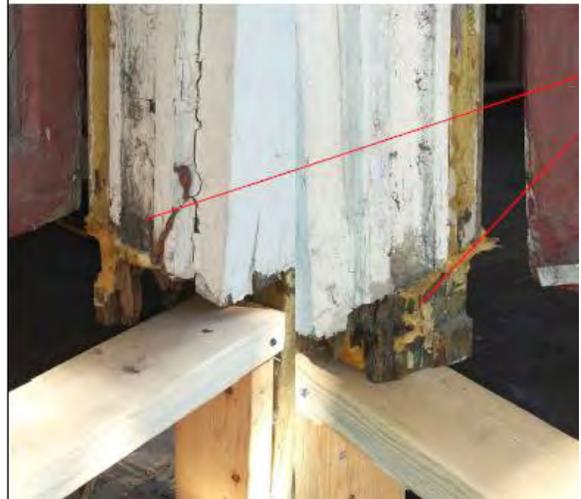
WINDOW 16

Staff and the City’s Structural Inspector performed multiple site visits to this property and found that the jambs and sills and the lower sashes of the windows have sustained significant damage. Staff and the inspector also found that all of the upper sashes are salvageable.

Proposed: The applicant asserts that the approved leveling and lifting of the structure revealed that the sills and jambs for windows 2, 4, 5, 12, 13, 15, and 16 had incurred significant damage from termites and rot. They state that since the jamb and sill are rotted, there is no way to effectively preserve these windows. The applicant also asserts that all of the window sashes for all of these windows are damaged beyond repair. The applicants have submitted photos of each of these windows illustrating damage to the sill, jamb, and sash. Staff and the City's Structural Inspector visited the site and confirmed the existence of sill and jamb damage on windows 2, 4, 5, 12, 13, 15, and 16 and the existence of sash damage on the lower sashes of each of these windows. The City Structural Inspector found that the upper sashes are in good condition on each of the windows.

HAHC Action: Approved with conditions: The upper sashes for 2, 4, 5, 13, 15, & 16 be repaired and retained. The deteriorated jambs, sills, and lower sashes can be repaired or replaced with salvaged sashes.

Staff's finds that historic windows consist of individual components that can be repaired or replaced while maintaining the remaining functioning components of the historic windows. Windows 2, 4, 5, 12, 13, 15, and 16 can have their damaged sills and jambs replaced with matching materials while the salvageable historic sashes can be maintained. In addition, the window sashes can have damaged muntins and rails replaced with in kind material while retaining the rest of the historic sash.
