**CERTIFICATE OF APPROPRIATENESS**

**Property:** 802 W. Temple Street, Lot 9, Block 218, East Norhill Subdivision. The property includes a historic 2,004 square foot, one-story brick veneer single-family residence and a detached garage situated on a 6,157 square foot (59' x 104') corner lot.

**Proposal:** Alteration – Replace 19 original wood 1-over-1 sash windows with 19 1-over-1 wood replacement windows.

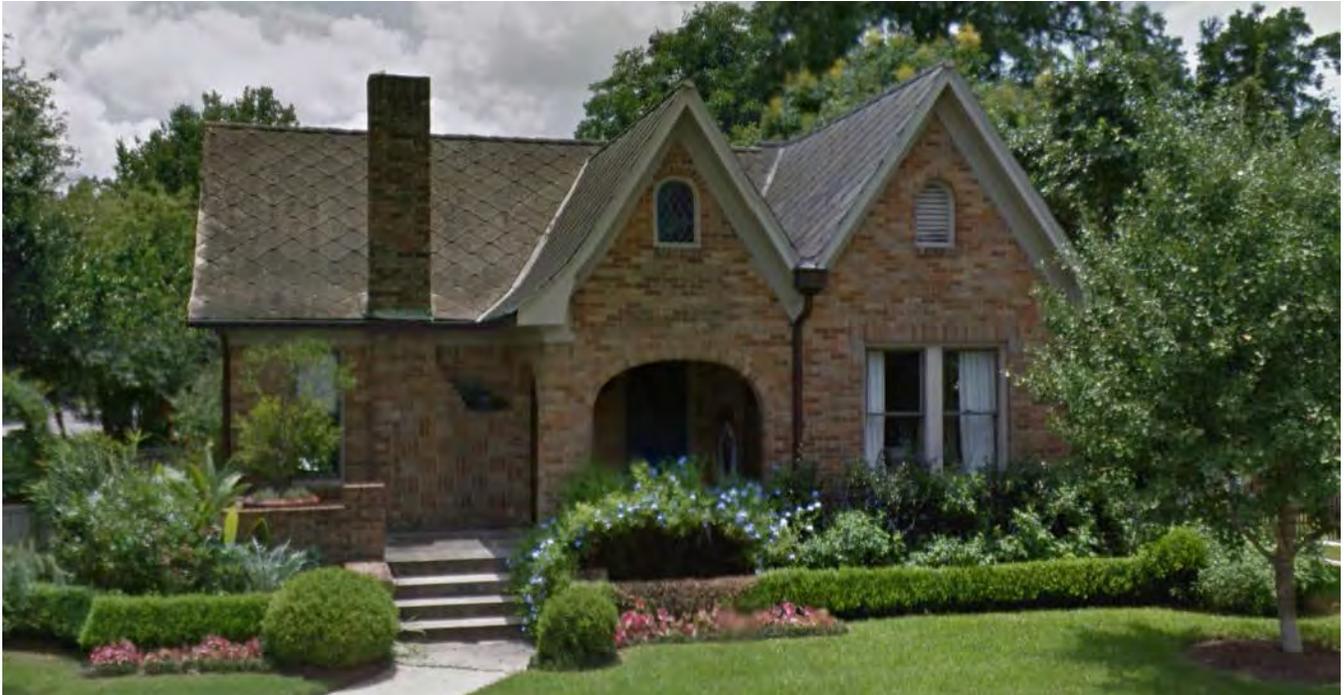
**NORTH ELEVATION – FRONT FACING W. TEMPLE STREET**

**Front Elevation:** Replace four original 1-over-1 wood sash windows with four 1-over-1 wood replacement windows.  
**(North)**

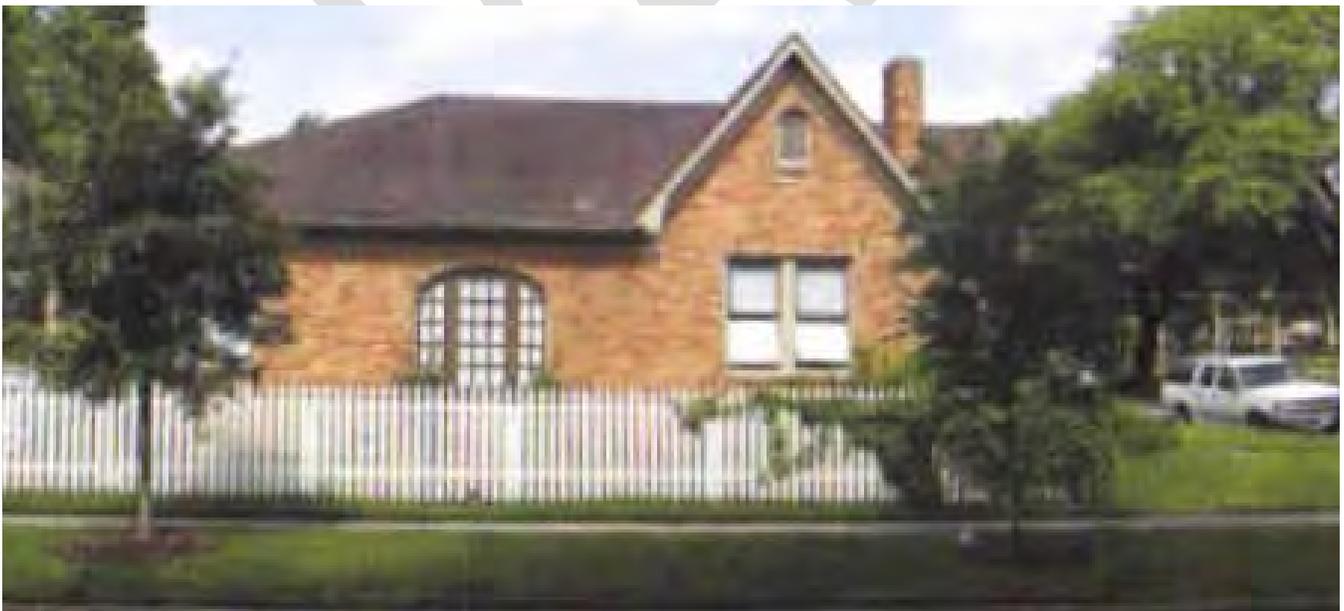
**EAST SIDE ELEVATION FACING WATSON STREET**

**Side Elevation:** Replace four original 1-over-1 wood sash windows with four 1-over-1 wood replacement windows.  
**(East)**

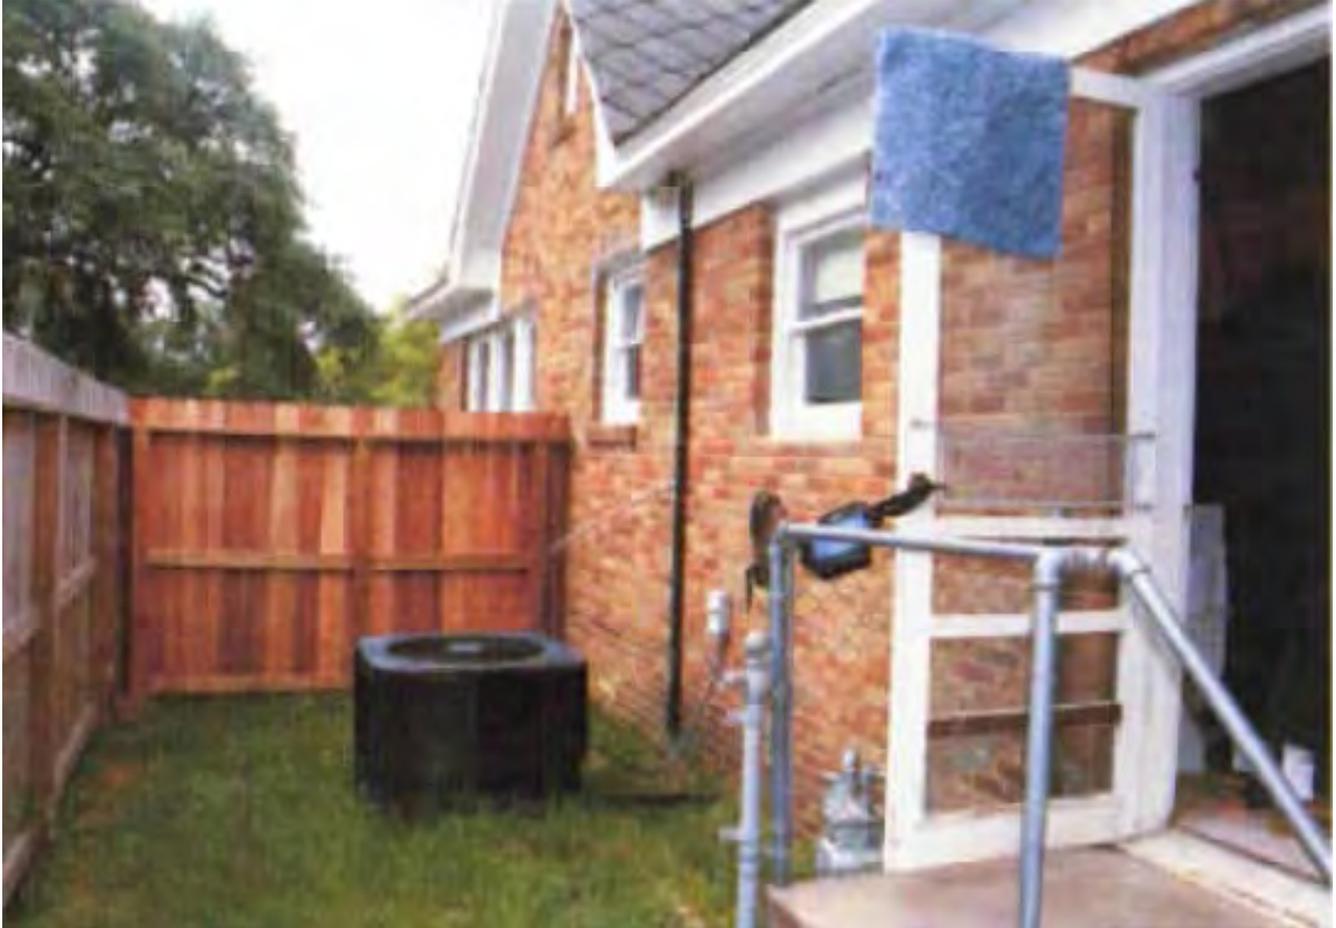
**WEST SIDE ELEVATION**  
**EXISTING**

**Side Elevation:** Replace seven original 1-over-1 wood sash windows with seven 1-over-1 wood replacement windows.  
**(West)**
