CERTIFICATE OF APPROPRIATENESS

Property: 1212 Tulane Street, Lot 27, Block 183, Houston Heights Subdivision. The property includes a historic 1,580 square foot, 1½-story wood frame single-family residence situated on a 4,400 square foot (33' x 132') interior lot.

Proposal: Alteration – Revision. Construction of a rear two-story 1,621 square foot addition beginning at the rear wall was granted approval at the HAHC in January 2015. All existing original 1-over-1 windows and original 117 wood siding were to be retained and repaired.

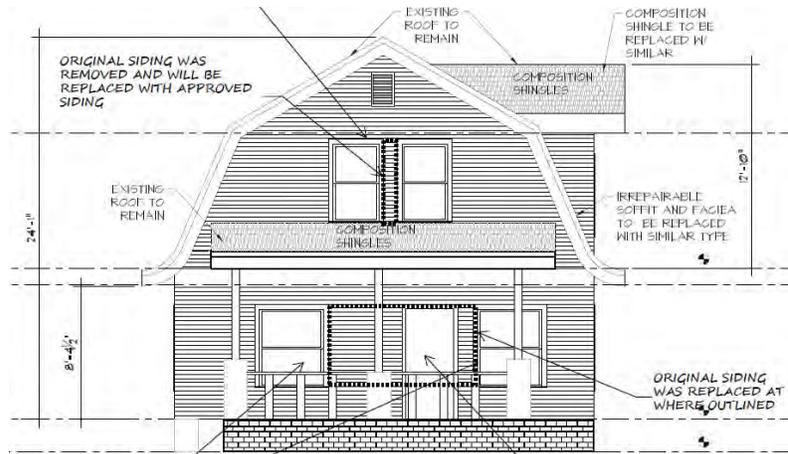
WEST ELEVATION – FRONT FACING TULANE STREET

June 2015: The applicant has exceeded the approved scope of work. Significant portions of the original siding have been removed and replaced, especially on the first story. All trim has been removed. All original windows have been removed and replaced with flange mounted vinyl windows. The two front windows were also reduced in width. The original portion of the house was raised 8" separating the porch roof from the columns (which are now topped by blocking). See drawings and photos for more detail.

- Removed Siding
- Reinstall Original Windows
- Install Replacement Composite Windows

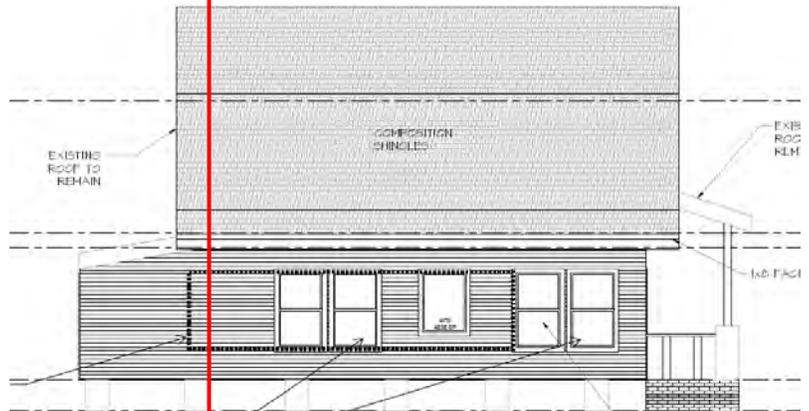
NORTH SIDE ELEVATION

June 2015: The applicant has exceeded the approved scope of work. The original portion of the house was raised 8" separating the porch roof from the columns (which are now topped by blocking). Significant portions of the original siding have been removed and replaced. All original windows have been removed and replaced with flange mounted vinyl windows. The westernmost pair of windows has also been significantly altered. The western window of this pair has been shifted to the west while the eastern window has been removed altogether. The addition now has three pairs of windows, five more windows than originally approved. See drawings and photos for more detail.

- Removed Siding
- Reinstall Original Windows
- Install Replacement Composite Windows

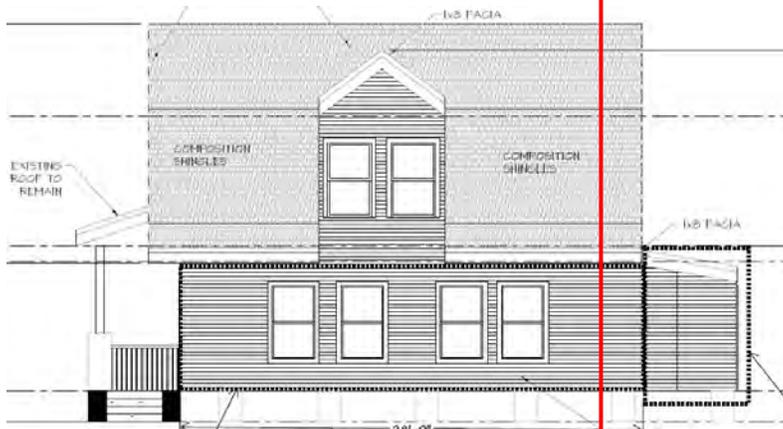
SOUTH SIDE ELEVATION

June 2015: The applicant has exceeded the approved scope of work. The original portion of the house was raised 8" separating the porch roof from the columns (which are now topped by blocking). All original siding has been removed and replaced. All original windows have been removed and replaced with flange mounted vinyl windows. The addition now includes two more windows than originally approved. The rear inset portion is now a porch with five columns and a railing system. The proposed additional dormer was never constructed. See drawings and photos for more detail.

- Removed Siding
- Reinstall Original Windows
- Install Replacement Composite Windows

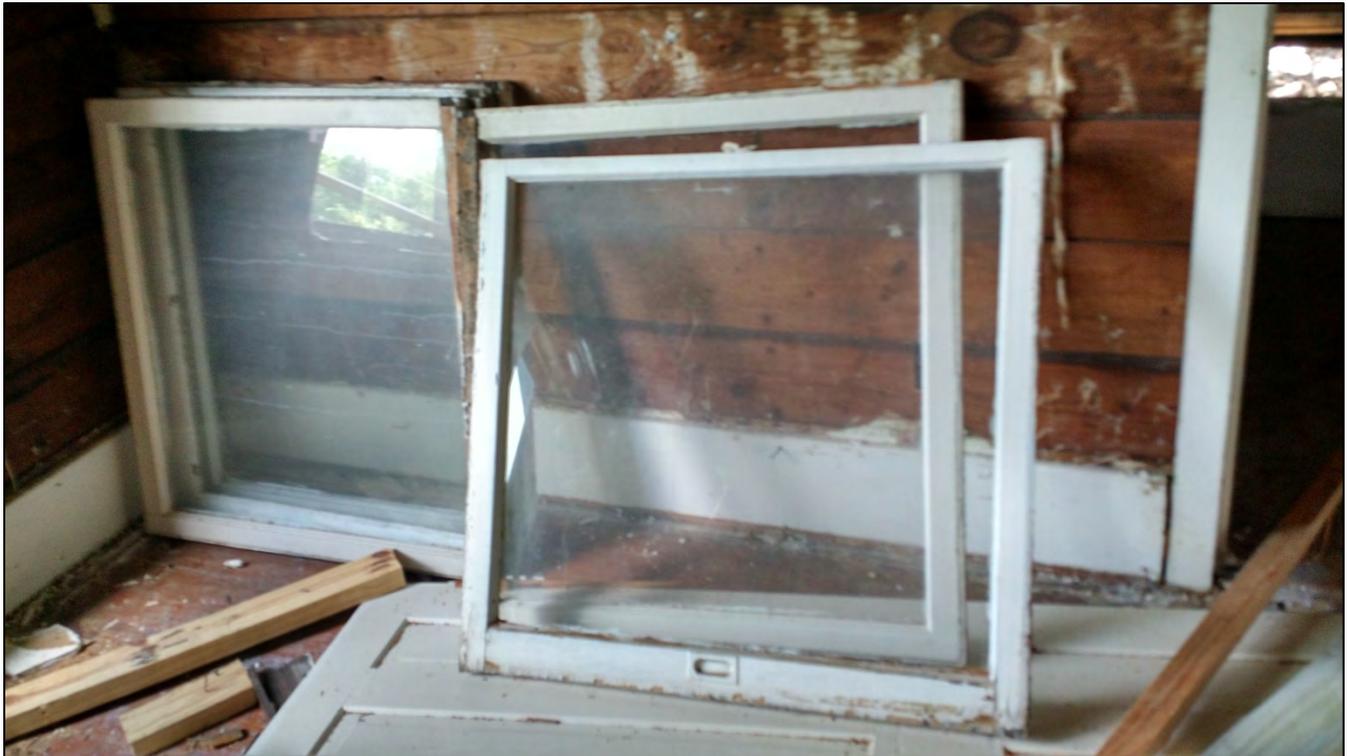
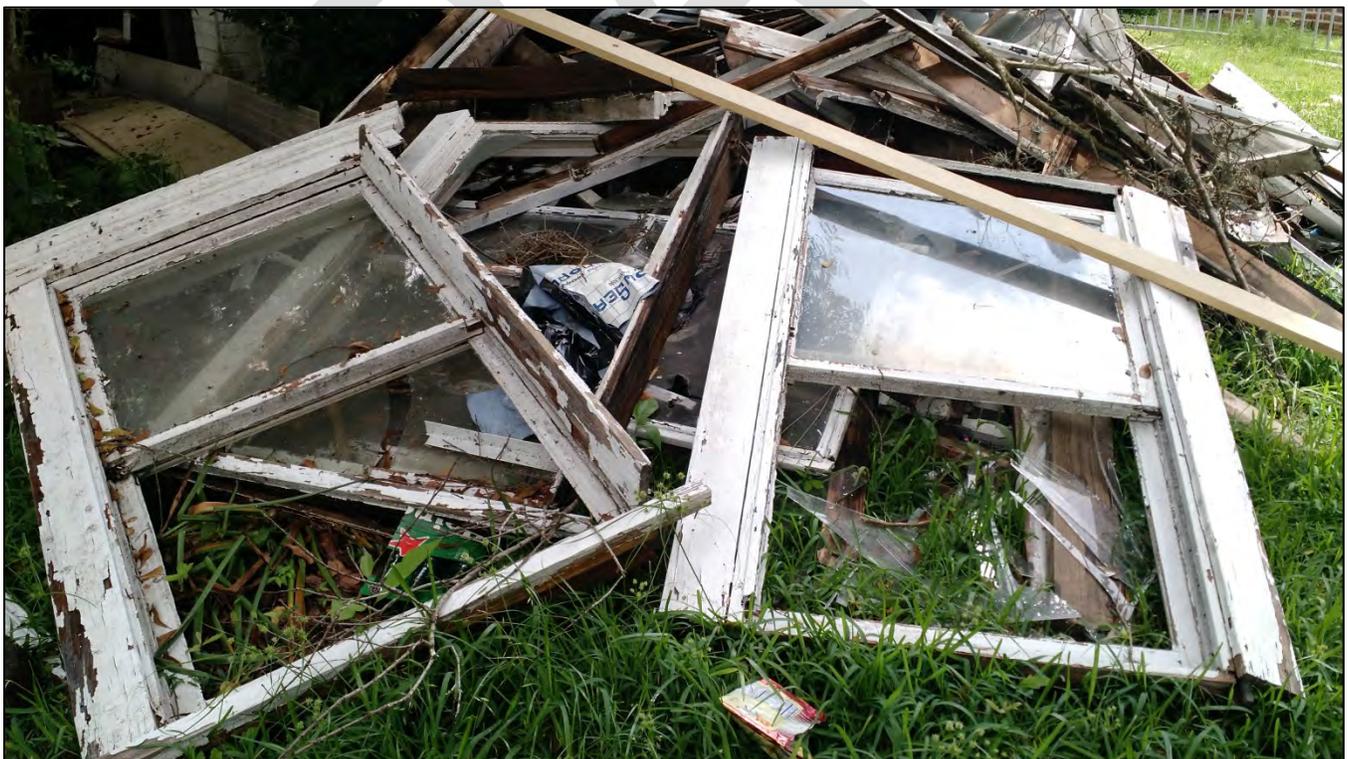
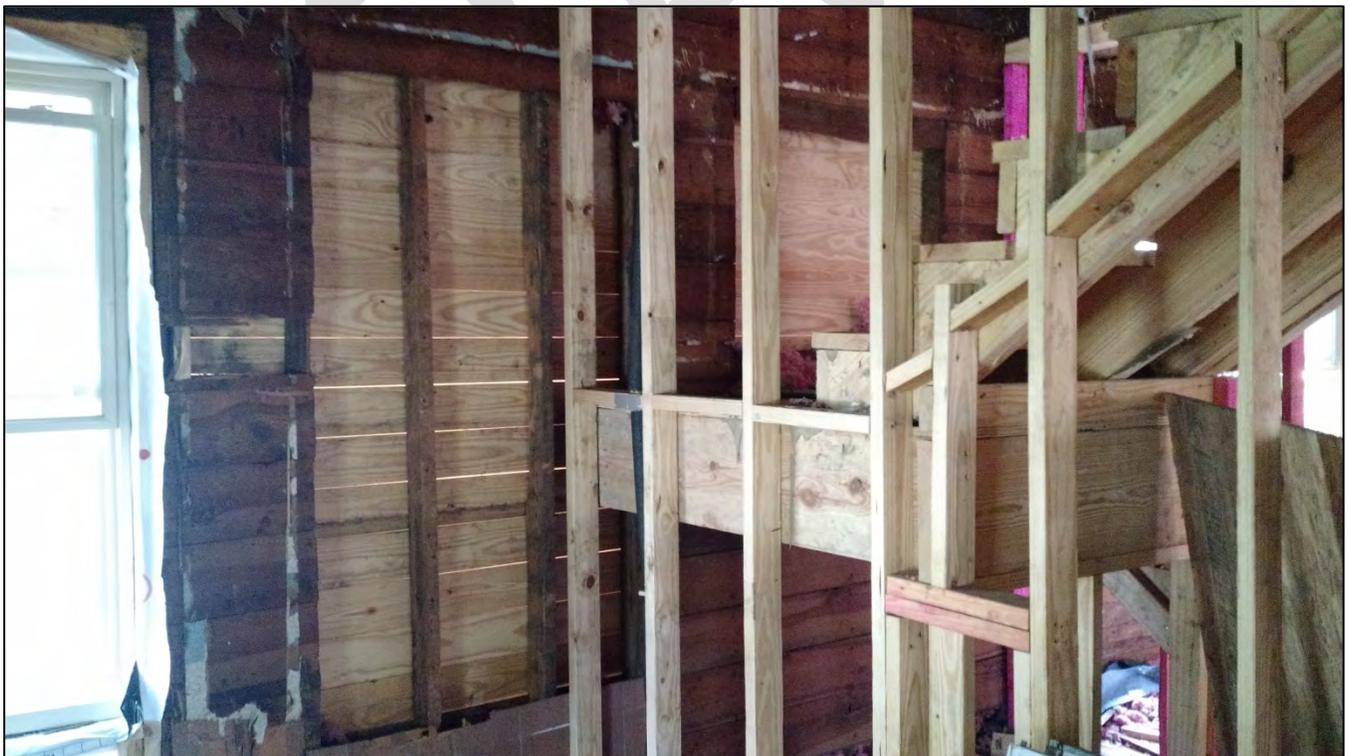
EXISTING WINDOWS / OPENINGS

June 2015: All historic windows have been removed and replaced with flush mount vinyl windows. Additionally, all historic window openings have all been reframed, with the two front windows on the first story reduced in width by half a foot. On the north elevation, one window has been shifted 1'-7" to the east, one window has been eliminated, and the window located at the stairs has been altered. Altogether, 13 original wood windows were removed, along with two non-original aluminum windows. The applicant proposes to reinstall 7 of the original wood windows that have been found on site. The remaining original windows have been destroyed. For the balance of the existing window openings, five new composite windows are to be installed and one window will be eliminated. The two non-original windows will be replaced with vinyl windows. Seven additional windows have been installed in the addition. The addition will retain the vinyl windows already installed. The existing door will be retained and repaired. See drawings, window/door schedule, and photos for more detail.

- 1 EXISTING WINDOWS SHALL BE REPAIRED UNLESS MISSING OR DAMAGE IS IRREPAIRABLE. IF DAMAGE ON WINDOWS ARE IRREPAIRABLE, IT SHALL BE REPLACED W/ APPROVED WINDOW MANUFACTURED BY GULF COAST WINDOWS (SAME SIZE WINDOW)
- 2 ALL EXTERIOR TRIM, WITH THE EXCEPTION OF THE FRONT PORCH TRIM, WAS REMOVED AND WILL BE REPLACED WITH SAME DESIGN TYPE USING WOOD MATERIAL. PORCH TRIM IS TO BE REPAIRED.

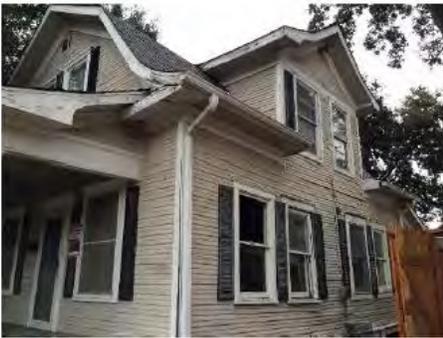
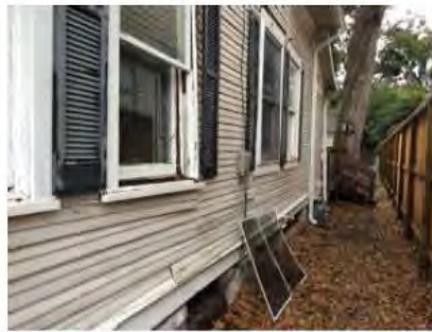
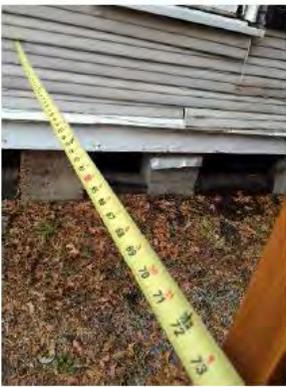
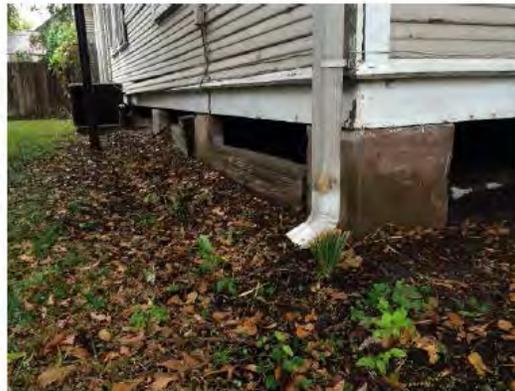
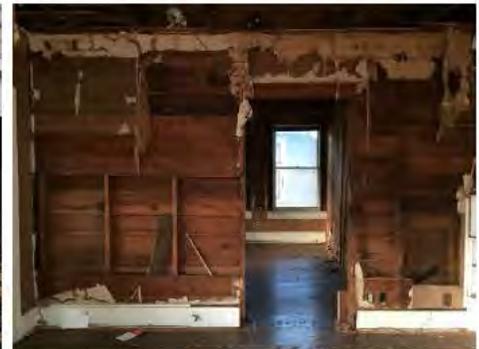
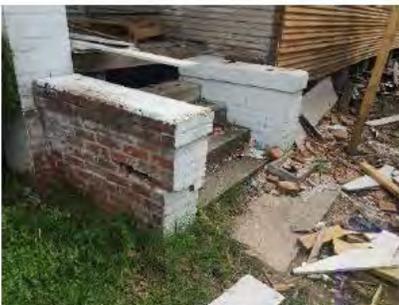
APPLICANT PHOTOS

June 2015: All original siding has been removed on the south elevation along with sections of siding on the first and second stories of the front (west) elevation and sections of the north elevation. New replacement 117 wood siding has been installed. All historic trim has been removed and destroyed. Removed trim will be replaced with new wood trim to match the profile of the removed material. Wood lattice skirting will wrap the foundation. See drawings and photos for more detail.
