CERTIFICATE OF APPROPRIATENESS

Property: 5003 Mandell Street, Lot 2, Block 1, Edgemont Subdivision. The property includes a historic 2,889 square foot, two-story wood frame single-family residence and a detached garage situated on a 5,000 square foot (50' x 100') interior lot.

Proposal: Alteration – Replace two historic windows on the second floor of the south side elevation.

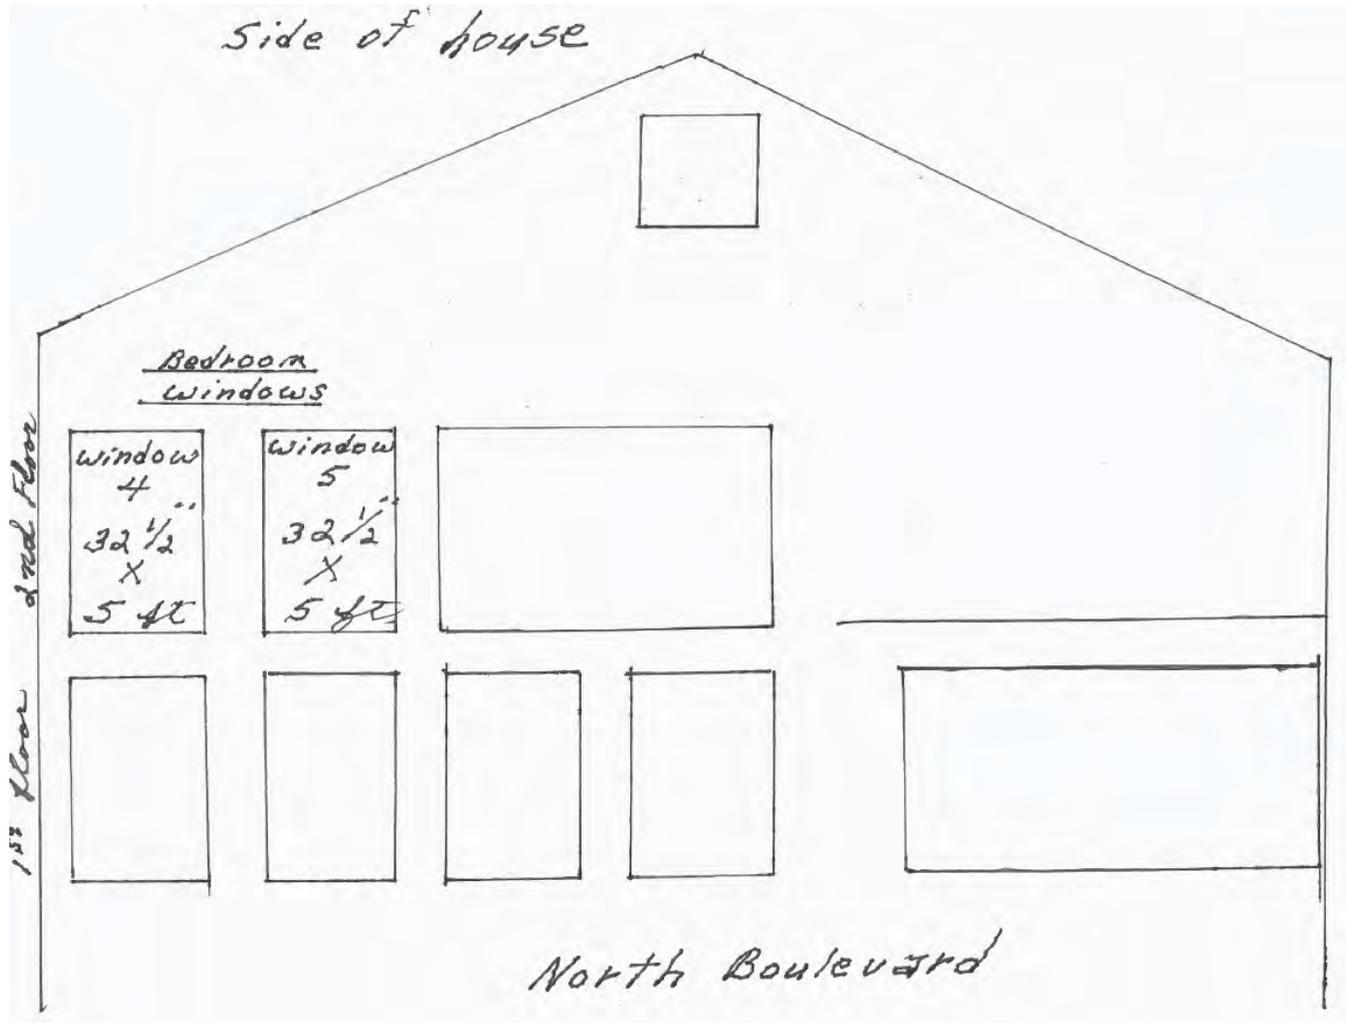
WINDOWS 4 AND 5

<i>Historic wood windows are an irreplaceable distinguishing quality of this structure, and other Contributing structures found throughout the Boulevard Oaks Historic District. Window 4 features lower sash deterioration but can be repaired, by replacing the damaged portion of the sash. Window 5 is not damaged. Removing these windows represents a failure to maintain the structure's distinguishing qualities.</i> |

Window 4 features a heavily deteriorated bottom rail on the lower sash. The rail is saturated with water to the point where it is soft and damp to the touch. The remainder of the window's components appear to be in good condition. The window is painted shut.

Window 5 appears to be in good condition. The window is painted shut.
