City of Houston Pedestrian and Bicycle Road Safety Audit

**Houston Safer Streets Initiative  
Top 12 Intersections  
Pedestrian/Bicycle Road Safety Audit  
First Six Locations**

Conducted:  
**September 24 - 28, 2018**

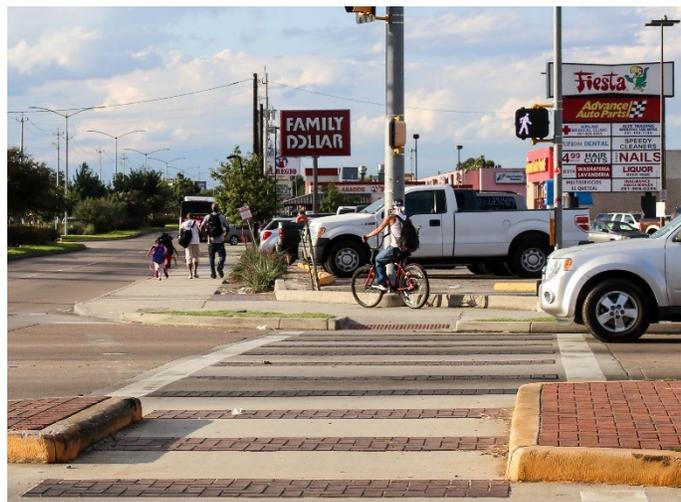
Figure 4: Pedestrian and bicycle activity at West and Airline.

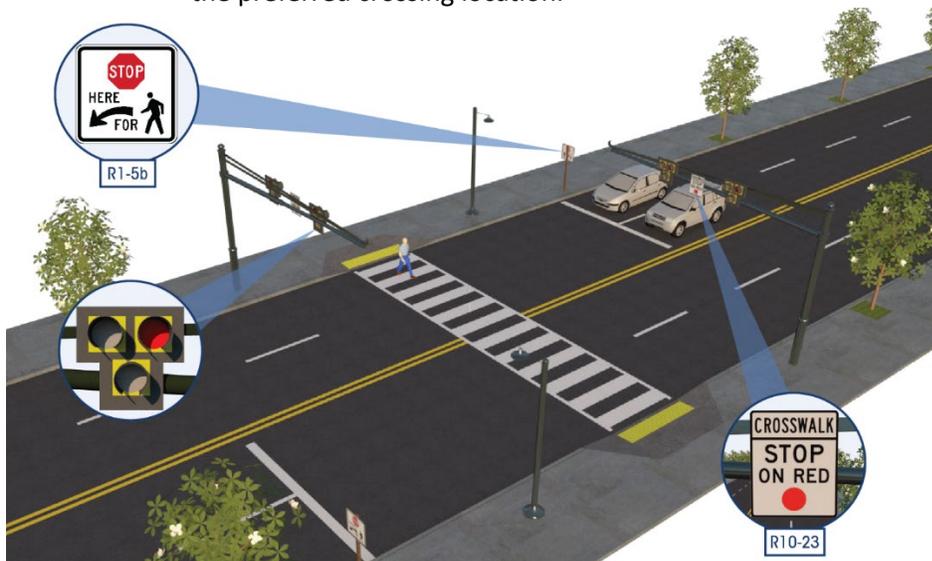
Figure 16: Pedestrian Hybrid Beacon (PHB).

- Recommendation: Coordinate with the school and school Police for potential improvements to crossings at school driveways. Work with school to determine a preferred safe crossing point across Airline.
  - Consider using a Pedestrian Hybrid Beacon (PHB) at that identified location (see Figure 16).
  - Reconfigure sidewalk outside of main entrance/exit of school building to lead directly to the preferred crossing location.

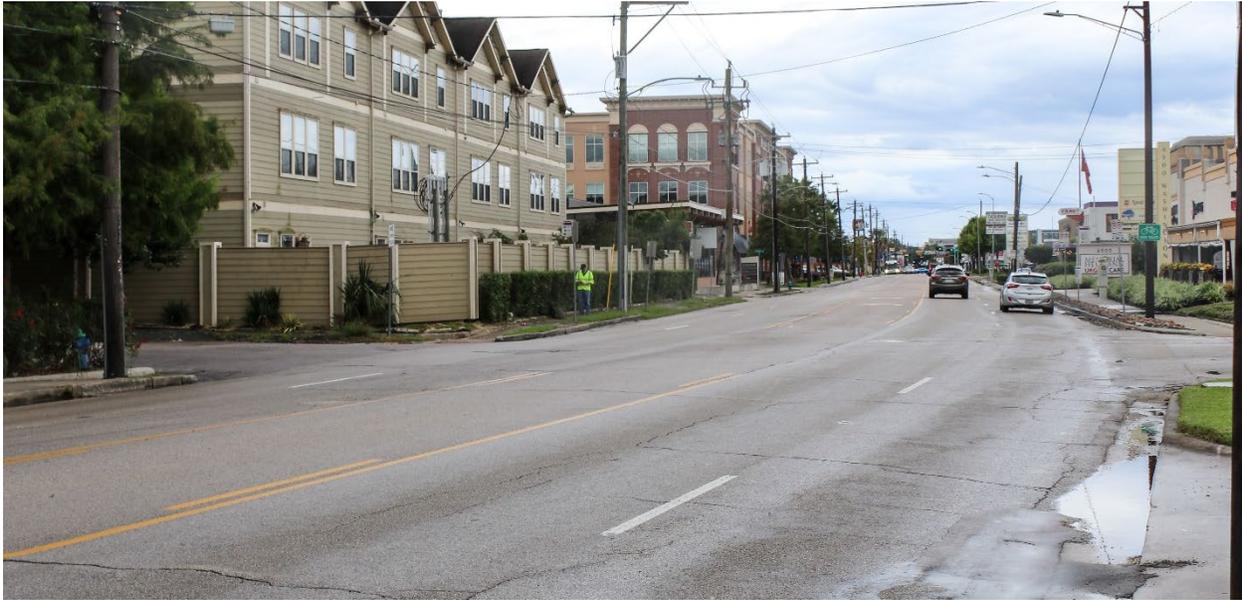
to Center Street, which is used by many bicyclists to travel parallel to Washington Avenue. The current intersection has two-way stop control with no marked crosswalks. Washington Avenue has five lanes including a center two-way left turn lane (see Figure 22). There are bus stops for both directions of travel along Washington located just west of the intersection with Patterson. The intersection is approximately 1,000 feet from the nearest signalized crossing to the west and 2,400 feet to the next signalized crossing to the east. There is steady foot traffic along and across Washington during peak restaurant and bar hours from the businesses to parking on neighborhood streets and residences.

Figure 22: Existing conditions.

Patterson south of Washington is typical of area streets with narrow widths and open storm drainage ditches. North of Washington the street has been widened and includes curb, gutter, and sidewalk. Several issues with drainage and condition of sidewalks and curb ramps were noted, including broken up sidewalk on Washington west of Patterson on the south side, dirt and gravel accumulating at the bottom of the curb ramps in all corners, and sidewalk that wasn't draining on the north side of Washington west of Patterson. On the northbound approach, vegetation partially blocked visibility of the stop sign and street name sign (see Figure 23), and a fence limited visibility of approaching traffic headed eastbound. The west side of Patterson south of Washington had vegetation blocking the roadway lighting, but other roadway lighting was generally good.

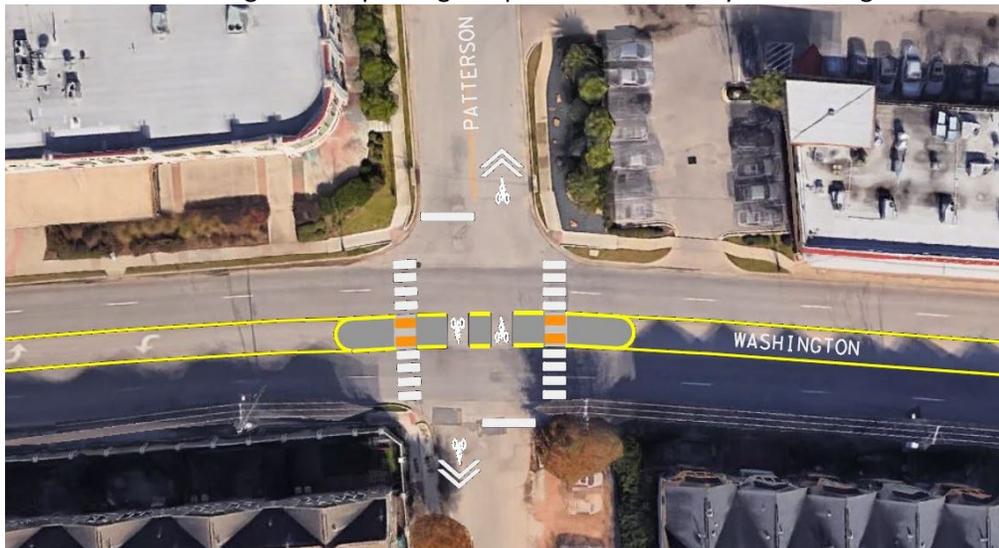
Figure 24: Possible median closure with pedestrian and bicycle crossing.

- Recommendation: Provide a median refuge for pedestrians and bicyclists crossing Washington. A full median closure is preferred, but raised medians that allow some movements may also achieve the goal of improving the pedestrian and bicycle crossing movements (see Figure 24).

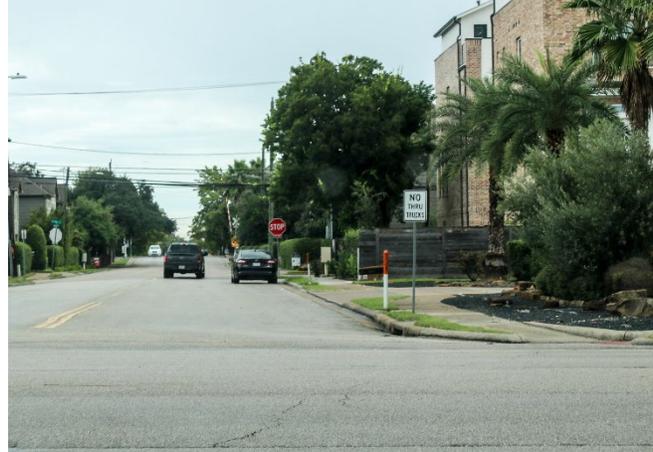
Figure 25: Possible bulb-out on Patterson.

- Recommendation: Consider ways to reduce the width of Patterson north of Washington to reduce turning speeds and improve the bicycle network.
  - Option: Add bulb-outs on Patterson to slow right turns but do not impede bicycle travel.
  - Option: Construct a bicycle facility on Patterson (bike lanes, cycle track, bicycle boulevard, or other) consistent with stakeholder input and safety needs.

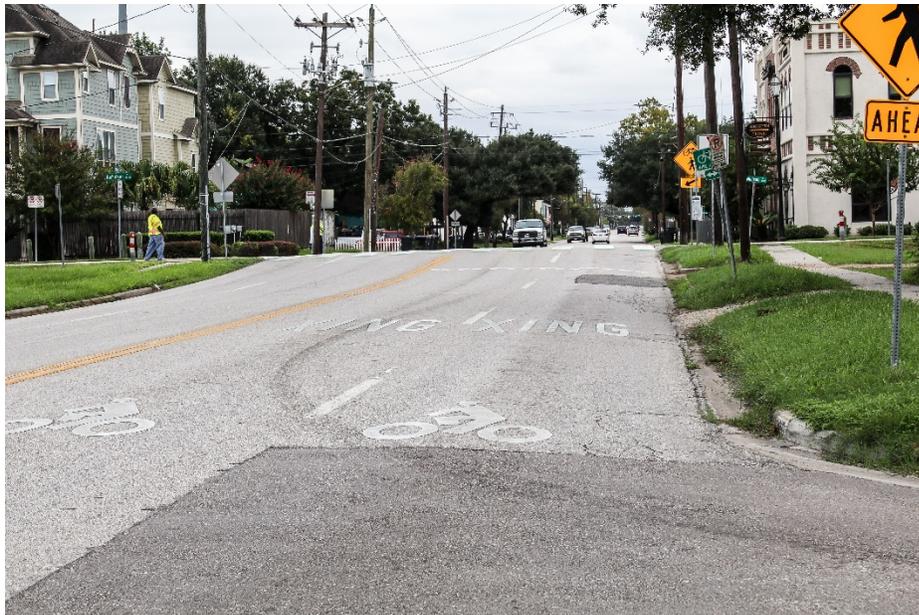
Figure 26: Existing 11th street approach to crossing.

The City has added several enhancements to the crossing in the past few years to address concerns of area stakeholders. These improvements include additional advance warning signs, extended high visibility crosswalk markings, and green pavement markings for bicycle designation (see Figure 26). The crossing is somewhat elevated from the previous elevation of the rail crossing, but not designed to reduce speeds along 11<sup>th</sup>. Some signs along 11<sup>th</sup> were leaning, turned away from the roadway, or partially blocked by vegetation and should be adjusted (see Figure 27).

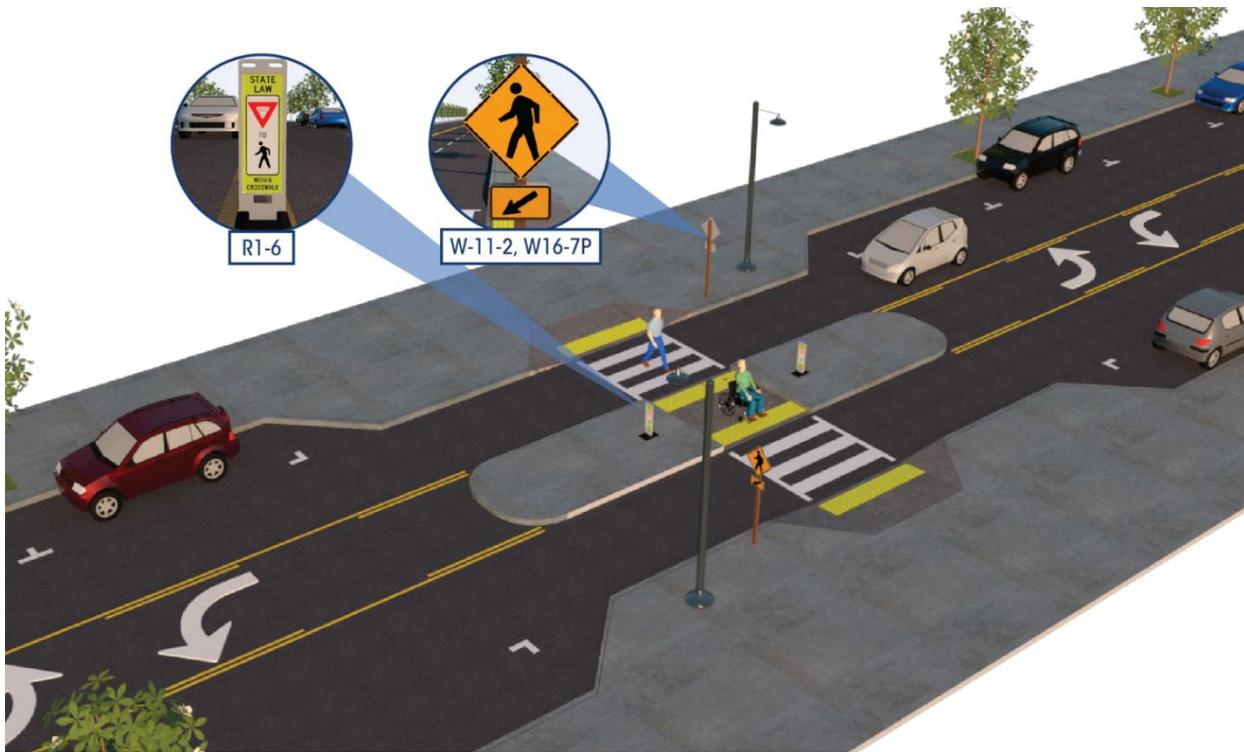
Figure 28: Potential lane reconfiguration and pedestrian refuge.

- Recommendation: Address the ease of crossing 11<sup>th</sup> for bicycles and pedestrians through physical controls.
  - Preferred option: Lane reconfiguration along 11<sup>th</sup>. A 4-to-3 lane conversion with bike lanes along 11<sup>th</sup> St, which would slow vehicle speeds for the entire segment and allow for a median refuge to break the crossing into two stages (see Figure 28).
    - The location should be evaluated for need of a Rapid Rectangular Flashing Beacon or PHB if there is a continued need for additional protection after the installation of a raised median and lane reconfiguration.

- Secondary option: Add a PHB or toucan crossing. These options would provide a protected crossing for bicyclists and pedestrians, but not control speeds along the segment of 11<sup>th</sup>.

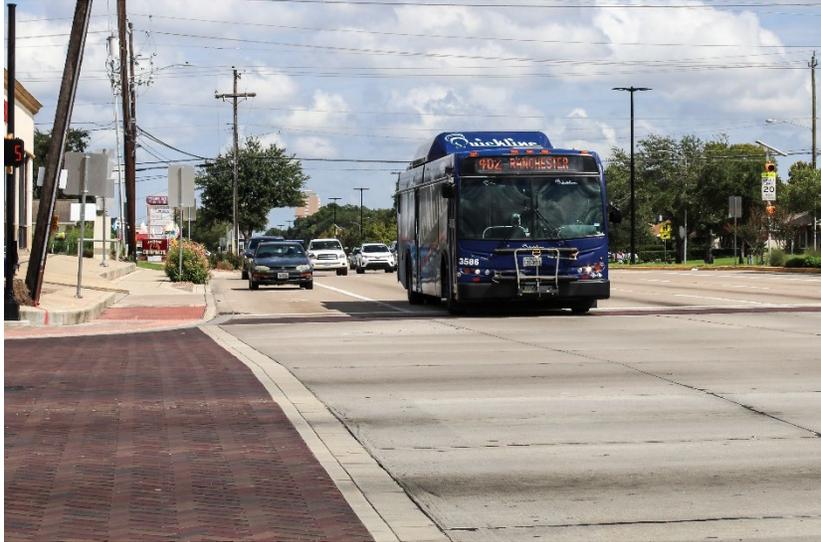
The Bellaire corridor includes four lanes for westbound traffic and three lanes for eastbound traffic. Traffic volumes are unbalanced with heavier westbound travel, but the travel counts provided may not warrant the need for four through lanes throughout the corridor. Given the frequency of buses and high levels of ridership, the westbound outside lane could be considered for a bus only / right turn lane which may improve bus service along the route.

Figure 33: Quickline bus service on Bellaire.

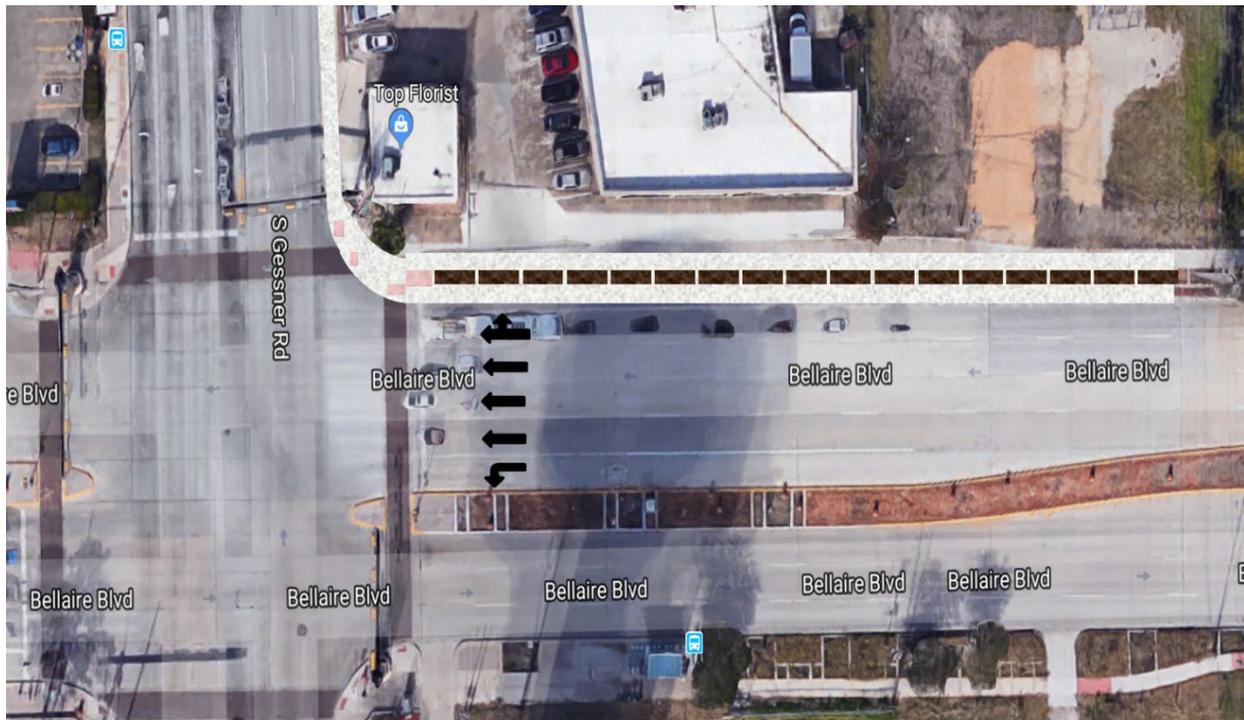
Figure 45: Possible removal of dedicated right turn lane.

- Recommendation: Assess pedestrian pushbutton locations and relocate to ensure ADA compliance and general usability (see Figure 44).
- Recommendation: Partner with METRO to improve bus stops on Gessner to better utilize sidewalk space (see Figure 42).
- Recommendation: Remove dedicated westbound right turn lane and reconstruct northeast corner to include wider sidewalks, standard dual curb ramps, improved pedestrian pushbutton locations, and improved visibility of crosswalks beyond the mast arm base (see Figure 45).
