**CERTIFICATE OF APPROPRIATENESS**

**Property:** 1610 Cortlandt Street, tract 15A and 16A, block 115, Houston Heights Subdivision. The property includes an original one-story bungalow with partially completed two-story rear and side addition on an 8,246 square foot (62' x 133') interior lot.

**Proposal:** Alteration – Revisions to a COA for a two-story rear and side addition.

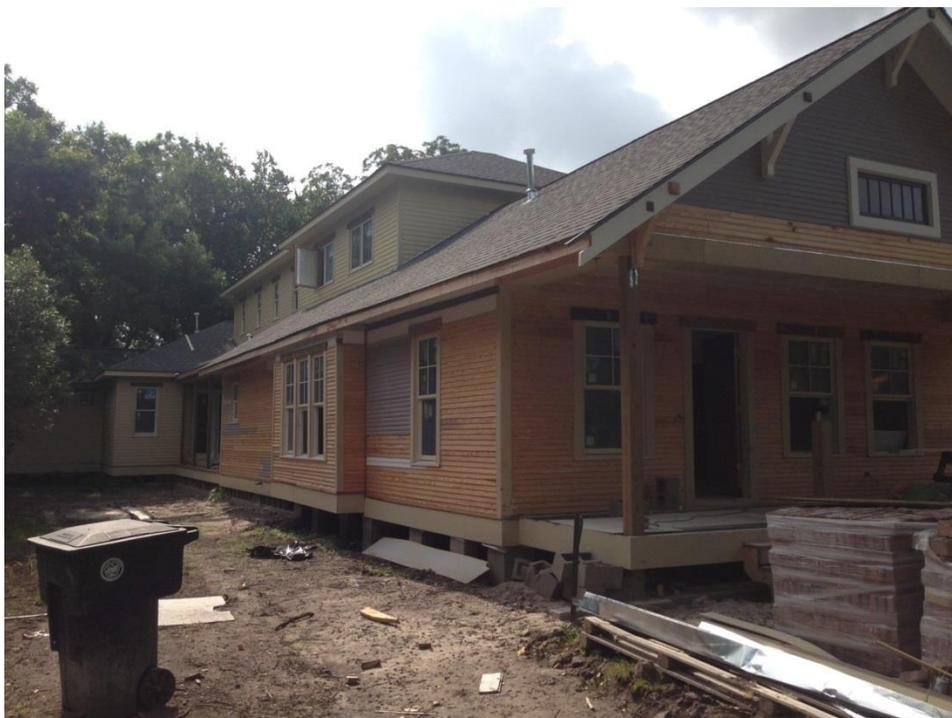
**PHOTO OF THE RESIDENCE DURING CONSTRUCTION**

Inspector visited the site and photographed the interior during construction. The Inspector's photos showed that the house's siding, structural shiplap, and three existing windows had been removed by this time. Photos also show that 3 of the 6 windows replaced were metal, non-original windows.

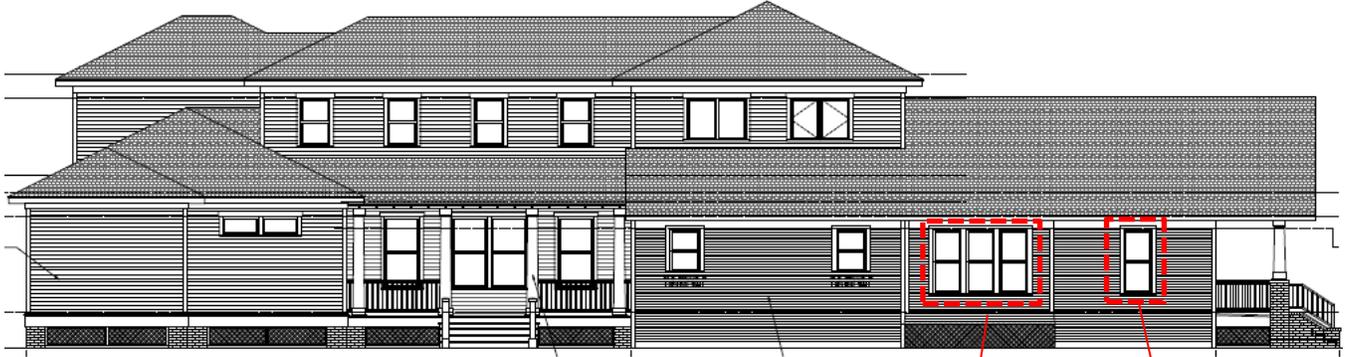
**NORTH SIDE ELEVATION**

NEW SIDING AND 4 OVER 1 WINDOWS INSTALLED

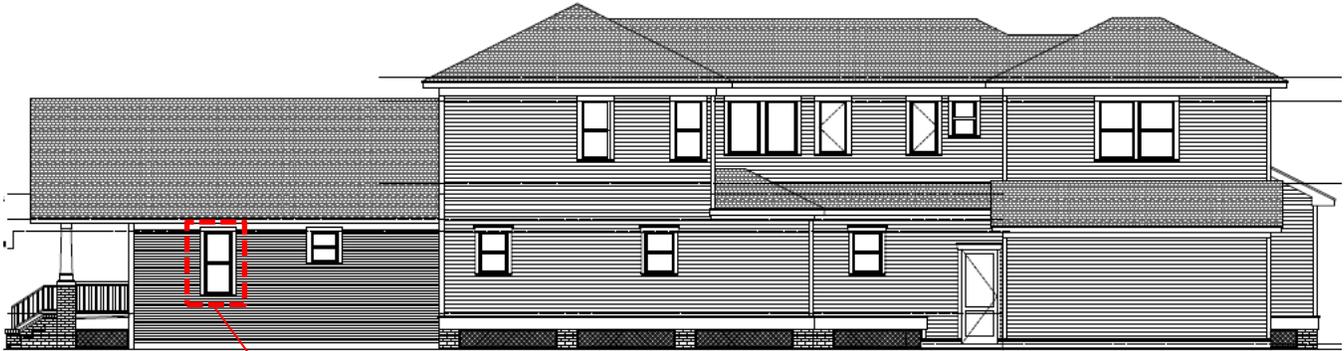
**SOUTH SIDE ELEVATION**

NEW SIDING AND 4 OVER 1 WINDOWS INSTALLED

Salvaged historic 117 siding (painted grey) installed alongside new siding. Applicant asserts that the siding towards the front of the house was from an earlier alteration to enclose the front porch.

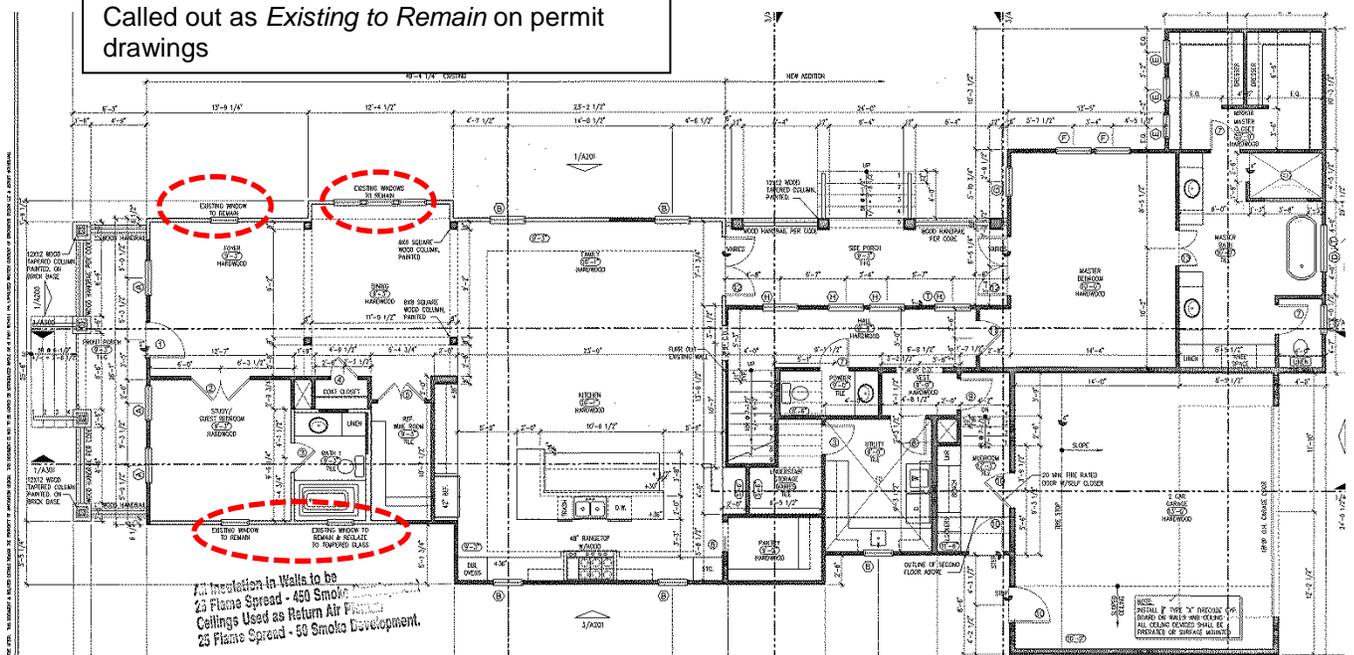
During an inspection, the Inspector noted that all of the 1 over 1 wood windows labeled "existing to remain" on plan drawings had been replaced with new 4 over 1 wood windows. Pictures taken of the windows indicated that siding had also been removed (this was confirmed by the Inspector on 6/17 and a staff site visit on 7/21).

Called out as *Existing to Remain* on permit drawings

NEW 4 OVER 1 WINDOWS INSTALLED

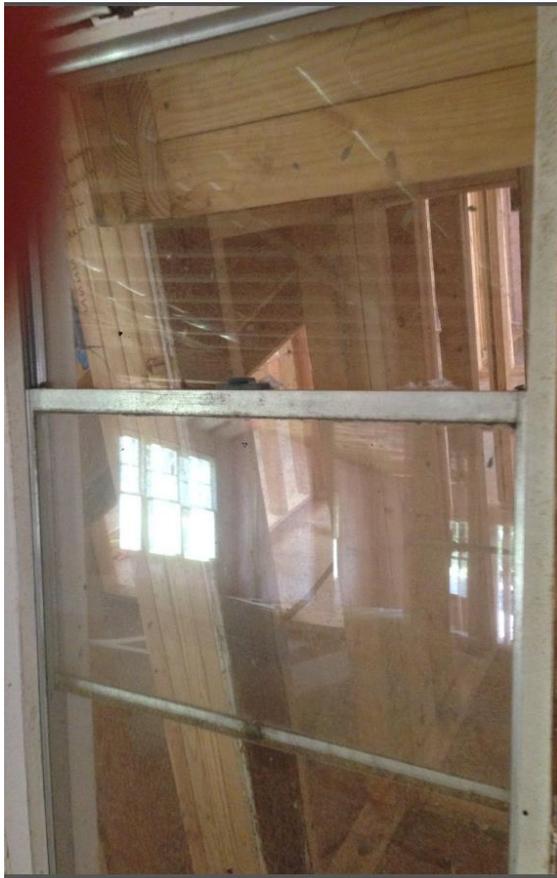
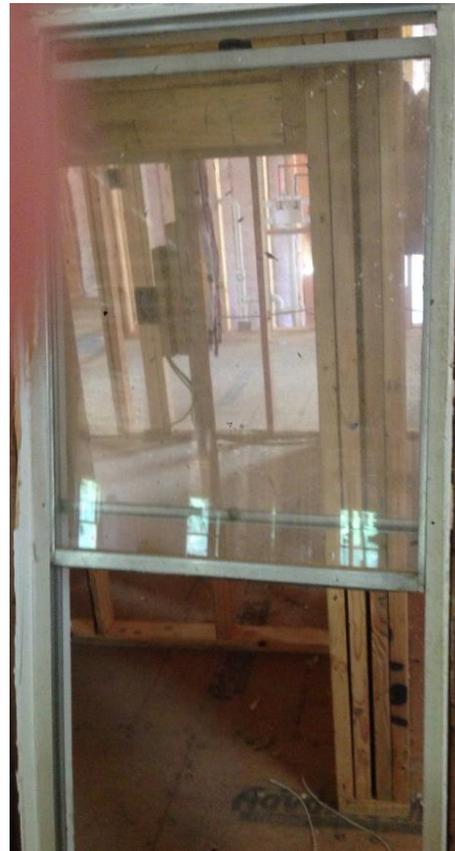
**APPLICANT SUBMITTED PHOTOS OF THE PREVIOUS WINDOWS**

**Windows/Doors:** The applicant was approved to retain six existing 1 over 1 windows on the historic portion of the existing house. The applicant has since replaced these windows with five new 4 over 1 wood windows and one 1 over 1 wood window. Photos provided by the Structural Inspector and the applicant indicate that these windows were non-original metal sash windows.
