CERTIFICATE OF APPROPRIATENESS

Property: 7654 Rockhill Street, Lot 1, Block 40, Glenbrook Valley Sec 7 Subdivision. The property includes a historic 1,746 square foot, one-story wood frame single-family residence and attached garage situated on an 8,510 square foot (74' x 115') interior lot.

Proposal: Alteration – Replace 8 historic aluminum framed windows with vinyl framed windows

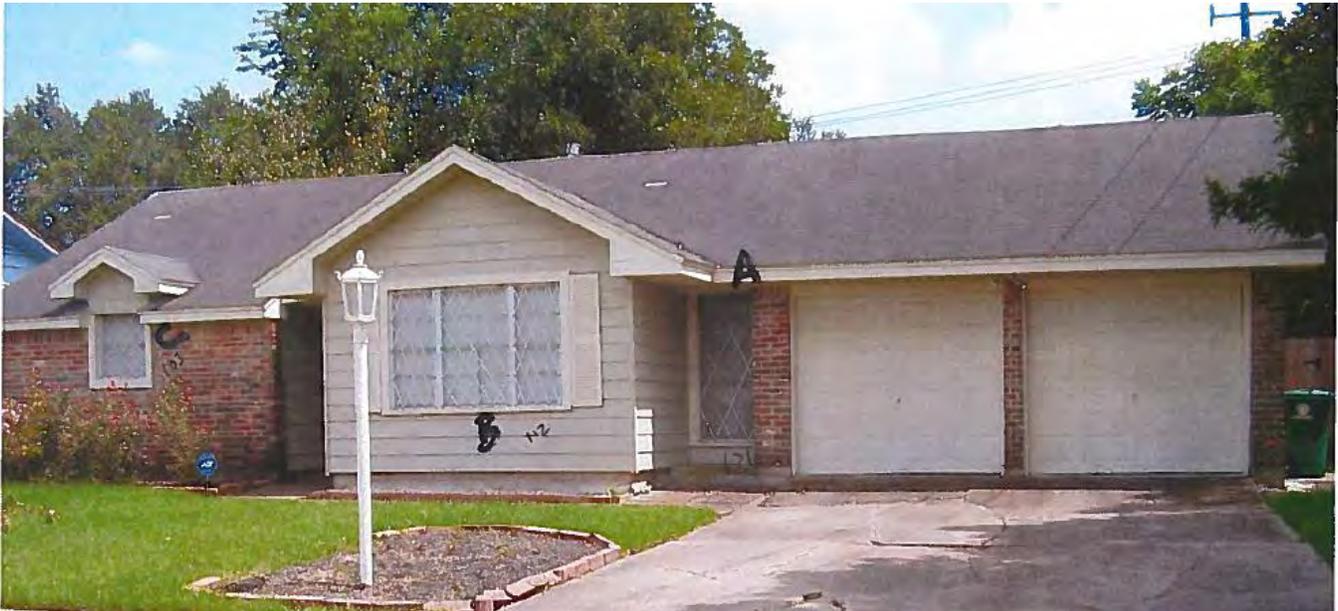
WINDOWS A, B, and C

NORTH ELEVATION – FRONT FACING ROCKHILL STREET

The existing windows are damaged beyond reasonable repair from the foundation settling. As the foundation has shifted, it has pulled the windows away from the brick veneer. This has rendered the window openings uneven, making the windows impossible to close all of the way and difficult to operate. Since the windows are mounted within the walls, removing them to make repairs would either damage the window further or result in removing a substantial amount of wall material.

Front Elevation: Windows A and C: Replace existing damaged 2-over-2 windows with new 1-over-1 windows.

(North) Window B: Replace existing damaged row of three 2-over-2 windows with a single-lite picture window.

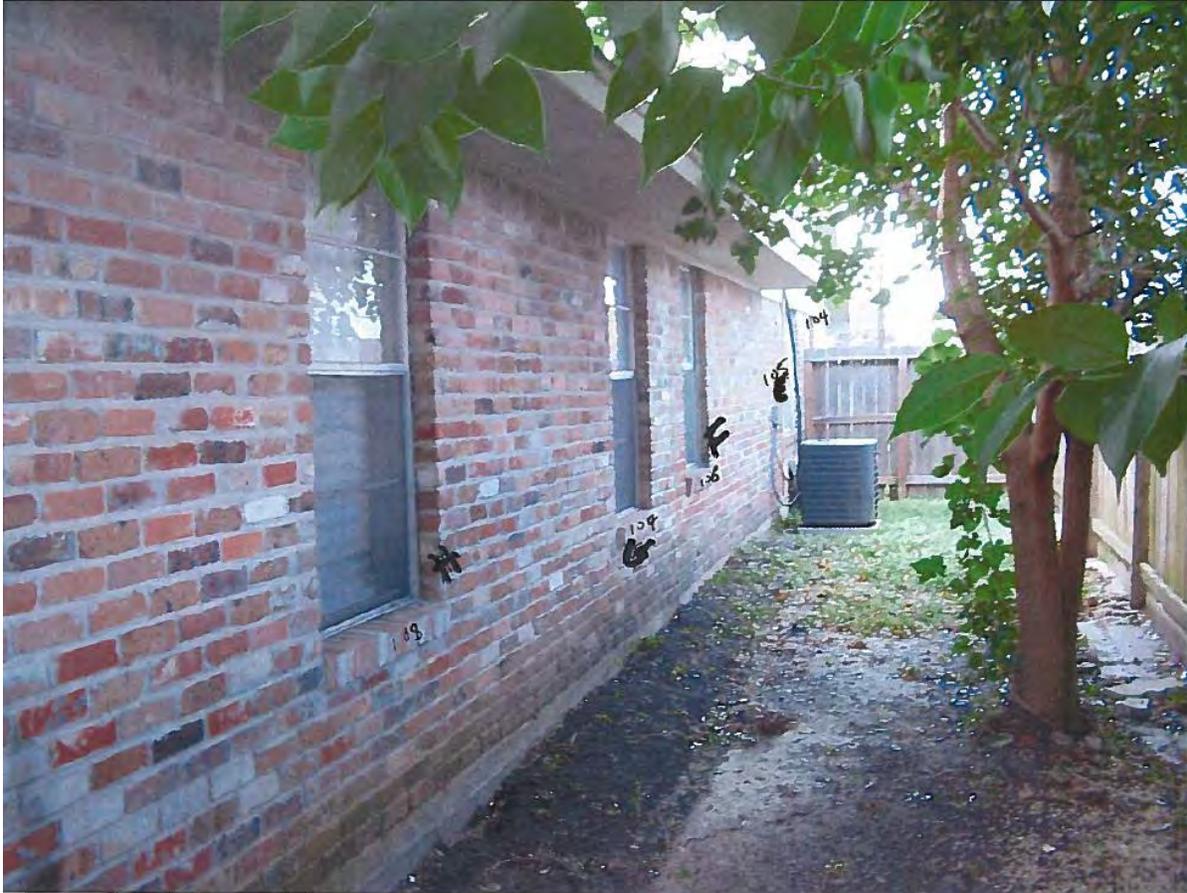
WINDOWS D, E, F, G, and H

EAST SIDE ELEVATION

Side Elevation: Windows D, F, G, and H: Replace existing damaged 2-over-2 windows with new 1-over-1 windows.

(East) Window E: Replace a damaged pair of 2-over-2 windows with a two lite gliding window.
