CERTIFICATE OF APPROPRIATENESS

Property: 8419 Dover Street, Lot 1, Block 36, Glenbrook Valley Section 7 Subdivision. The property includes a historic 2,262 square foot, one-story wood frame single-family residence and an attached garage situated on a 12,650 square foot (110' x 115') corner lot.

Proposal: Alteration – Windows

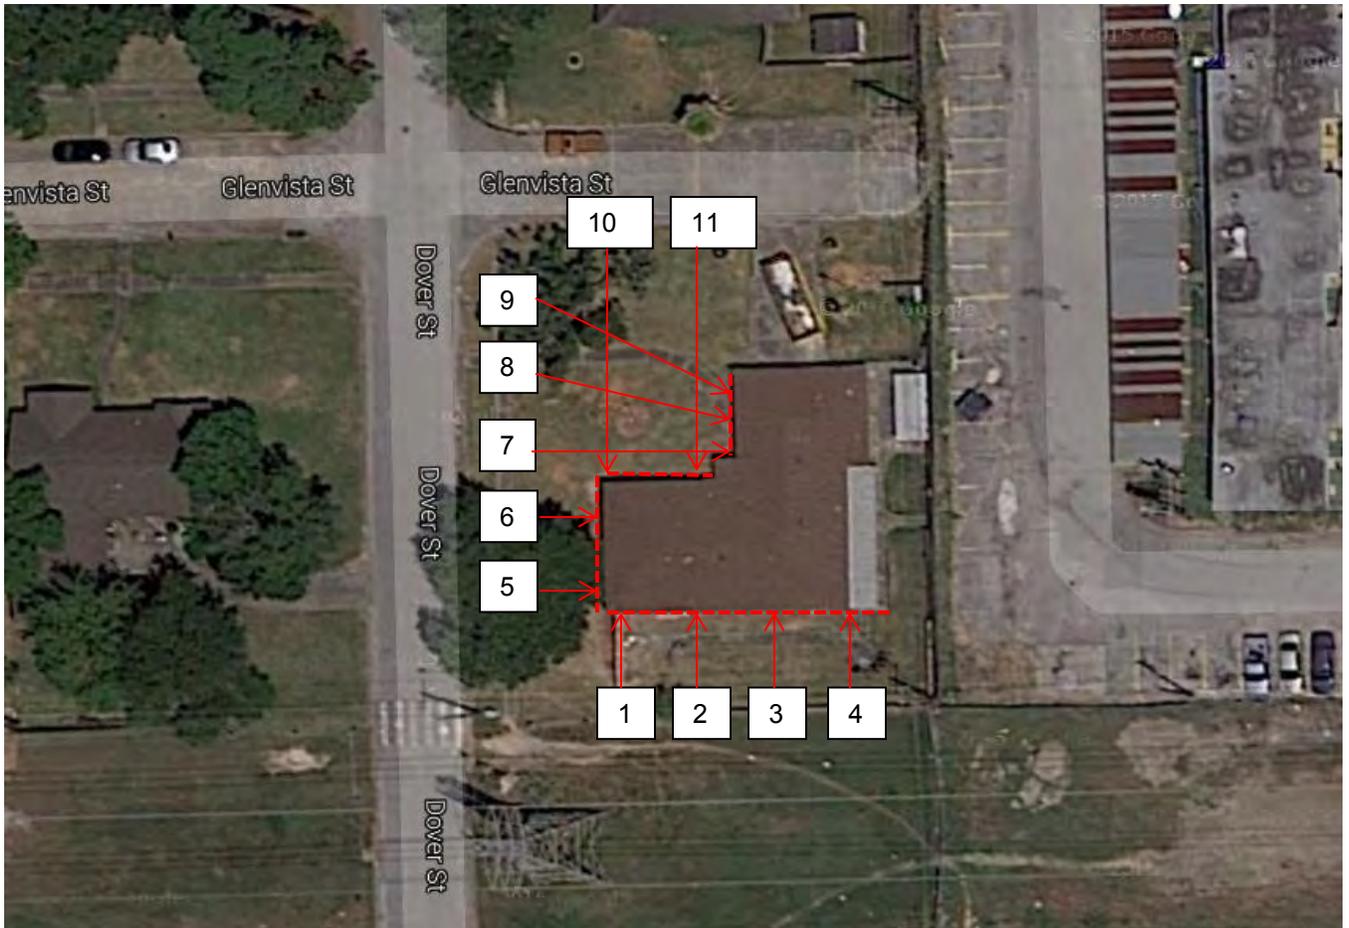
WEST (FRONT) ELEVATION

They also feature bent framing due to foundation damage and repair. The resulting differential settlement from foundation failure pulled the façade and window frames away from the structure. Recent repair of the masonry and slab foundation corrected the house's structural damage, but caused further damage to the windows. The bent window framing has left the windows inoperable and with damaged sashes and glass.

The applicant proposes to replace each of these windows with new vinyl 1-over-1 windows. The new windows will be mounted within the existing window openings.
