# CERTIFICATE OF APPROPRIATENESS APPLICATION FORM

Address 501 Highland Street  
Historic District / Landmark Woodland Heights HCAD # 0372840000016  
Subdivision Woodland Heights Lot 16 Block 19

Subject: COA Application – 501 Highland Description

01.20.15  
**501 HIGHLAND**  
LIEBL RESIDENCE

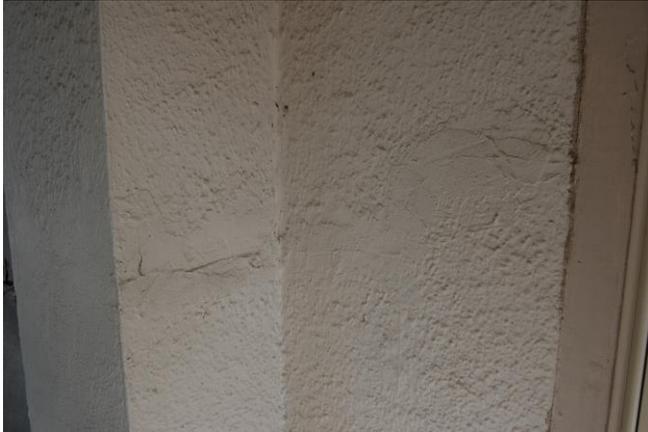
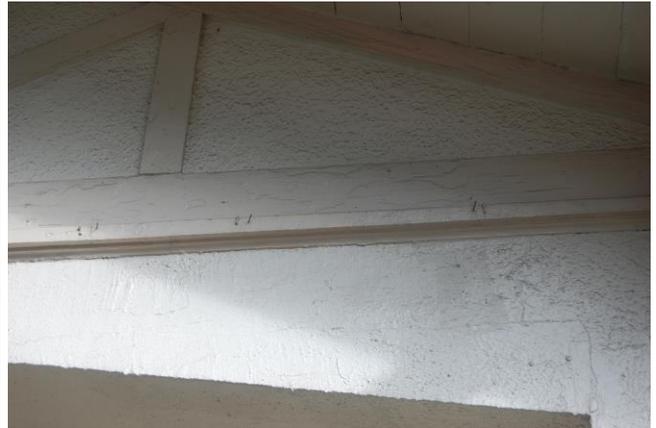
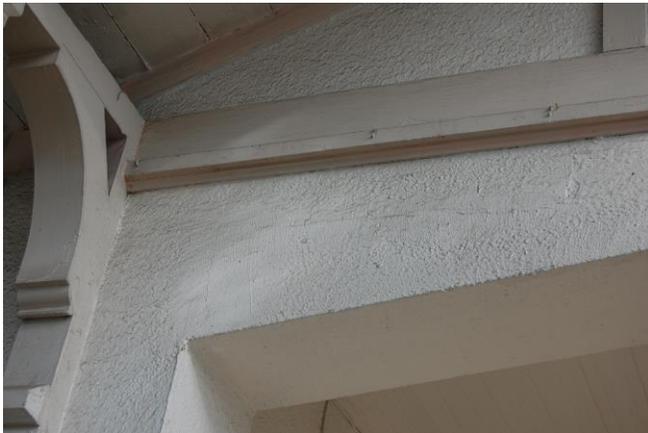
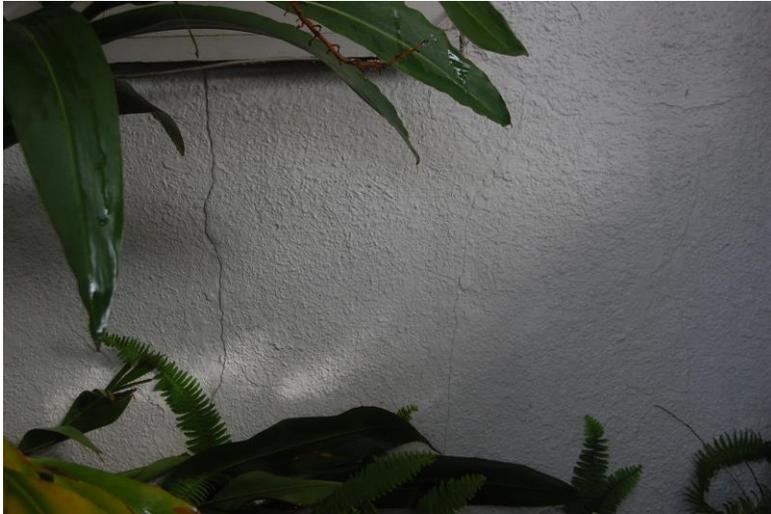
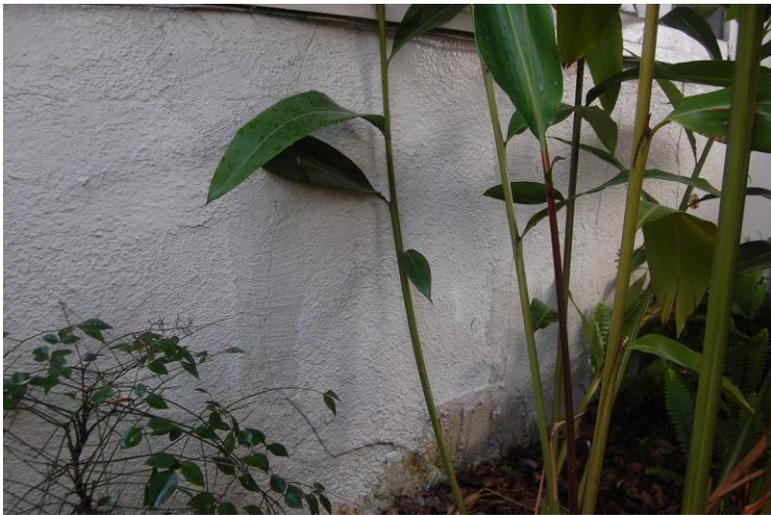
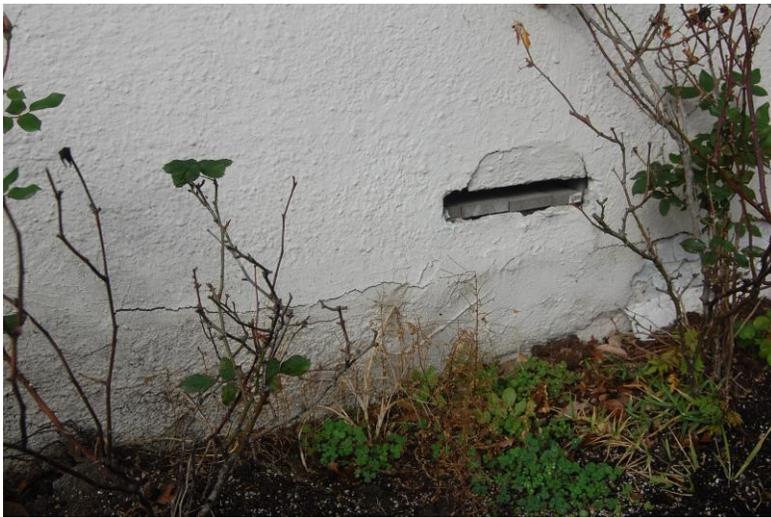
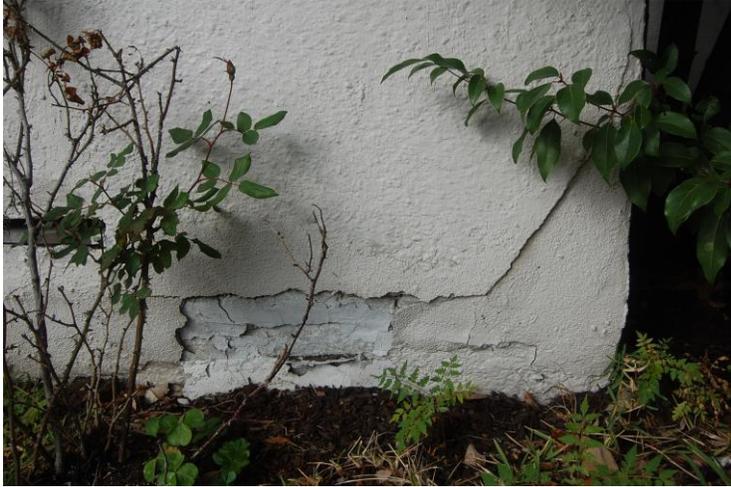
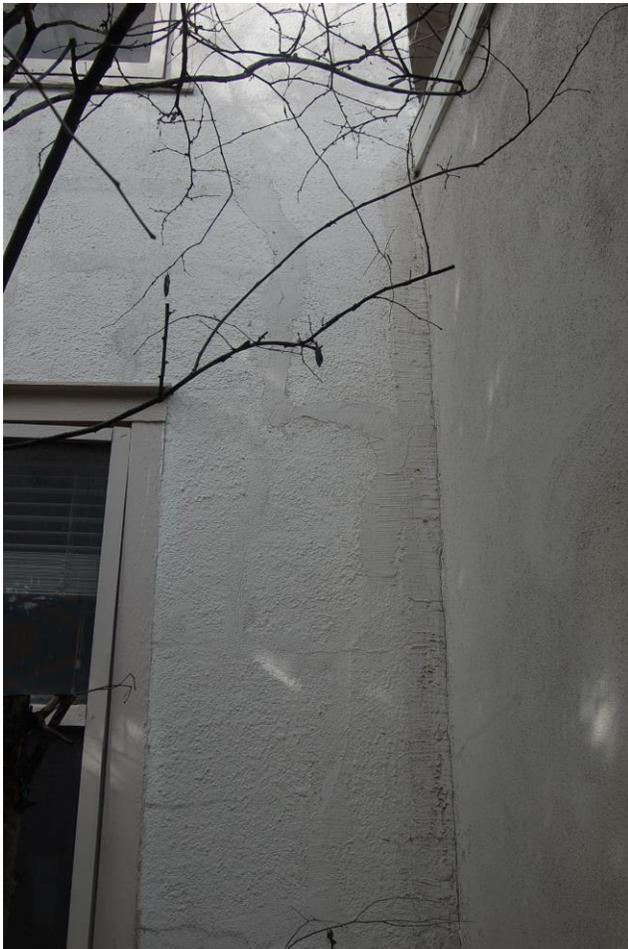
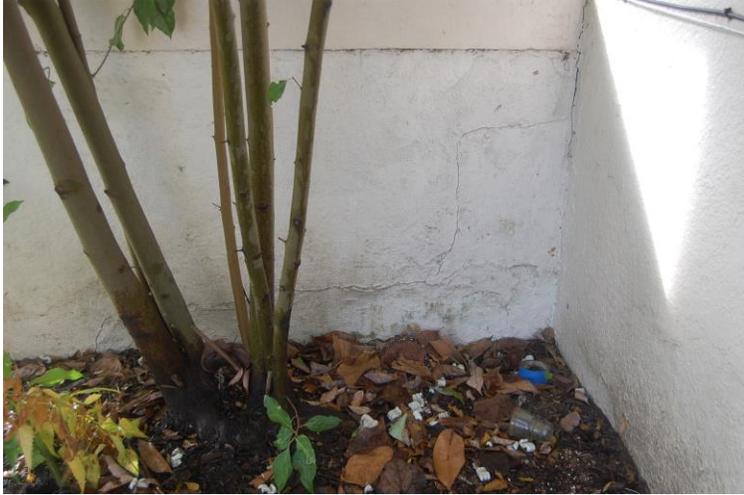
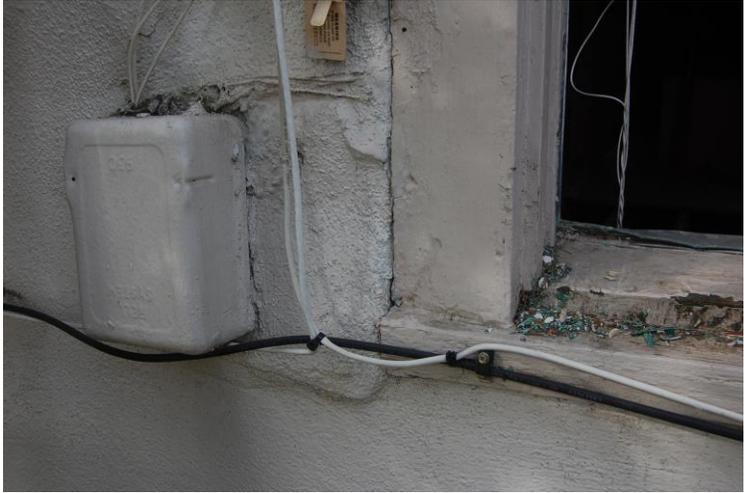
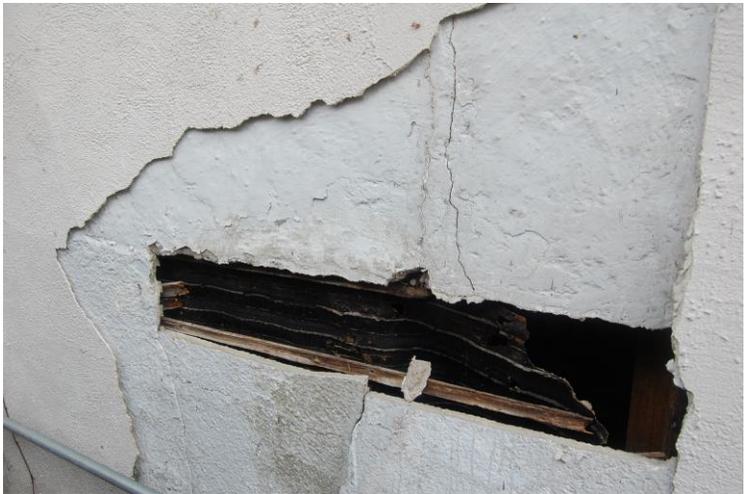
### Photos of the Existing Stucco

Many different textures and patches are visible on the existing stucco from many years of repairs. You can also see cracks and damage due to improper installation and moisture problems. There are also numerous layers of stucco patches already existing. If any additional layers of stucco or paint are added, the windows will become recessed into the stucco and overtake the existing window trim.

The existing stucco is going to be removed and replaced due to the moisture and termite damage inside the home as it was not installed properly. Please see the stucco review letter from Victor Flores for details and the attached photos. We will be matching the existing stucco finish and texture with the new replaced stucco on both the house and the addition.

After inspecting the stucco application at 501 Highland, it is my recommendation that the stucco be removed so that a correct stucco/plaster application is performed and brought up to today's standards in a uniform manner. It is obvious that stucco repair has been attempted over the years and failed not only to achieve an aesthetic standard but more importantly a functional one. Cracks observed in the walls where stucco repair has been attempted in the past have failed to seal with original application causing damage to it and water penetrations at window seams and corners. Bringing the stucco to today's standards by adding waterproof building paper, and metal lath will prevent any future water seepage into the structure and wood windows allowing the home to stand for generations to come.

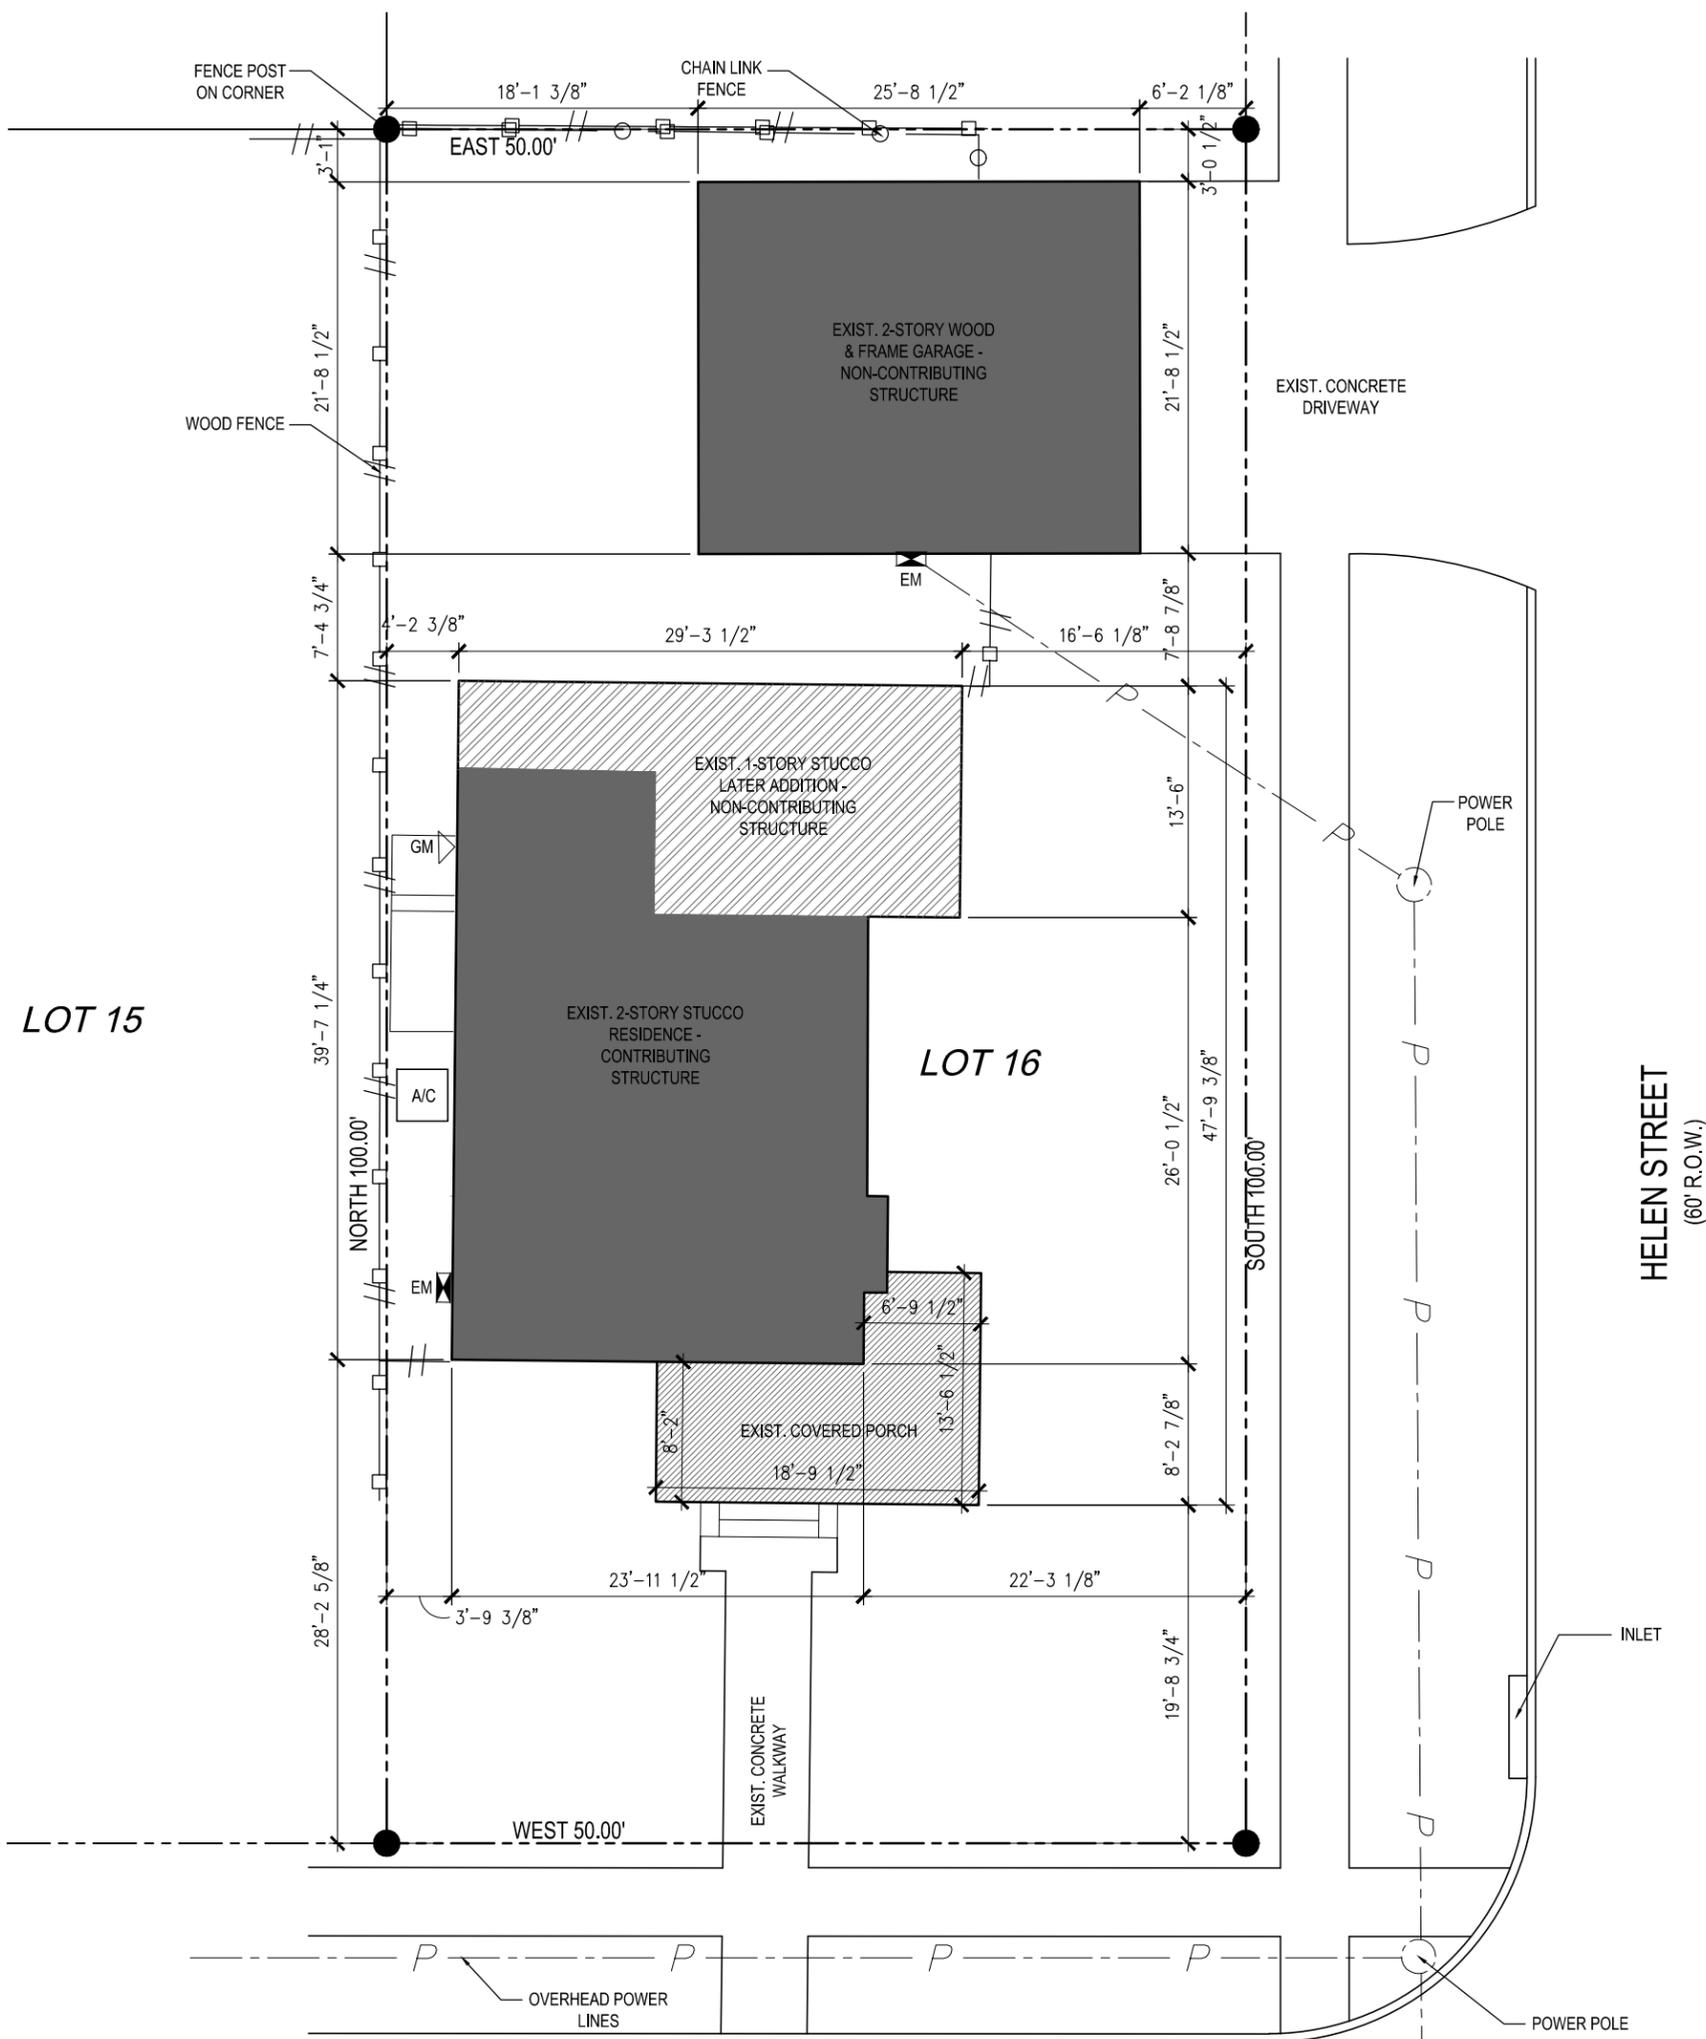
**EXISTING SITE PLAN**

LEGEND	
	EXISTING RESIDENCE TO BE REMODELED
	EXISTING ADDITION ADDED TO HISTORIC RESIDENCE

SCALE: 3/32" = 1'-0"

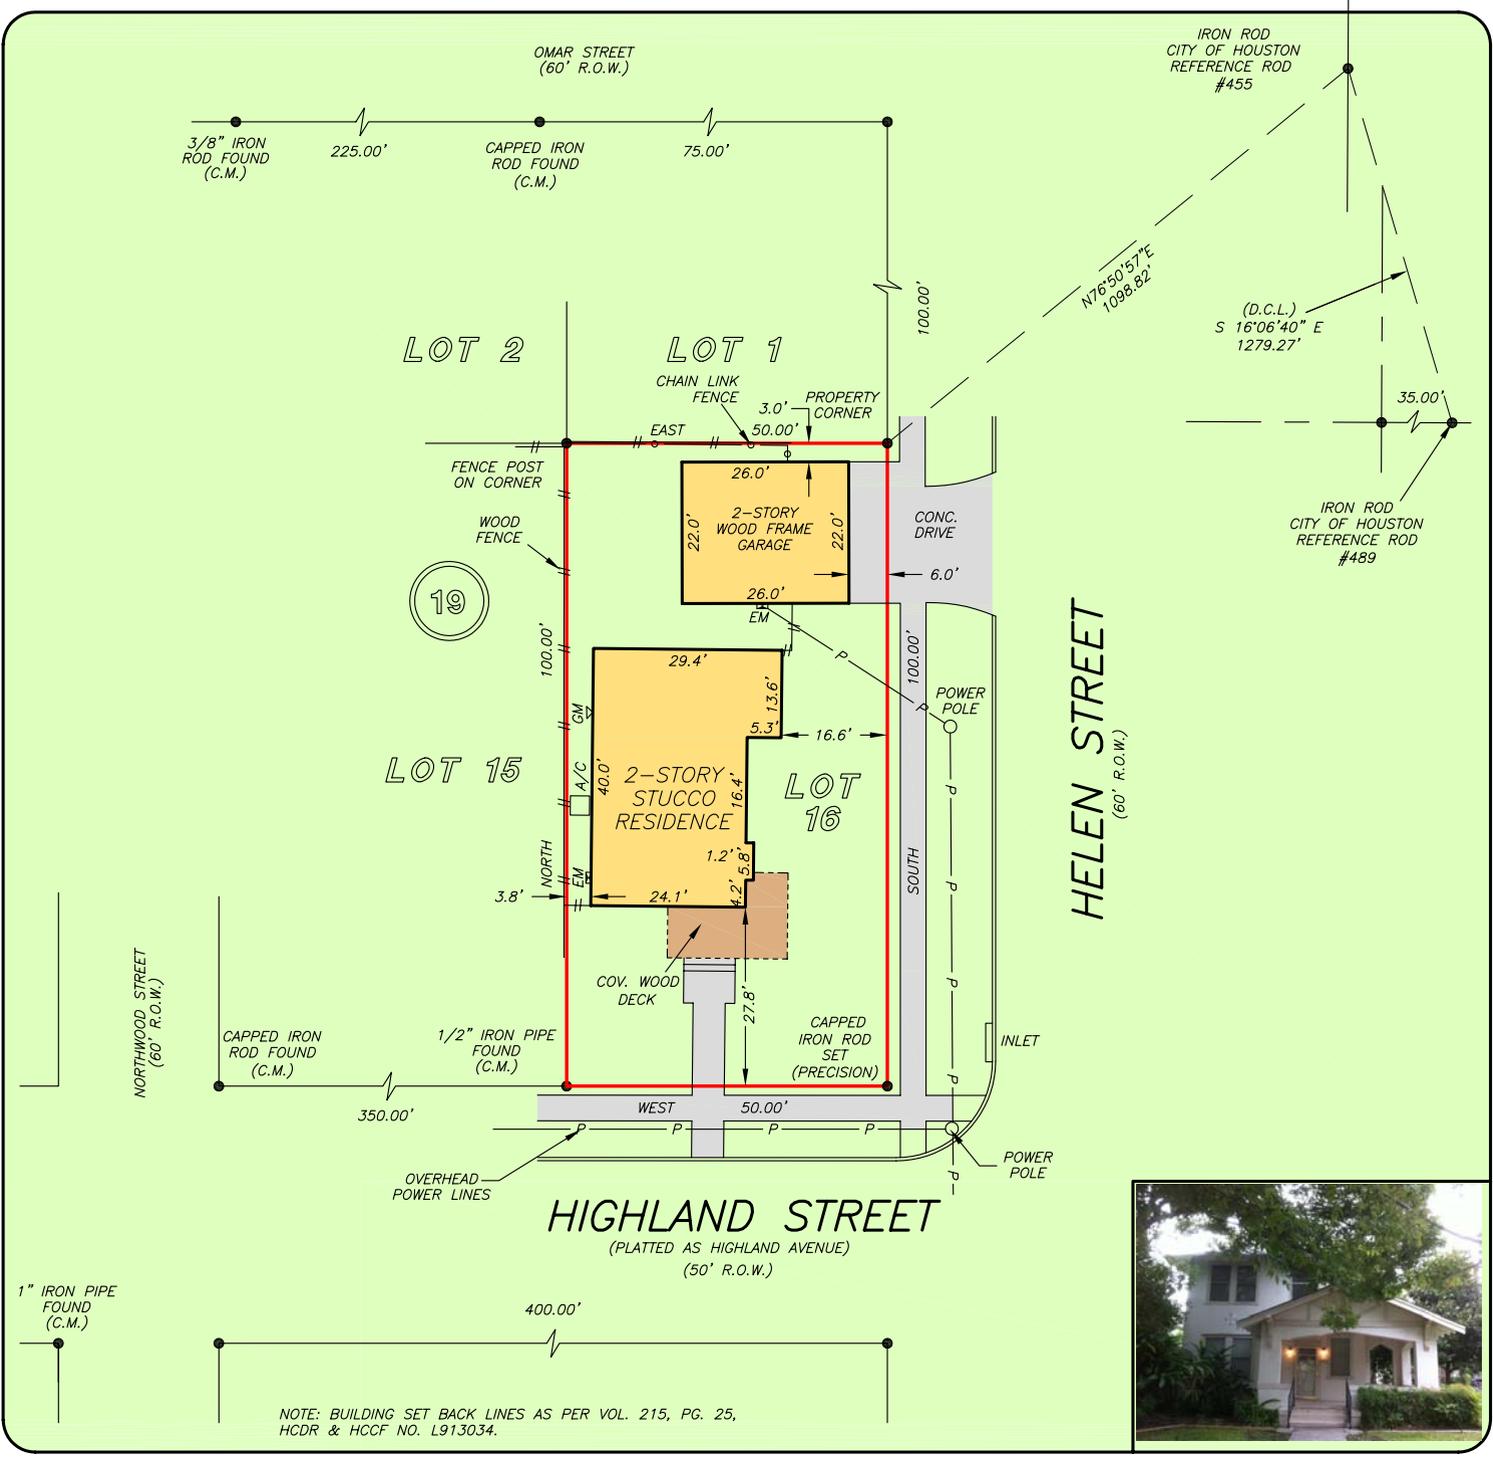
# LOT 16, BLOCK 19 WOODLAND HEIGHTS

AN ADDITION IN HARRIS COUNTY, TEXAS  
 ACCORDING TO THE MAP OR PLAT THEREOF RECORDED  
 IN VOLUME 2, PAGE 33 OF THE MAP RECORDS  
 OF HARRIS COUNTY, TEXAS

THIS PROPERTY DOES NOT LIE WITHIN THE 100 YEAR FLOOD PLAIN AS PER FIRM PANEL NO. 48201C 0670 M MAP REVISION: 06/09/2014 ZONE X BASED ONLY ON VISUAL EXAMINATION OF MAPS. INACCURACIES OF FEMA MAPS PREVENT EXACT DETERMINATION WITHOUT DETAILED FIELD STUDY

D.C.L. = DIRECTIONAL CONTROL LINE RECORD BEARING: VOL. 2, PG. 33, HCDR

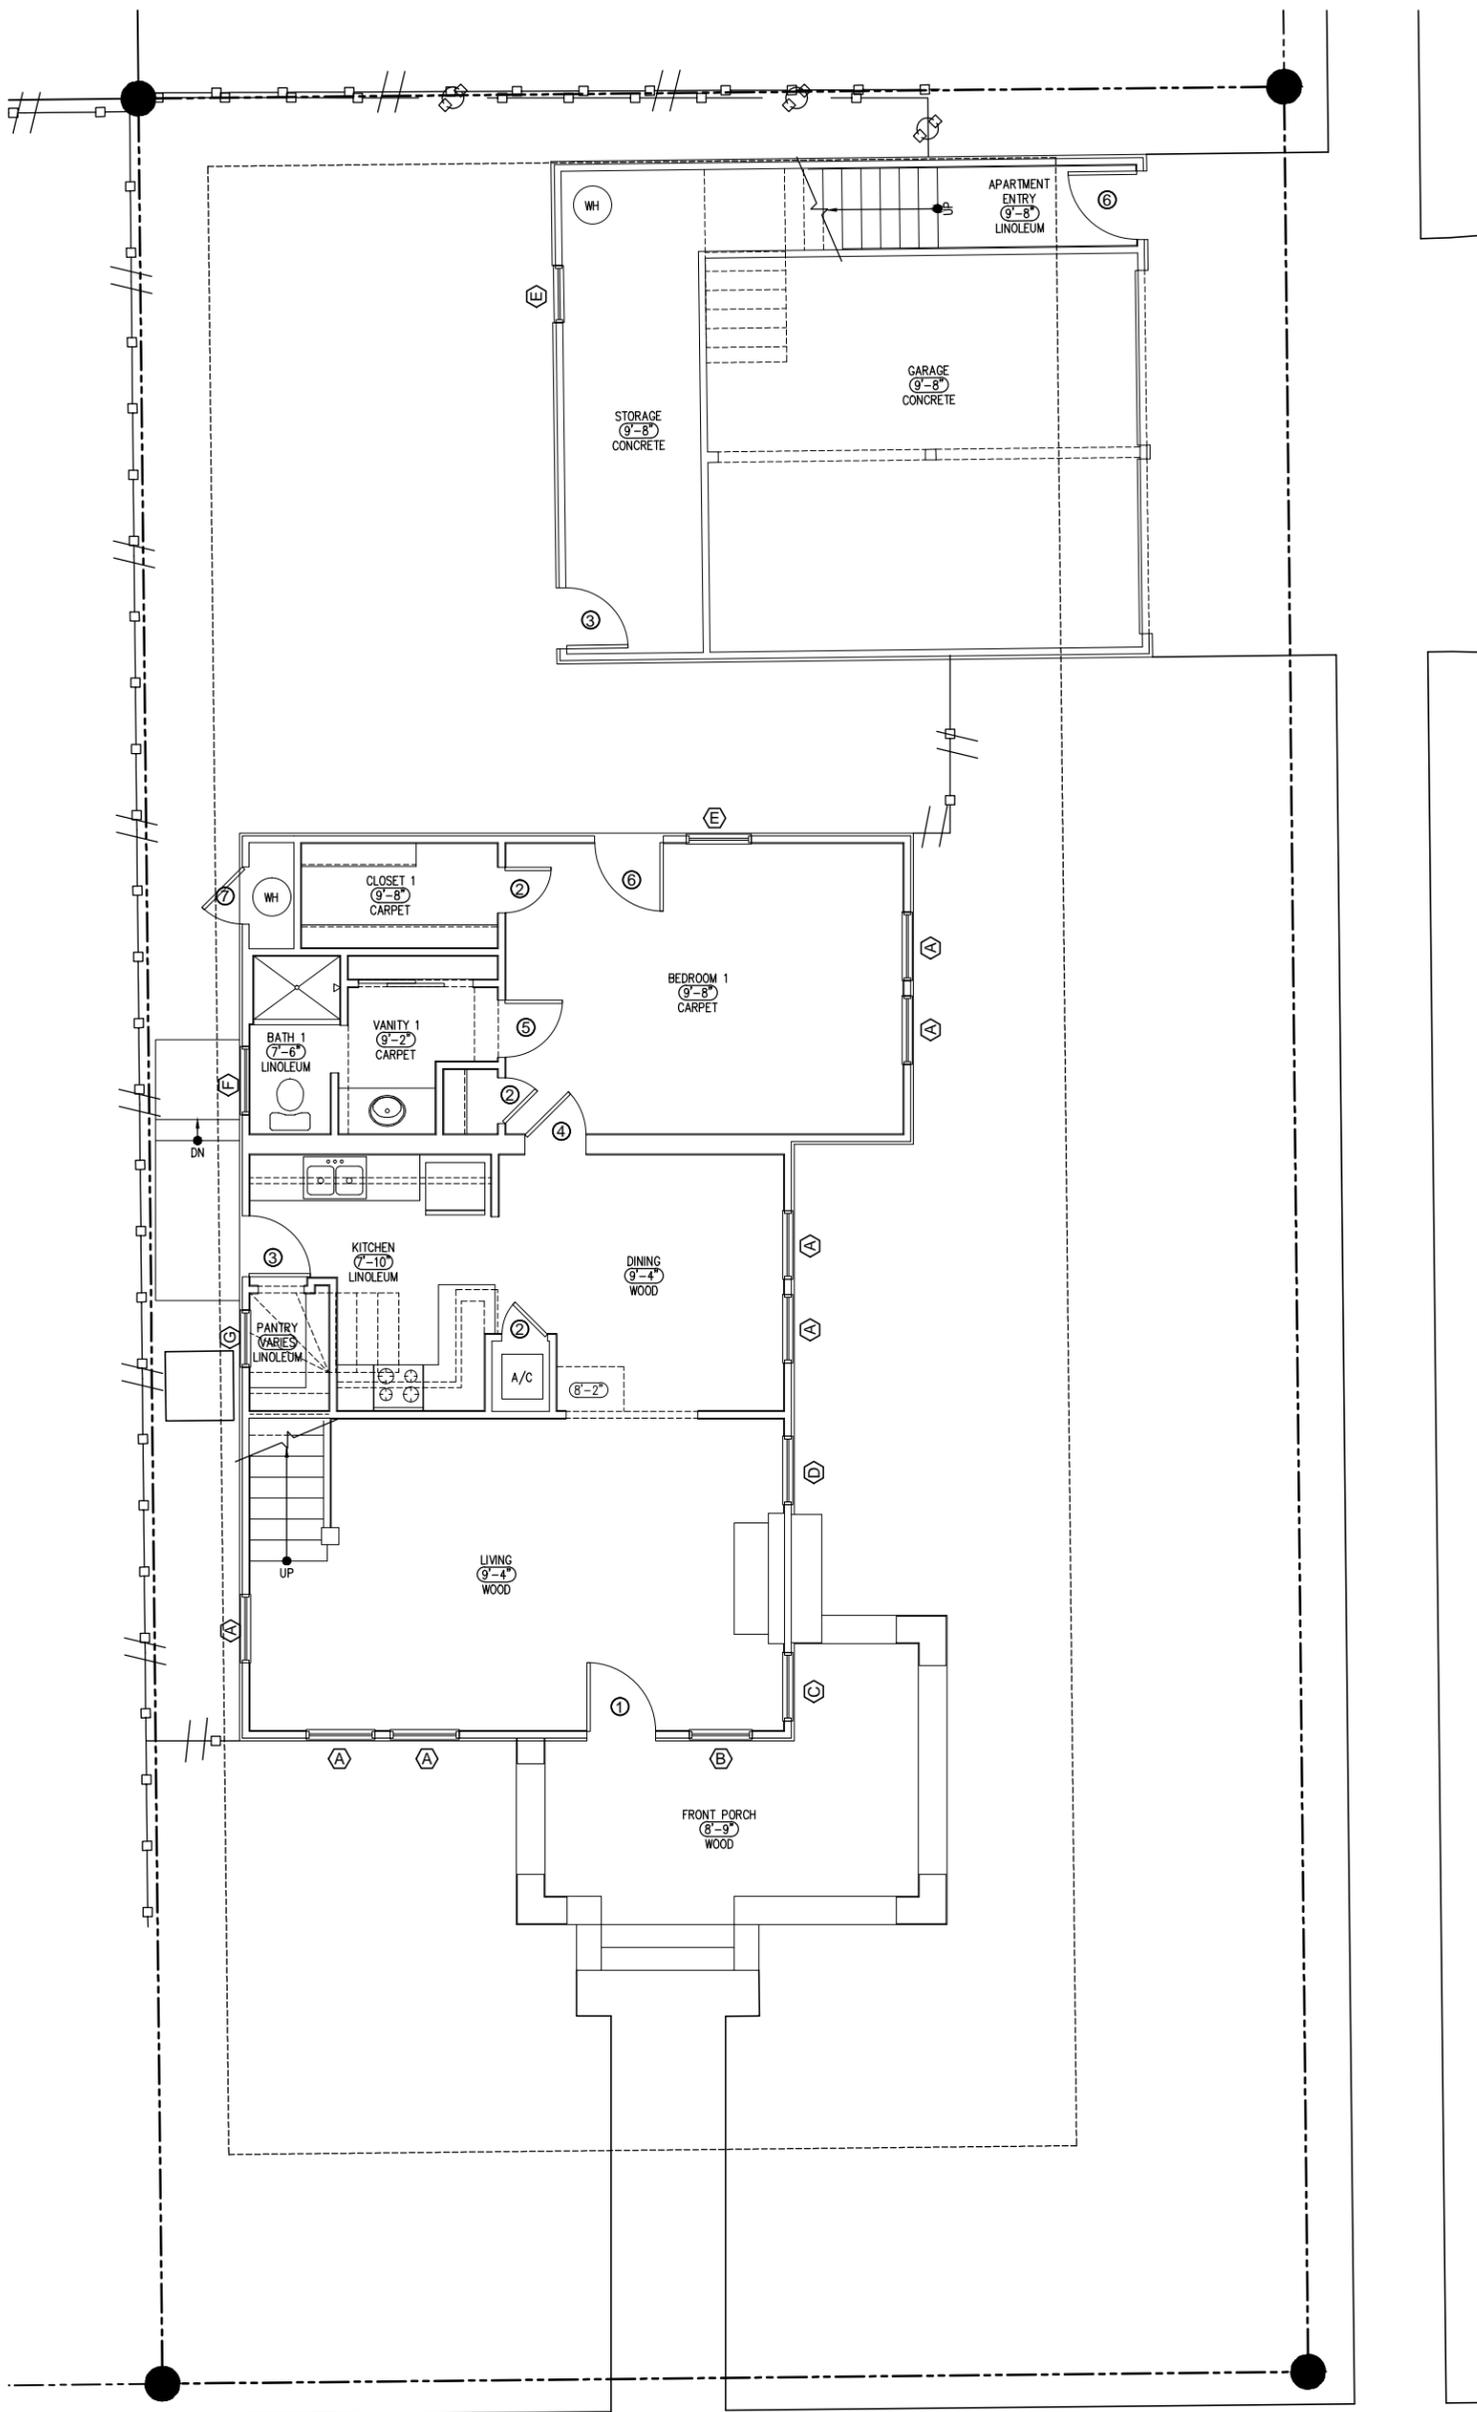
**EXISTING FIRST FLOOR PLAN**

SCALE: 1/8" = 1'-0"

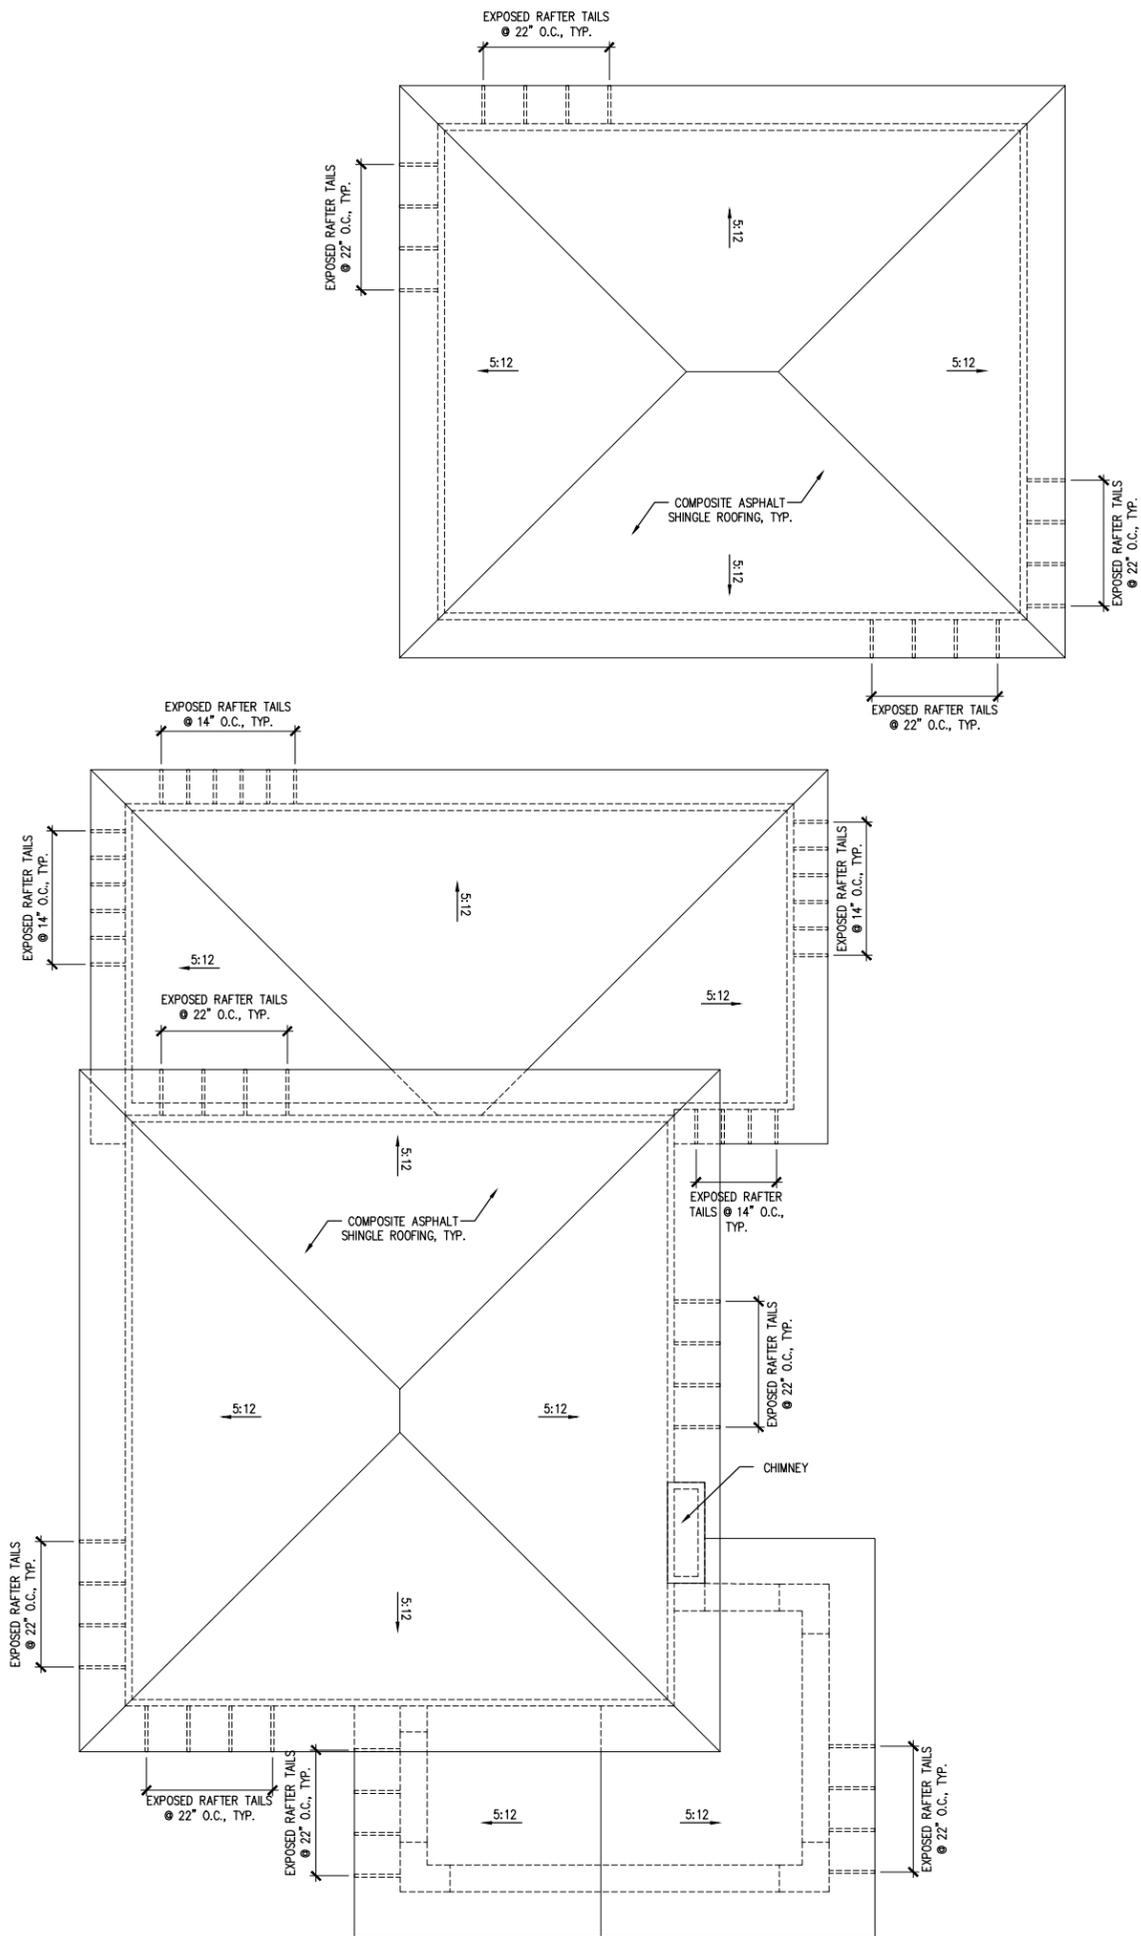
**EXISTING ROOF PLAN**

SCALE: 1/8" = 1'-0"

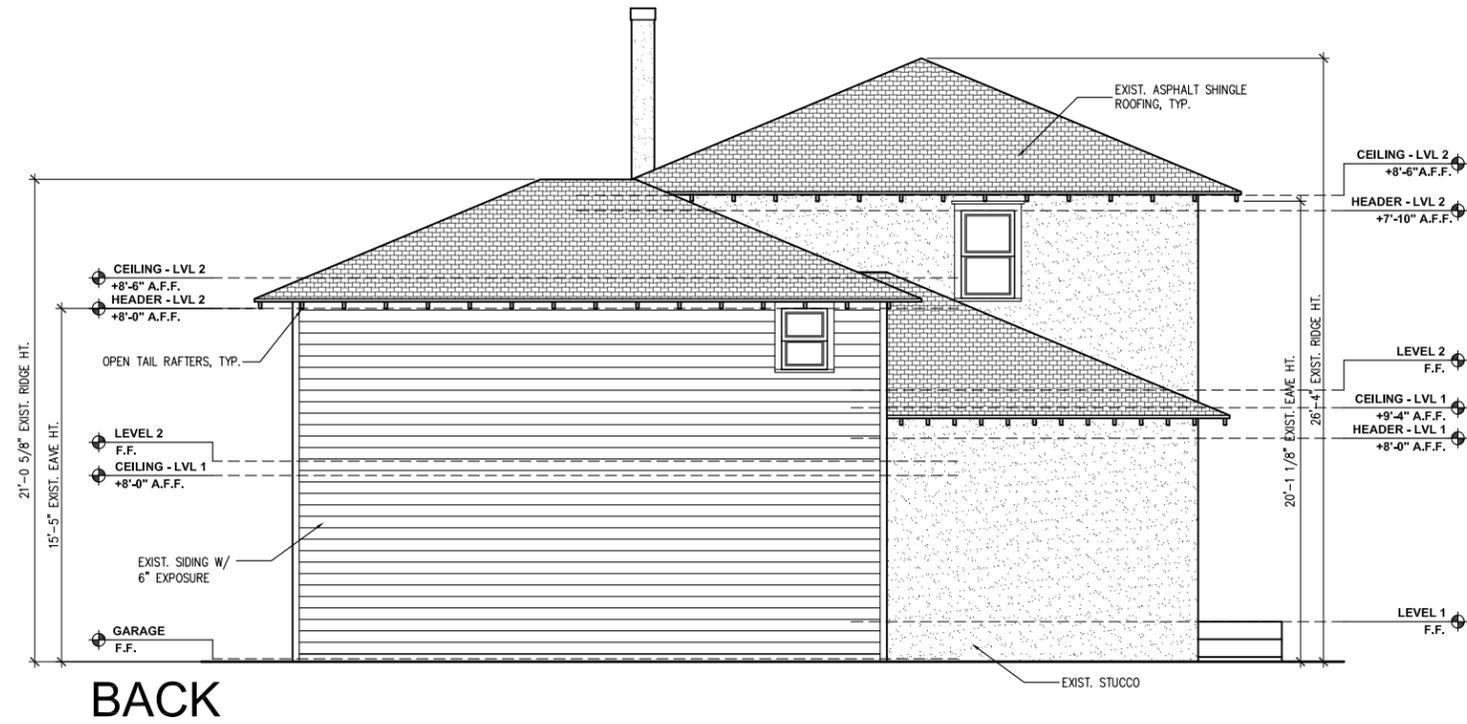
**BACK**

**EXISTING ELEVATIONS**  
SCALE: 1/8" = 1'-0"

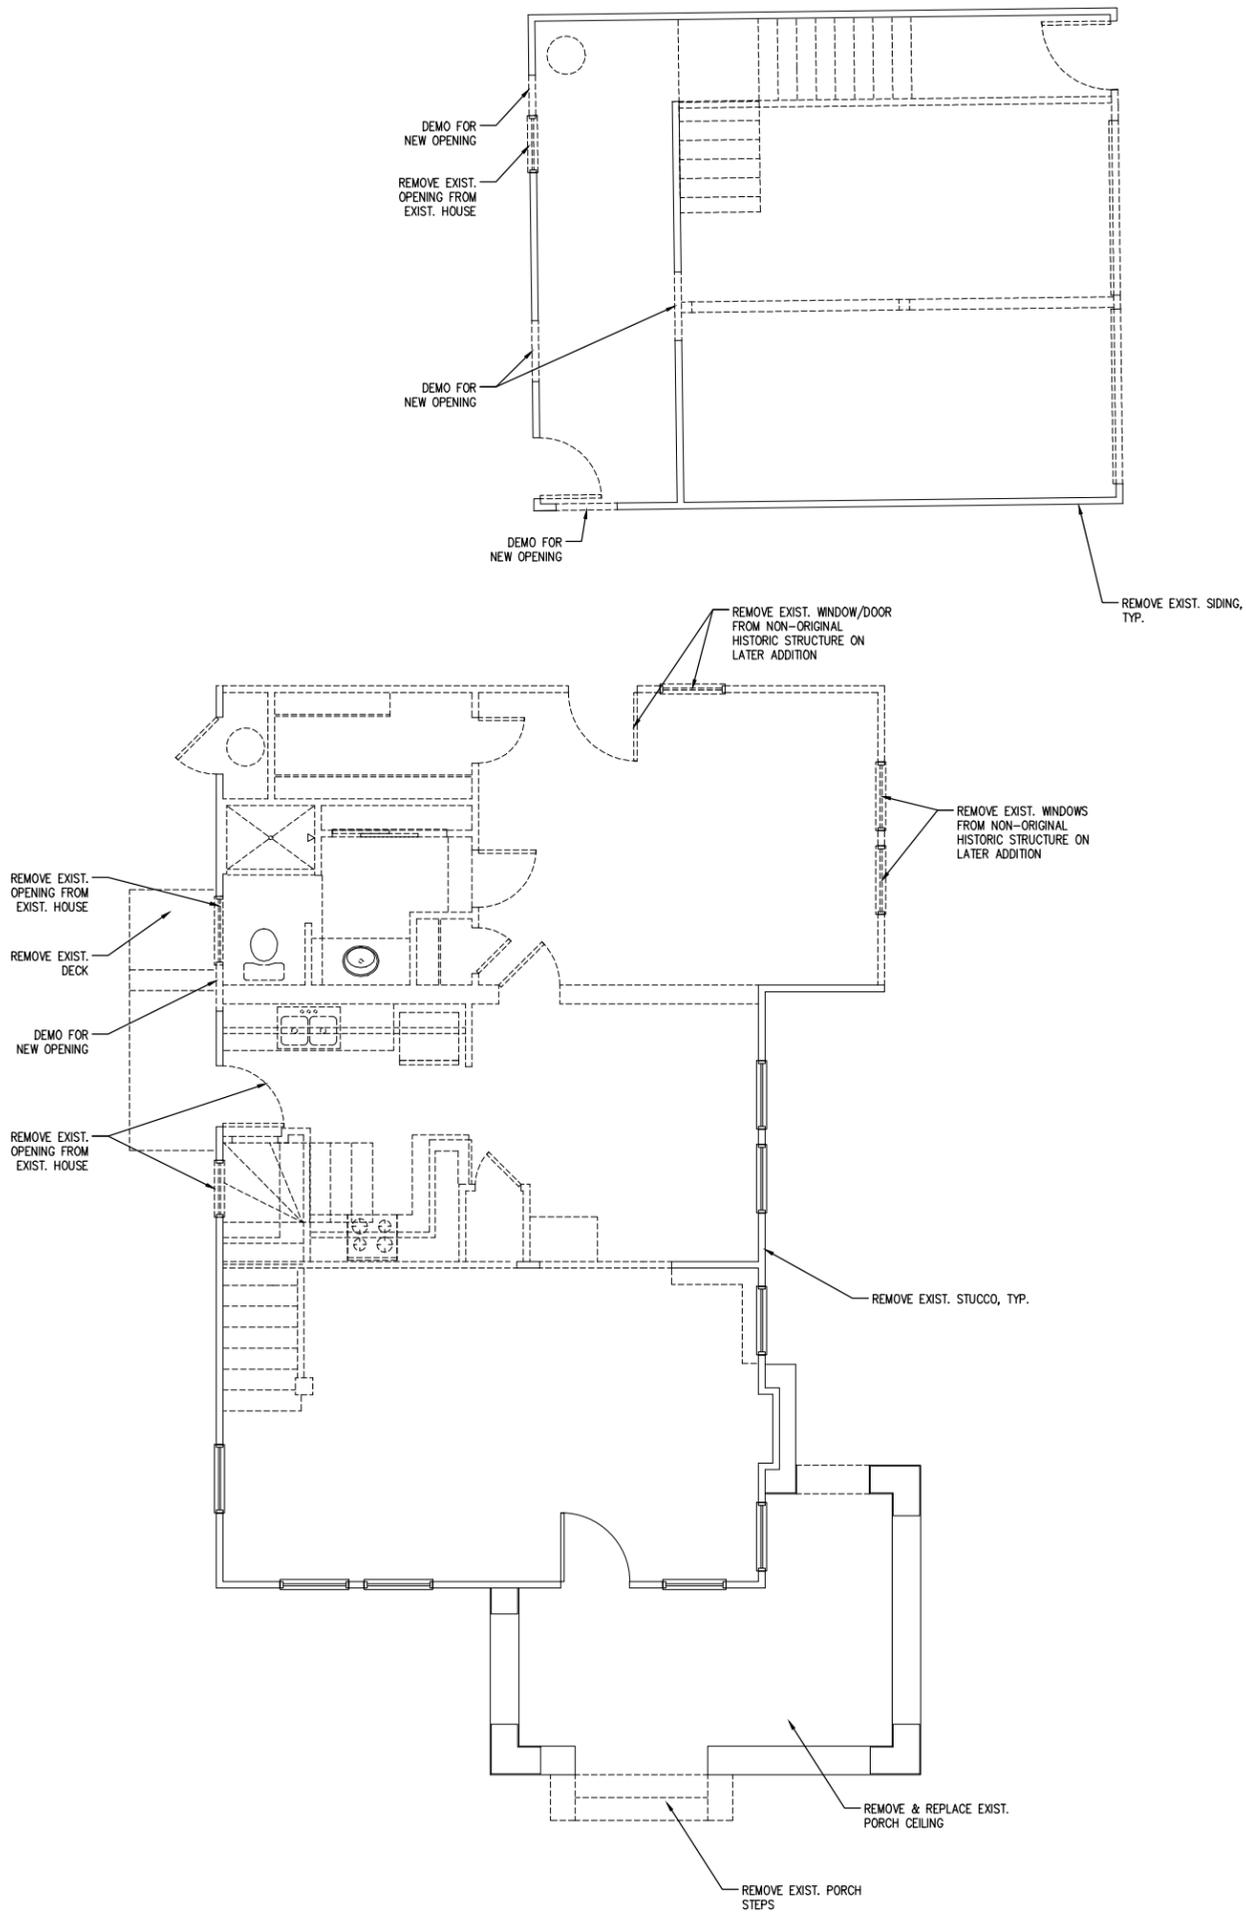
**FIRST FLOOR DEMO PLAN**

**LEGEND**

- EXISTING TO REMAIN
- - - - - DEMO

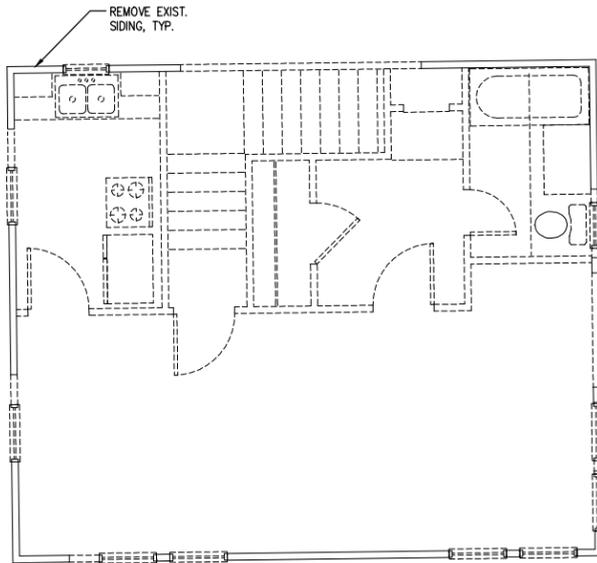
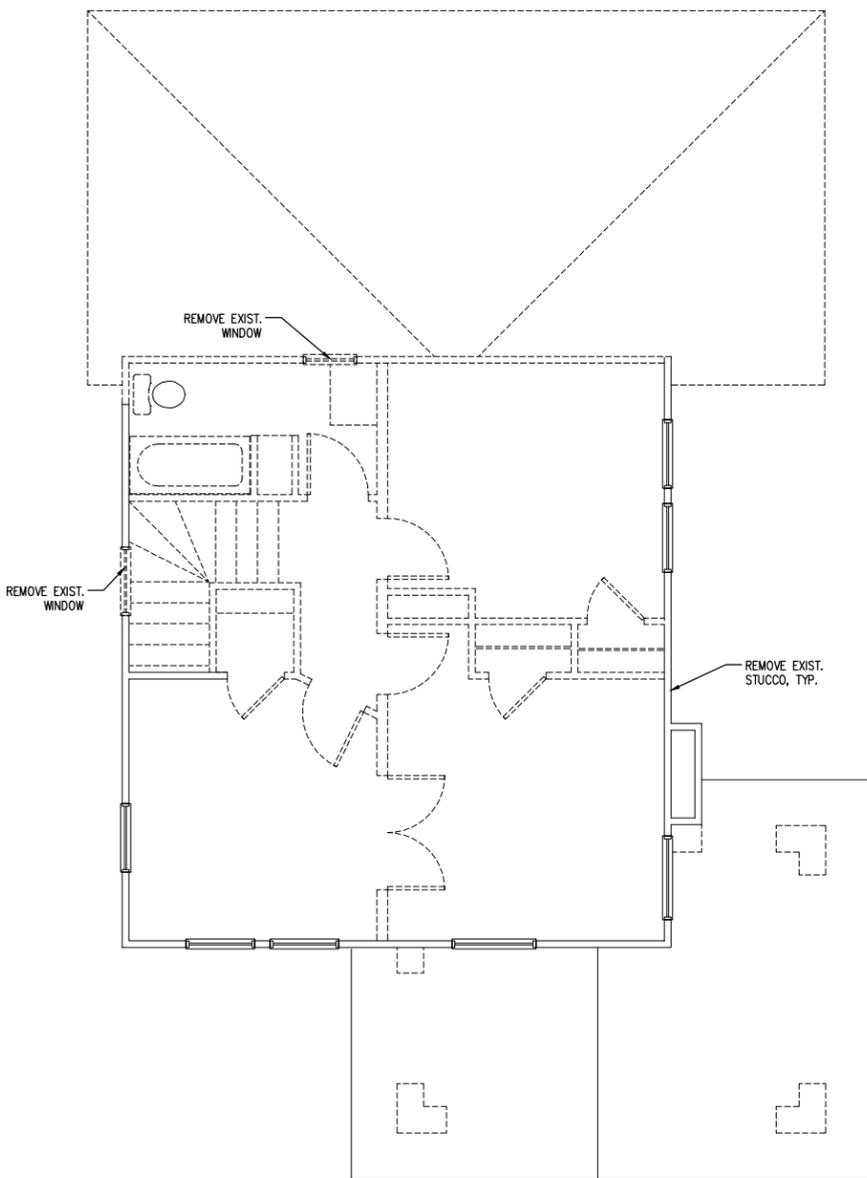
**SECOND FLOOR DEMO PLAN**  
SCALE: 1/8" = 1'-0"

LEGEND	
———	EXISTING TO REMAIN
- - - - -	DEMO
