# CERTIFICATE OF APPROPRIATENESS APPLICATION FORM

Address 501 Highland Street  
Historic District / Landmark Woodland Heights HCAD # 0372840000016  
Subdivision Woodland Heights Lot 16 Block 19

Subject: COA Application – 501 Highland Description

01.20.15  
**501 HIGHLAND**  
LIEBL RESIDENCE

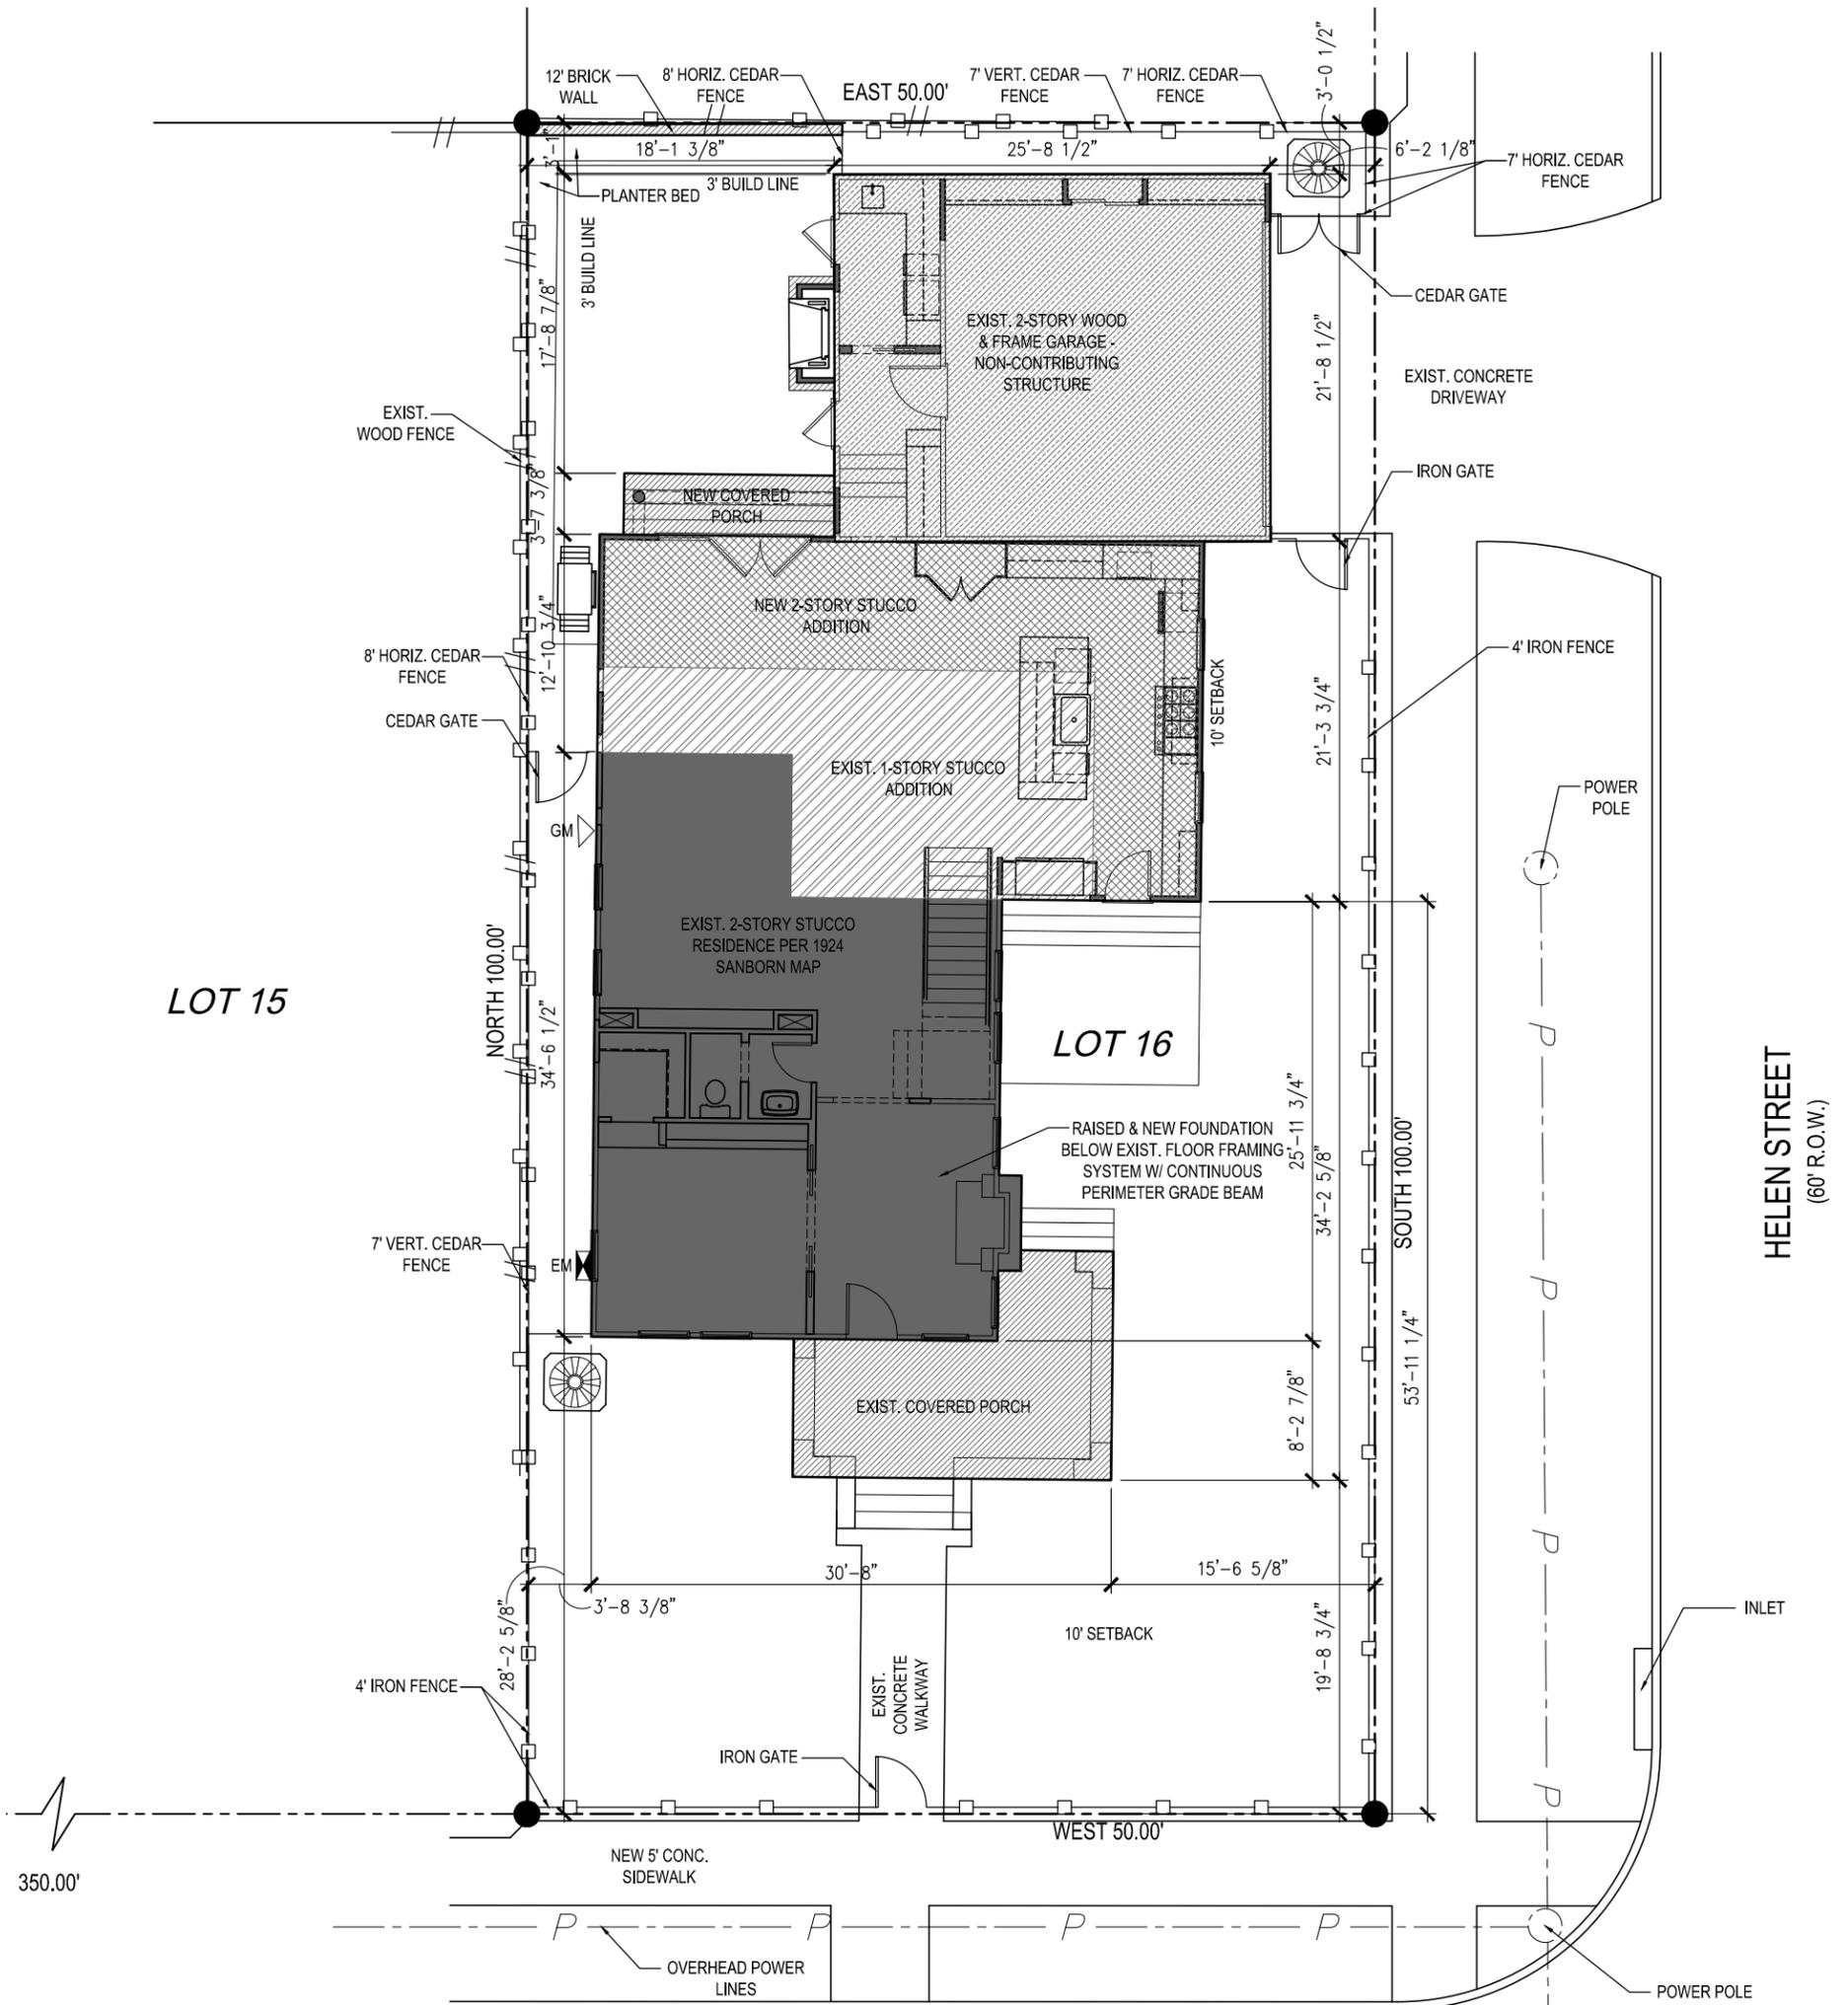
**PROPOSED SITE PLAN**  
SCALE: 3/32" = 1'-0"

LEGEND	
	EXISTING HISTORIC RESIDENCE TO BE REMODELED
	EXISTING ADDITION ADDED TO HISTORIC RESIDENCE
	EXISTING NON-CONTRIBUTING STRUCTURE
	NEW COVERED AREA
	NEW ADDITION

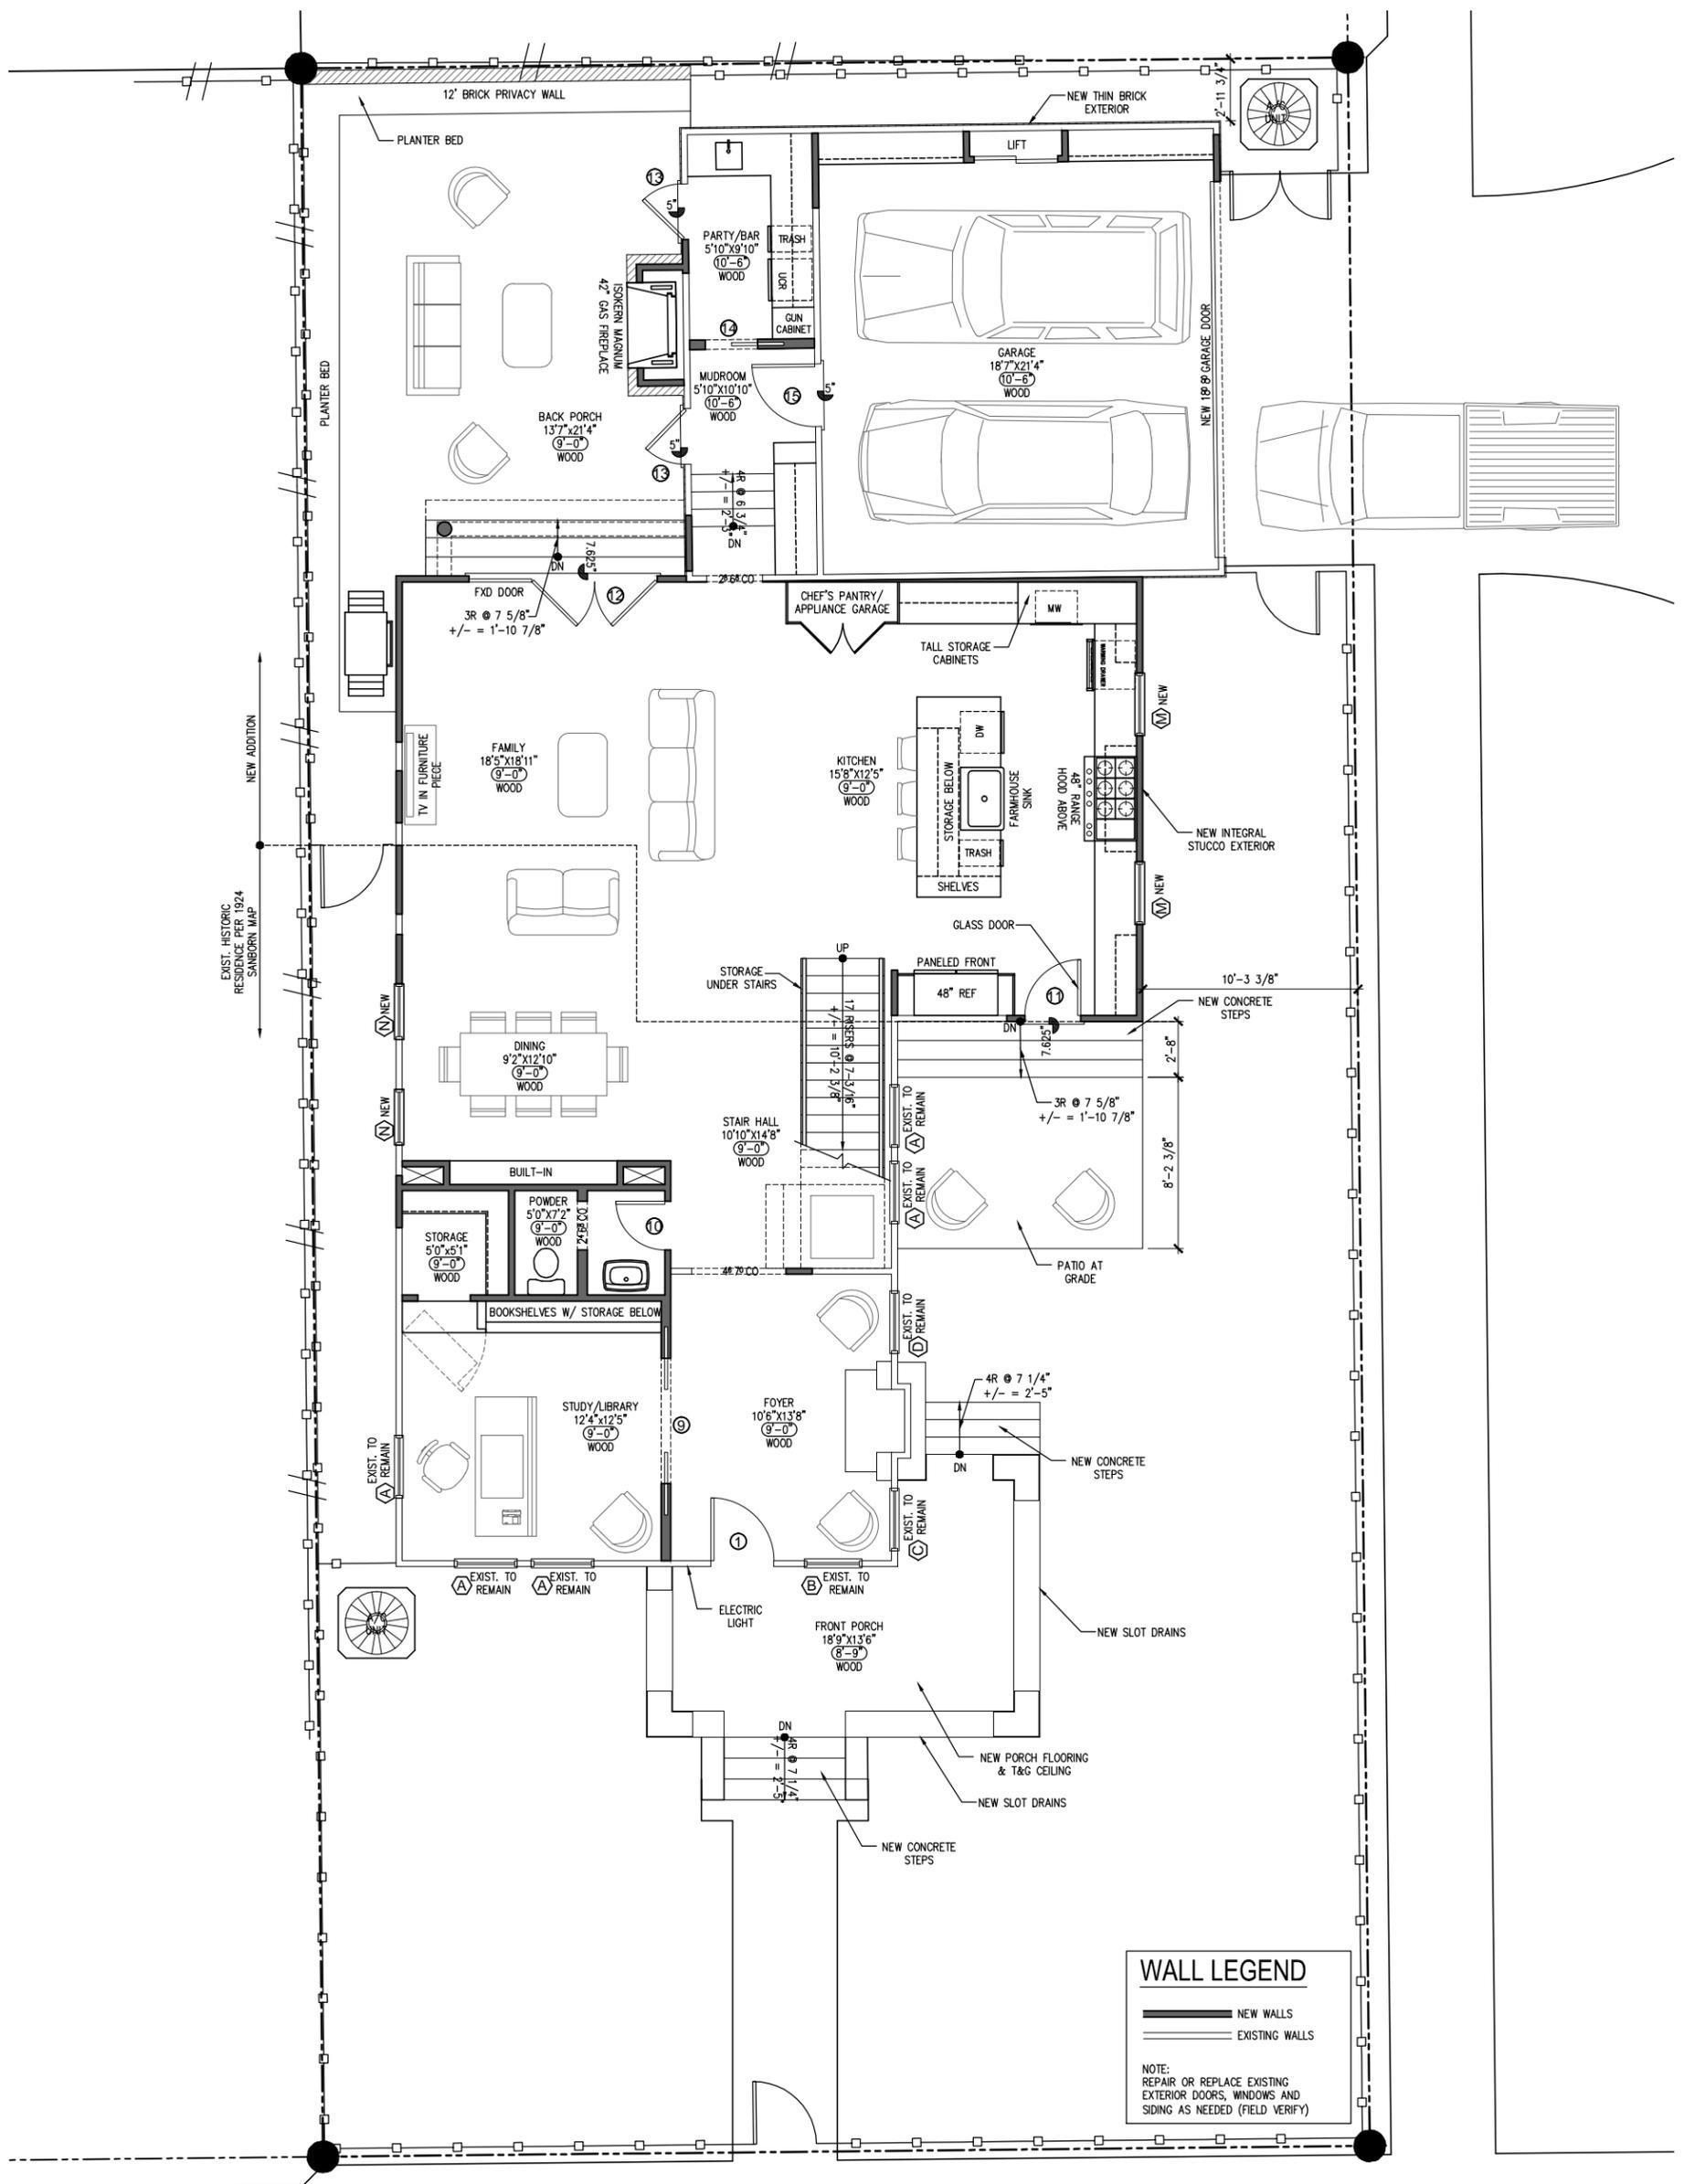
## PROPOSED FIRST FLOOR

### Square Footage:

EXISTING		NEW		TOTAL	
LEVEL ONE	1,096 S.F.	LEVEL ONE	437 S.F.	LEVEL ONE	1,533 S.F.
LEVEL TWO	1,177 S.F.	LEVEL TWO	745 S.F.	LEVEL TWO	1,922 S.F.
TOTAL A/C	2,273 S.F.			TOTAL A/C	3,455 S.F.
FRONT PORCH	190 S.F.	SIDE PORCH	127 S.F.	FRONT PORCH	190 S.F.
STORAGE	151 S.F.	BACK PORCH	45 S.F.	SIDE PORCH	127 S.F.
GARAGE	328 S.F.	GARAGE	79 S.F.	BACK PORCH	45 S.F.
TOTAL COVERED	2,952 S.F.	TOTAL ADDITION	1,433 S.F.	TOTAL PORCHES	372 S.F.
				GARAGE	407 S.F.
				TOTAL COVERED	4,224 S.F.

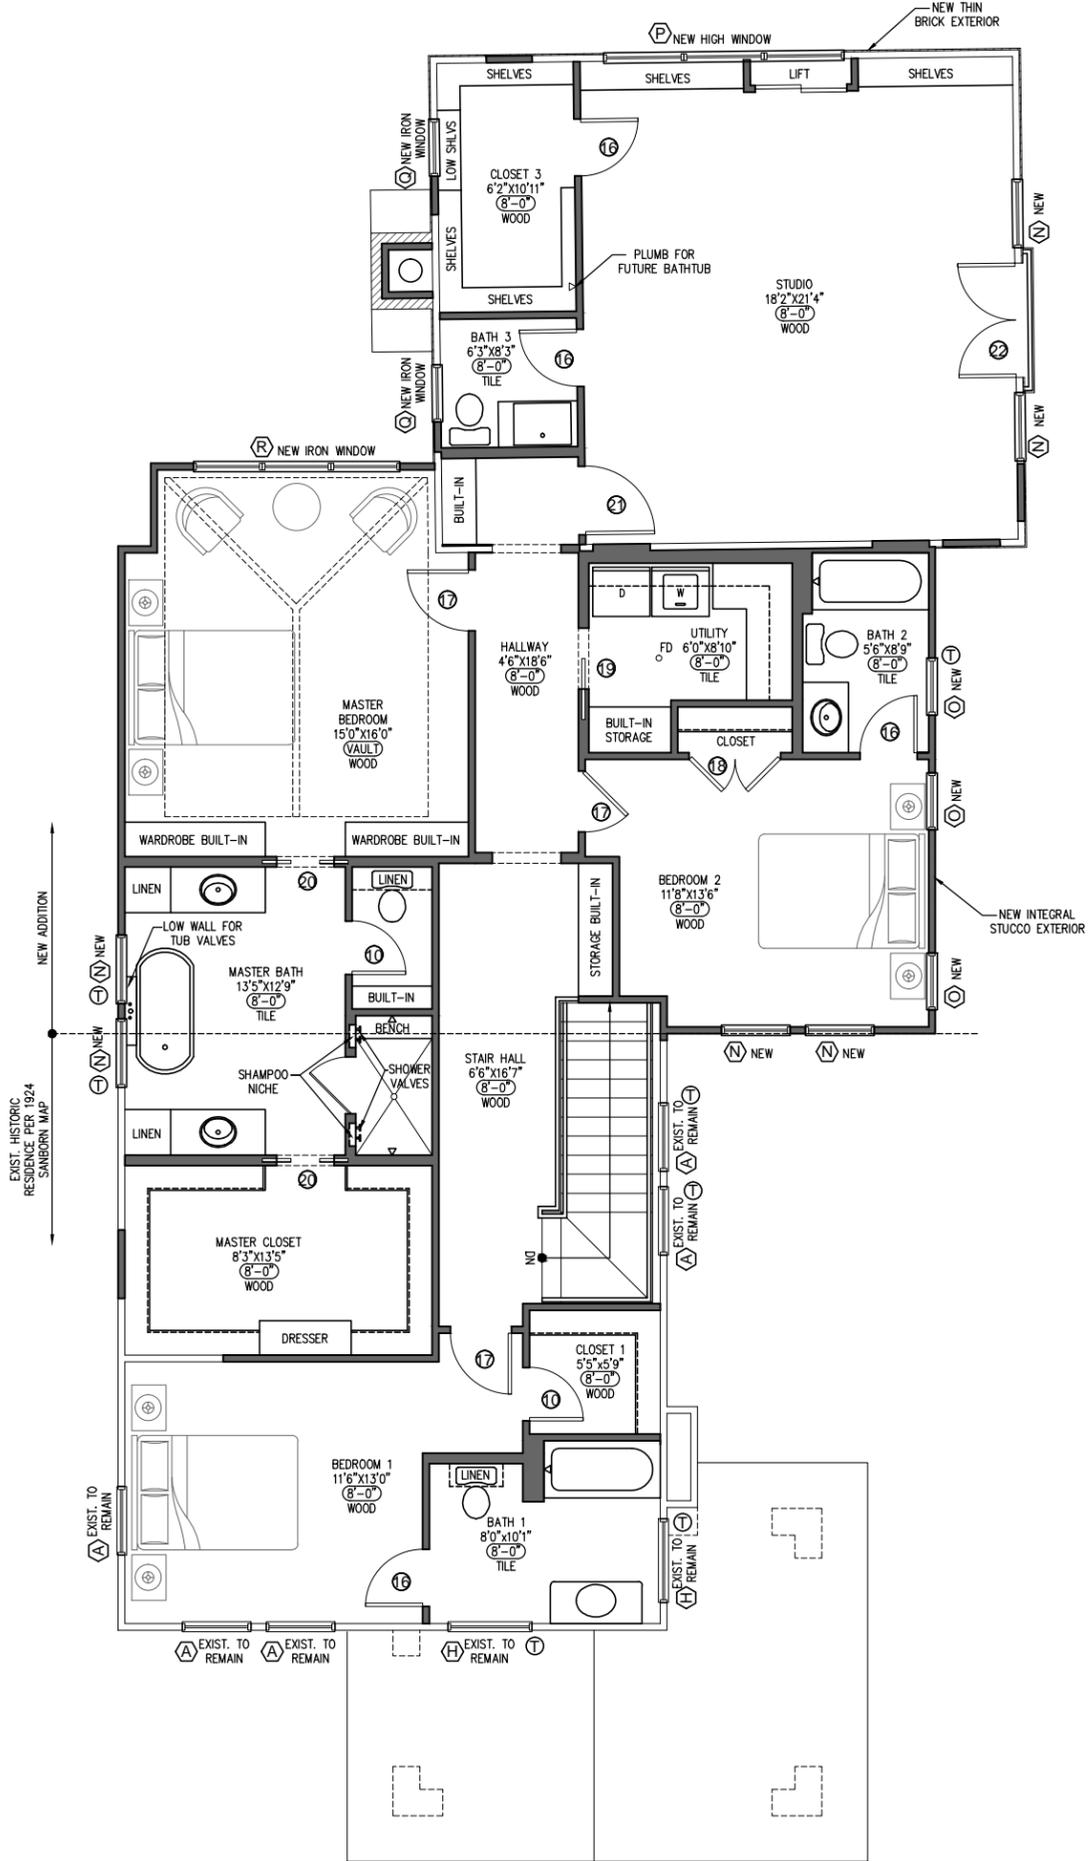
**PROPOSED SECOND FLOOR**

EXIST. HISTORIC RESIDENCE PER 1924 SANBORN MAP

NEW ADDITION

— NEW WALLS  
 - - - EXISTING WALLS

NOTE:  
 REPAIR OR REPLACE EXISTING EXTERIOR DOORS, WINDOWS AND SIDING AS NEEDED (FIELD VERIFY)

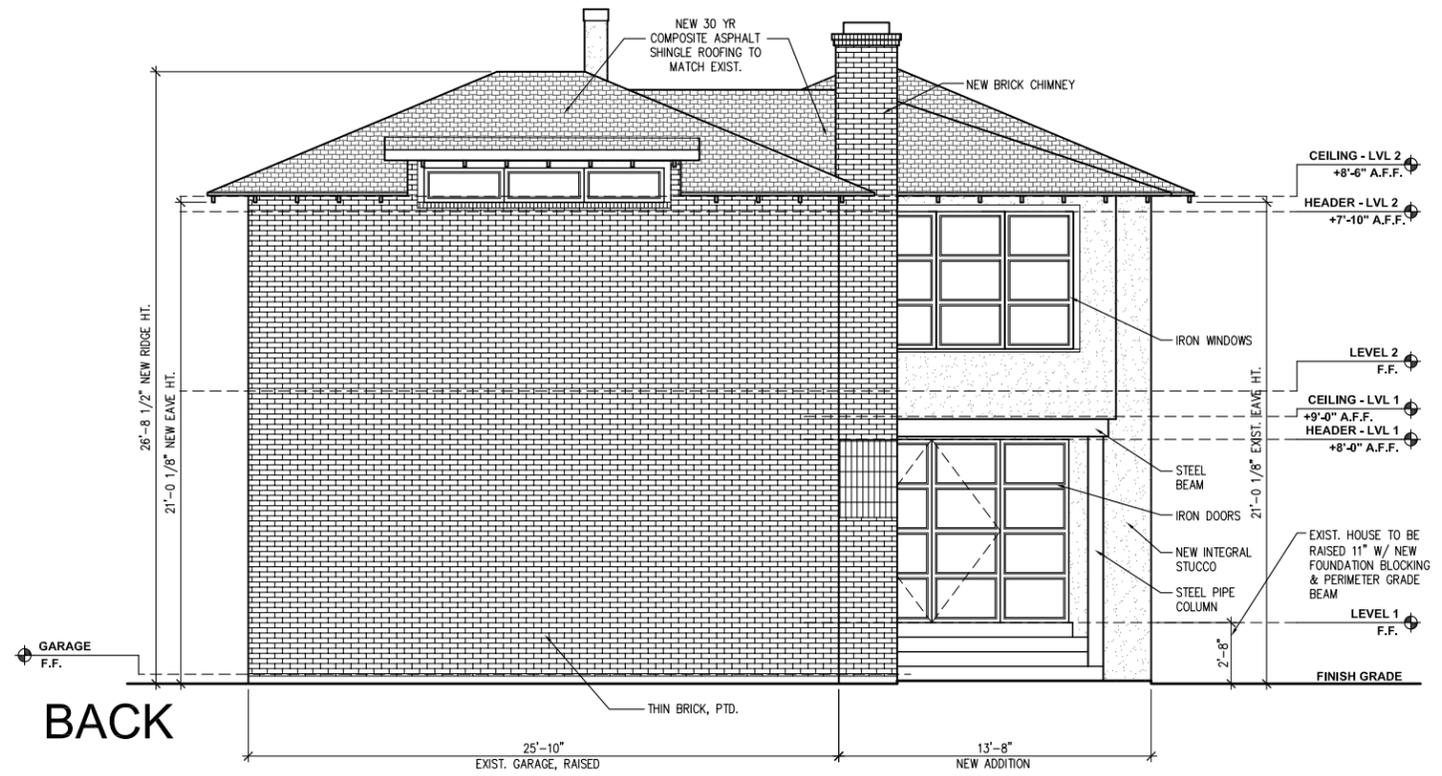
**BACK**

**PROPOSED ELEVATIONS**  
SCALE: 1/8" = 1'-0"

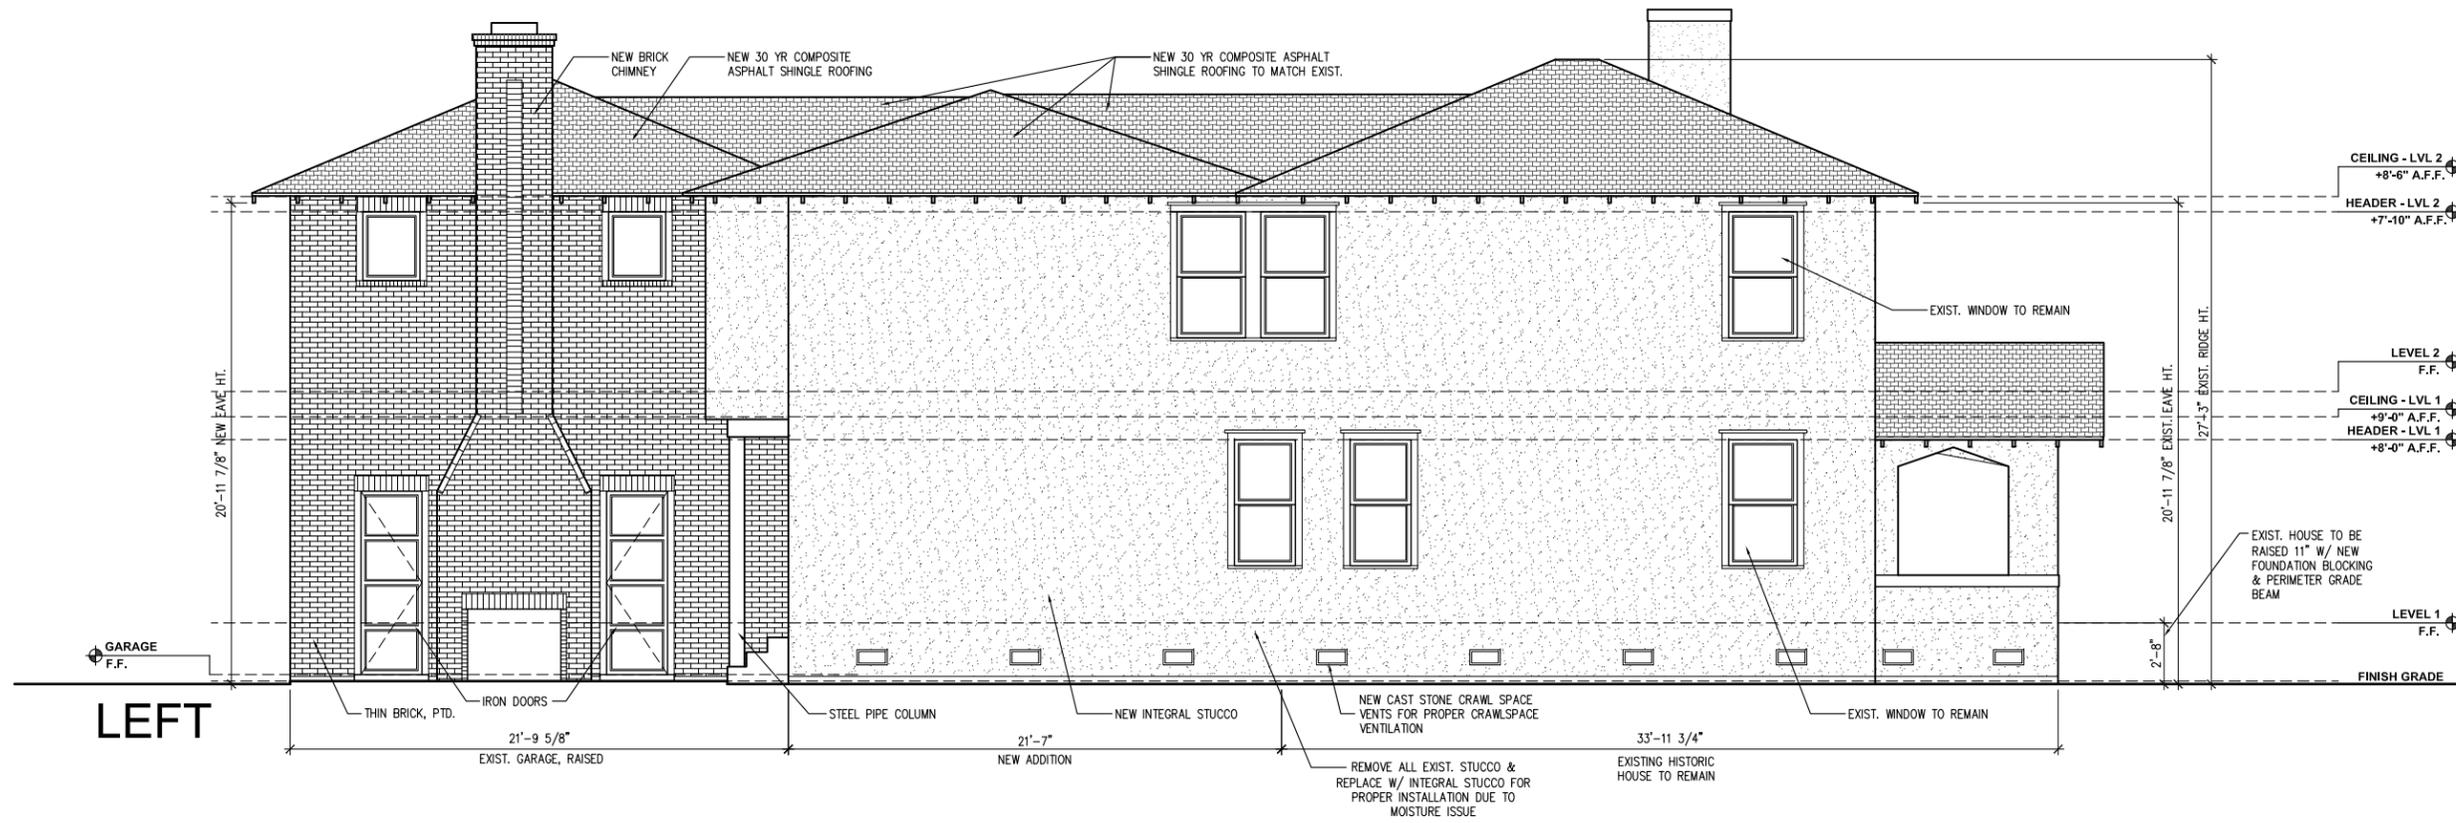
LEFT

PROPOSED ELEVATIONS  
SCALE: 1/8" = 1'-0"

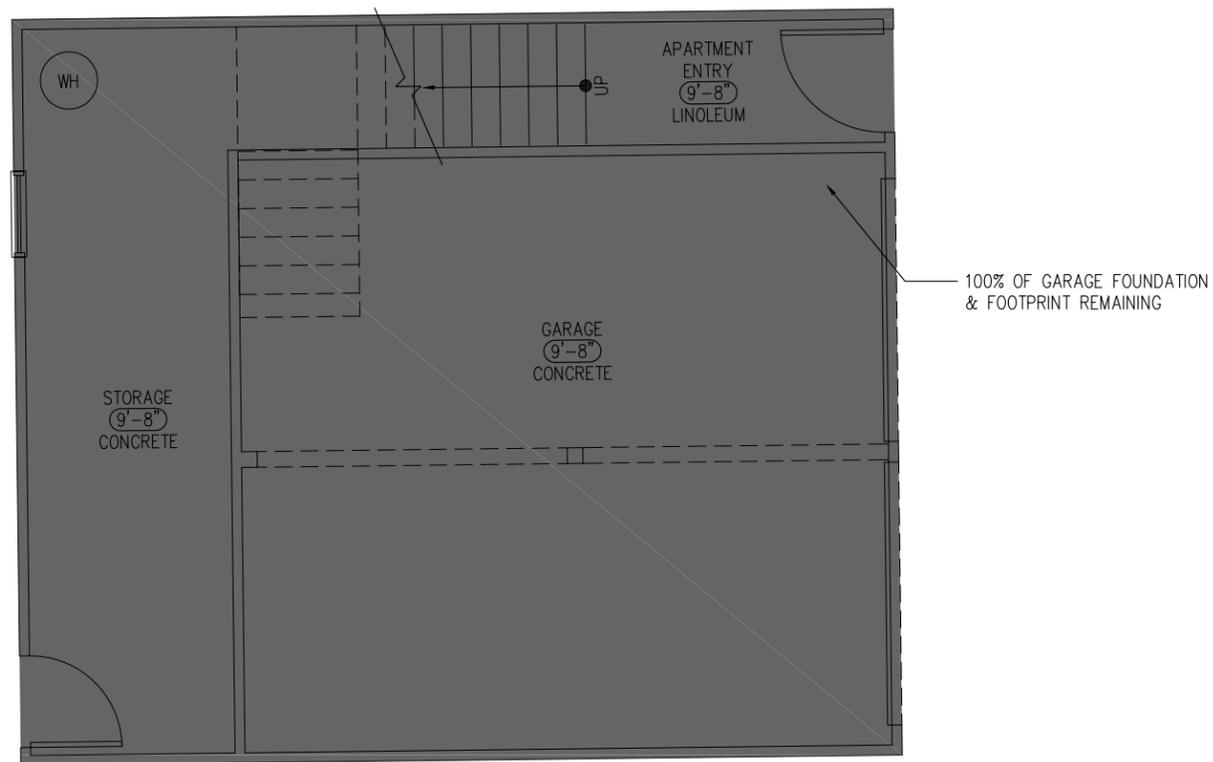
EXIST. GARAGE PLAN

EXISTING GARAGE DIAGRAM  
SCALE: 3/16" = 1'-0"
