CERTIFICATE OF APPROPRIATENESS

Property: 417 West 12th Street, tract 19a, 20a, and 21a, block 183, Houston Heights Subdivision. The property includes a historic 1,007 square foot residence situated on a 4,100 square foot (41' x 100') interior lot.

Proposal: Alteration – Construct a two story 1,498 square foot addition on top of and to the rear of a one story 1,007 square foot Contributing residence.

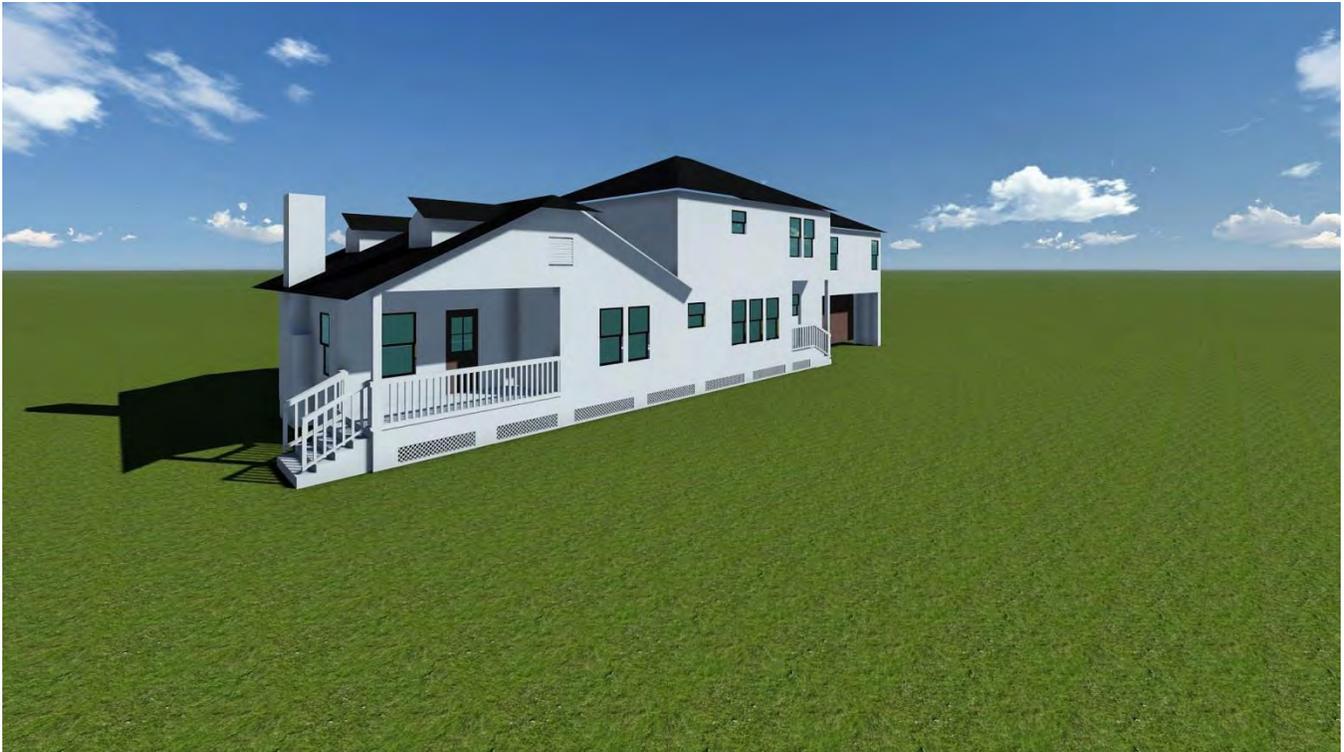
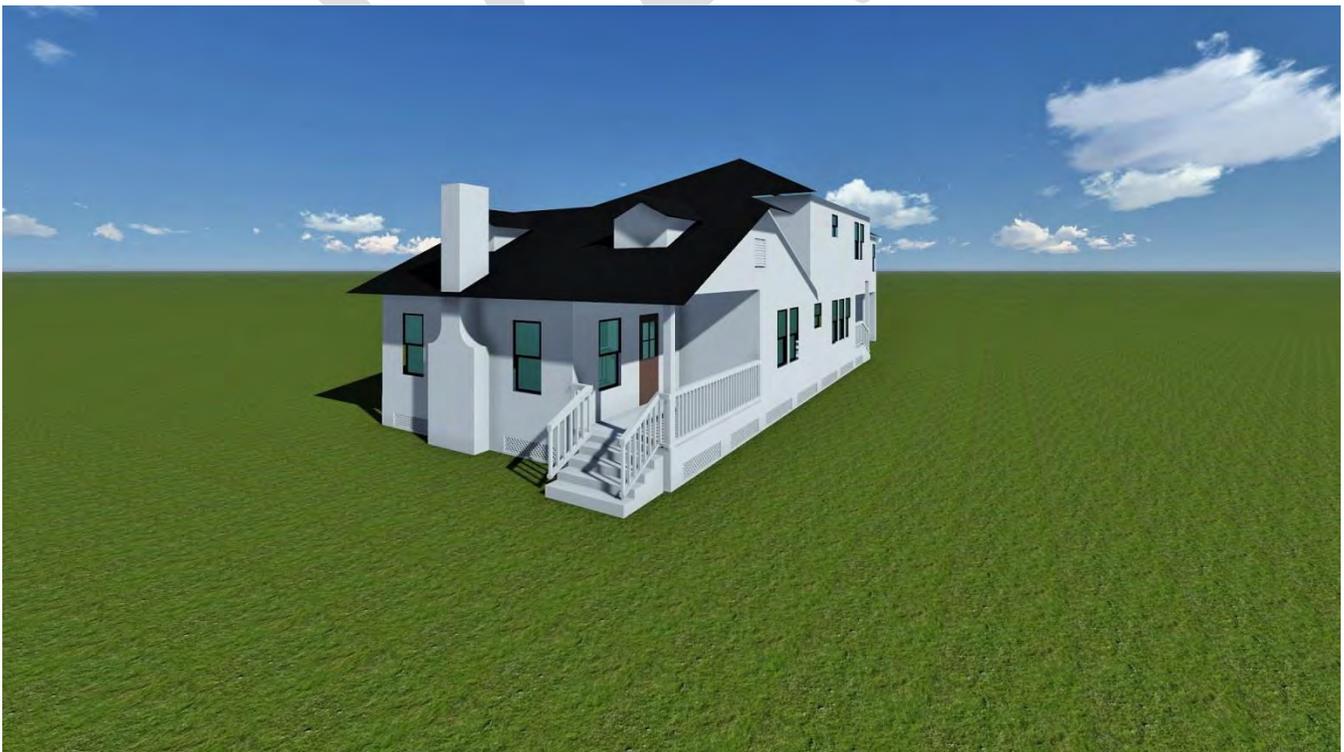
3D RENDERING

PROPOSED

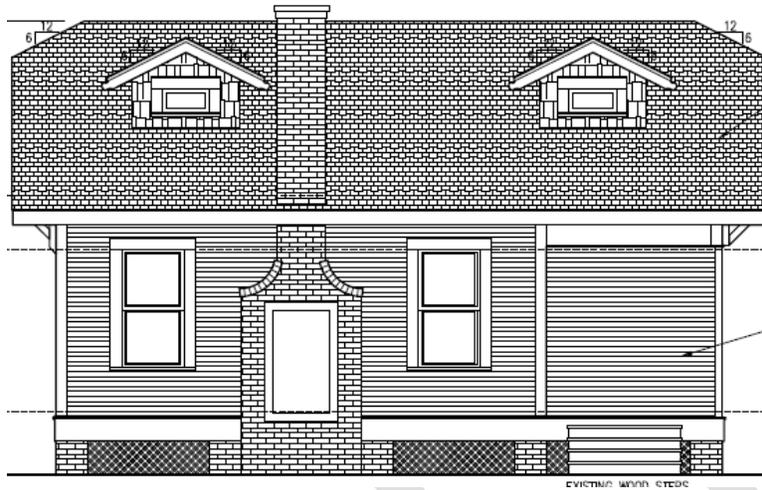
SOUTH ELEVATION – FRONT FACING WEST 12TH STREET

EXISTING

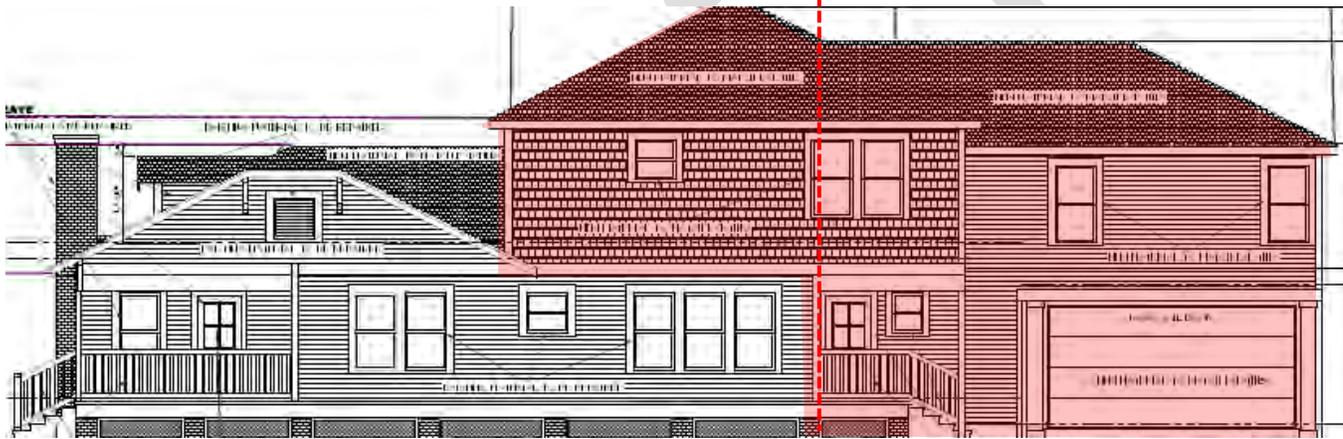
PROPOSED

**Red Dashed Line indicates the original
rear wall of the existing house**

Side Elevation: The addition will begin approximately 27' from the front wall, encroaching over the rear 19' of the original structure. A 10' deep non-original rear addition will also be removed in order to incorporate the new addition. The portion of the existing home behind the side gable is inset 7' from the front portion of the house. The addition will preserve this condition on the first floor but will build second story living space above the inset area. The result will be a covered side porch facing the west side property line. The second story of the addition will feature a side facing upstairs balcony directly above the first floor porch.
(West)

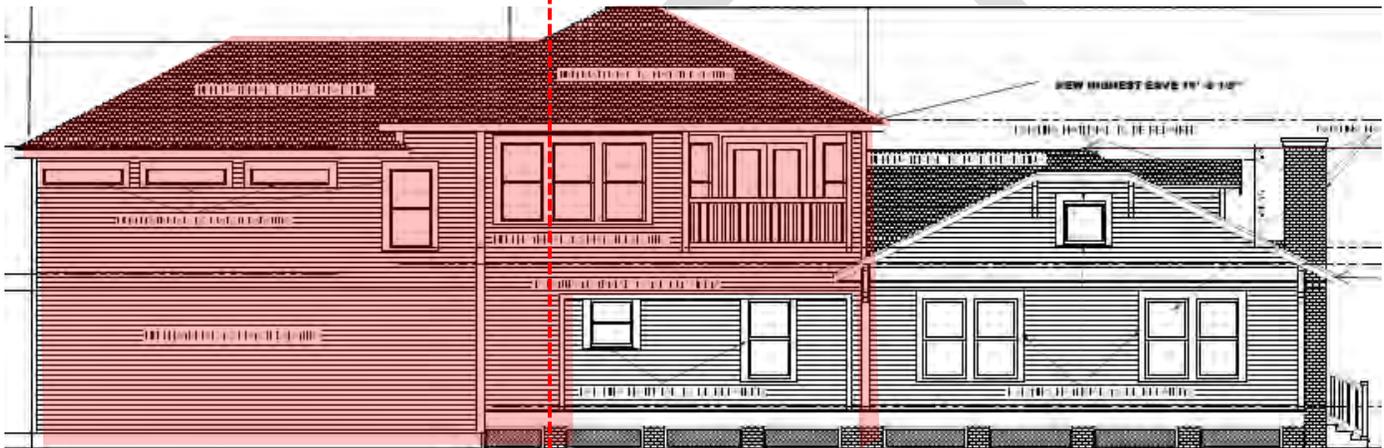
PROPOSED

**Red Dashed Line indicates the original
rear wall of the existing house**

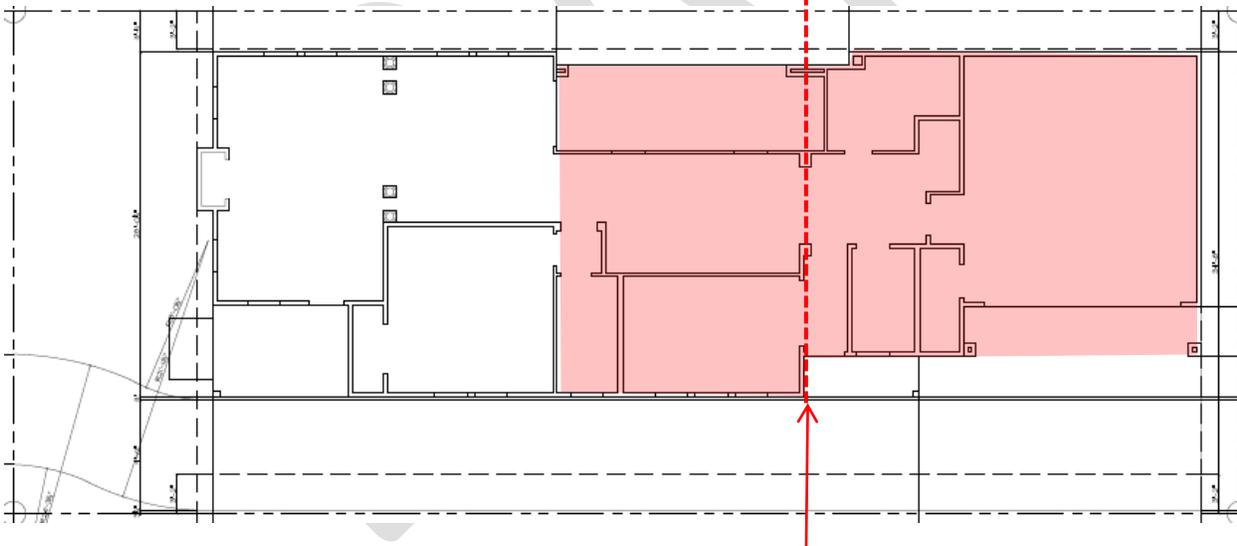
PROPOSED

Red Dashed Line indicates the original rear wall of the existing house

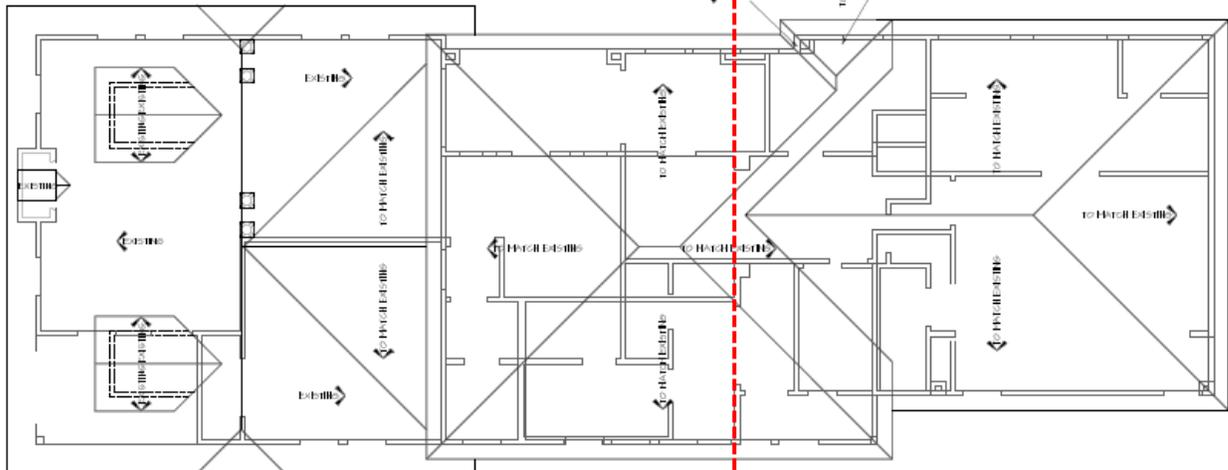
PROPOSED

**Red Dashed Line indicates the original
rear wall of the existing house**

<i>The proposed second floor addition will result in the loss of over half of the existing home's roof structure. In addition, the placement of a second floor jeopardizes the essential form and integrity of the structure, as the historic wall framing is often heavily altered or replaced in order to carry the added weight of the second floor.</i> | | | | | |

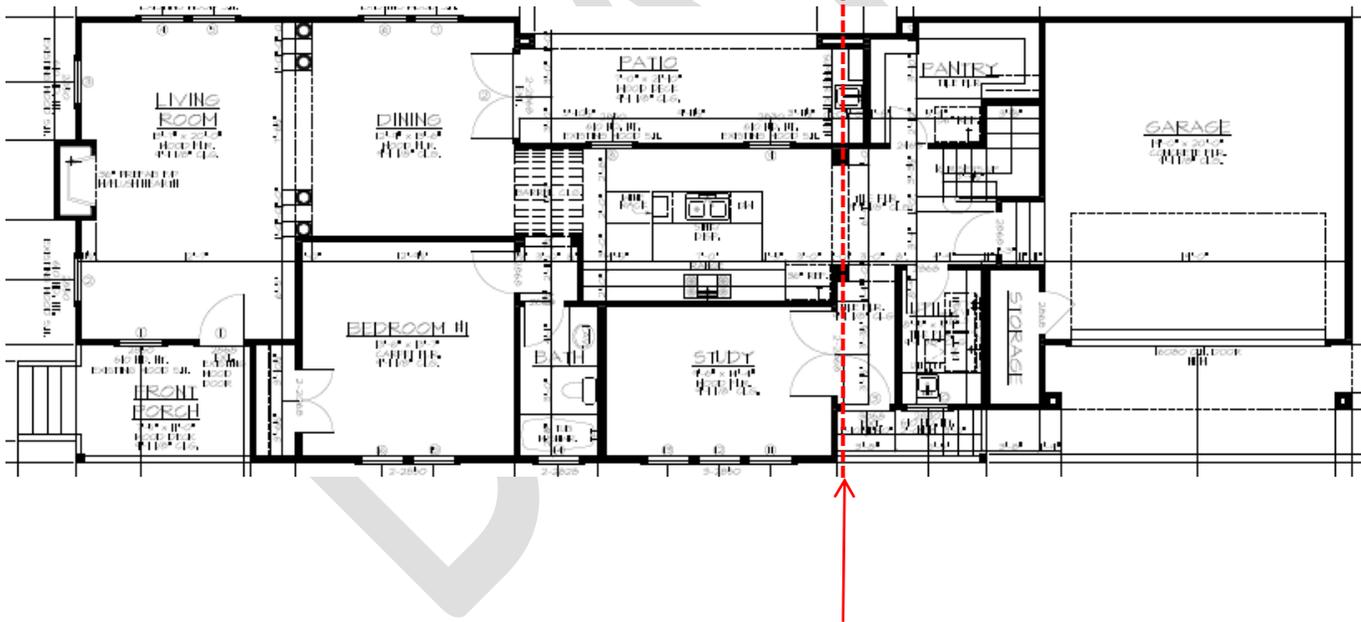
PROPOSED

Red Dashed Line indicates the original rear wall of the existing house

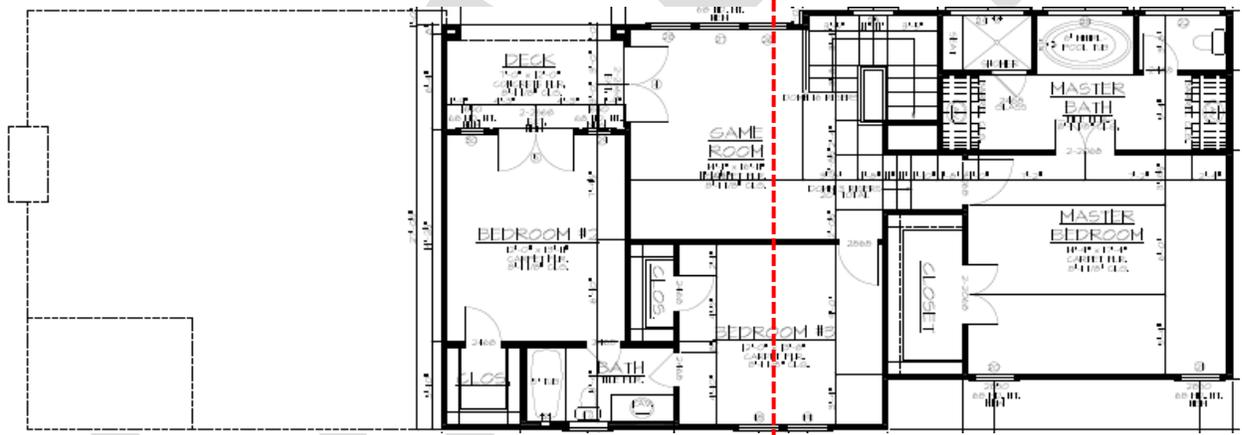
PROPOSED

Red Dashed Line indicates the original rear wall of the existing house

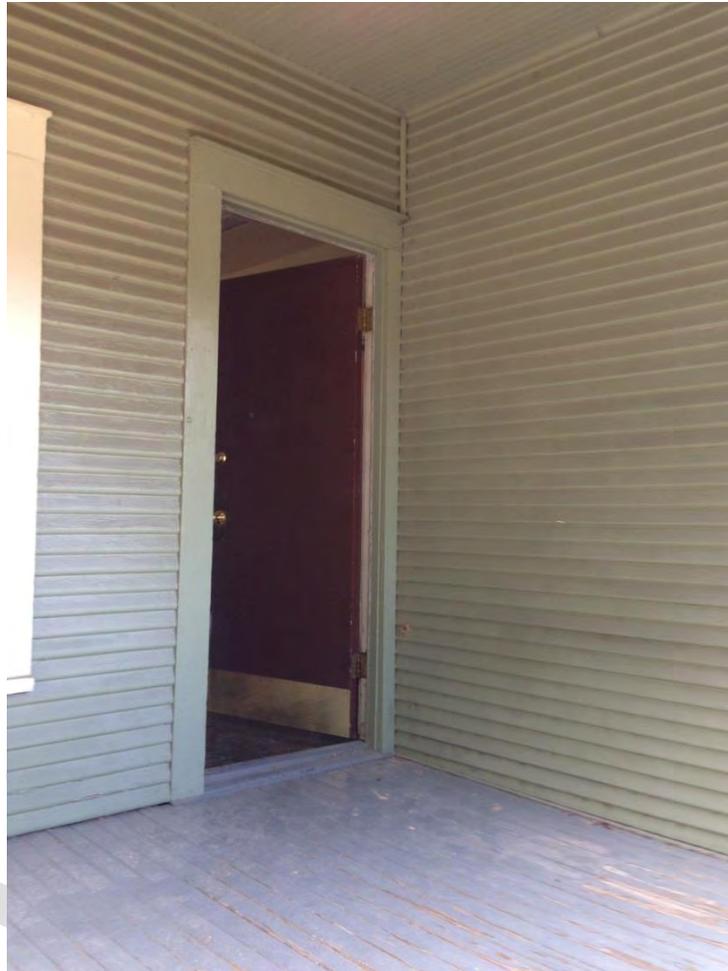
EXISTING NON-ORIGINAL FRONT DOOR

Windows/Doors: The existing house features historic 1 over 1 wood windows. These will be retained. The addition will feature interior sash mounted 1 over 1 vinyl windows. The applicant proposes to replace a non-original steel door with a wood craftsman style door within the existing opening.
