CERTIFICATE OF APPROPRIATENESS

Property: 1031 Le Green Street, Lot 13, Block 110, North Norhill Subdivision. The property includes a historic 1,190 square foot one-story wood frame single-family residence and detached garage situated on a 5,000 square foot interior lot.

Proposal: Alteration – Revision. Alter the fenestration of the existing south (front) and east elevations of the historic residence. The removal of the single original windows and installation of new wood paired windows on the front elevation, as well as the removal of a side window and installation of a smaller slider window, was denied at the July 2015 HAHC meeting. The applicant now proposes the following work:

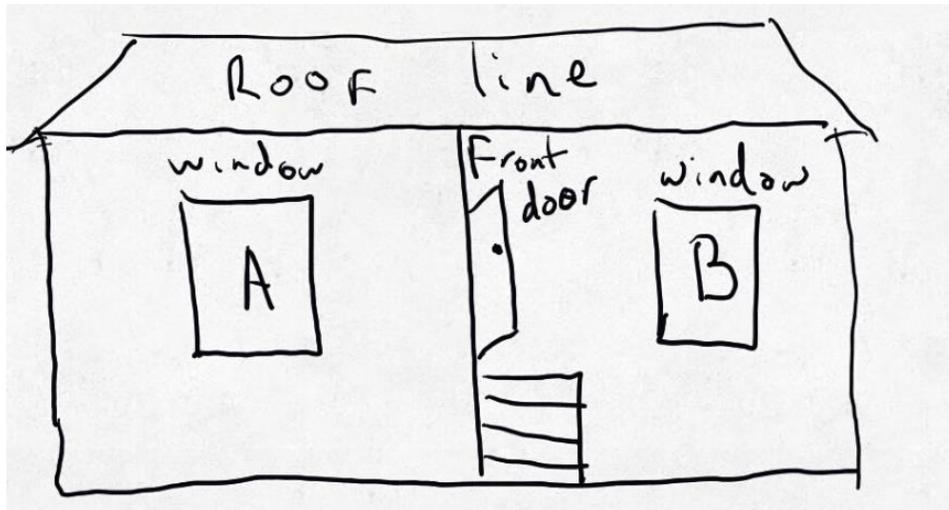
EXISTING

SOUTH ELEVATION – FRONT FACING LE GREEN STREET

July 2015: The two existing windows on the front elevation were removed. The existing openings were then expanded 1.5' on either side and two new pairs of 3' x 5' 1-over-1 wood double hung windows were installed. On the east elevation, the third window (from the street (after the pair)) was removed and replaced with a 3' x 2' wood slider window. The remainder of the opening was patched with new 117 wood siding to match existing.

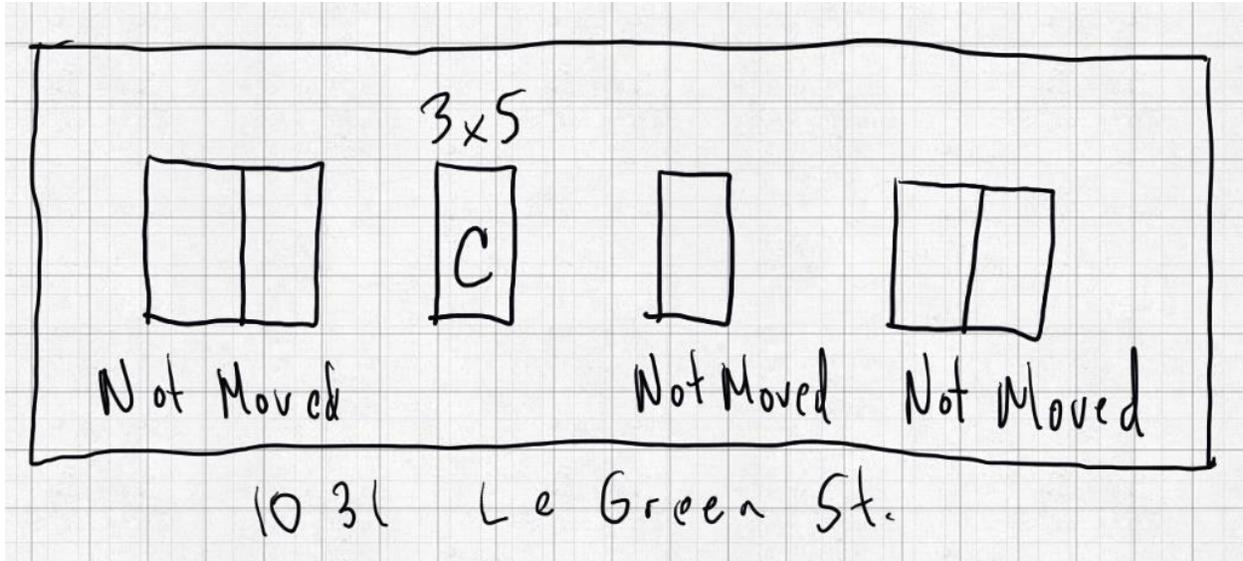
EXISTING

EAST SIDE ELEVATION

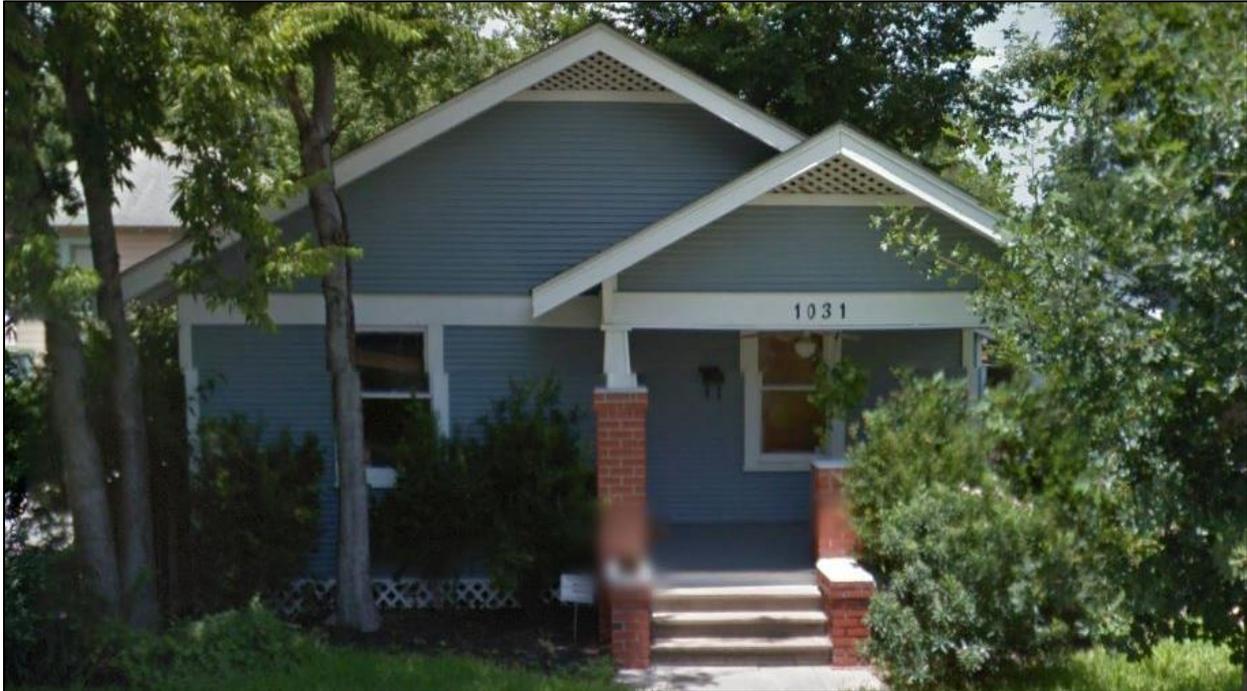
INSTALLED WINDOWS
FRONT FACING LE GREEN STREET
ORIGINAL

In order to enlarge the existing openings to accommodate the expanded width of the paired windows on the front (south) elevation, historic siding was removed. In order to close the opening on the east elevation, due the smaller size of the new slider windows, new wood 117 siding was installed to match existing. The original trim on the two front windows and the one altered east elevation window was removed and replaced. See photos and drawings for more detail.

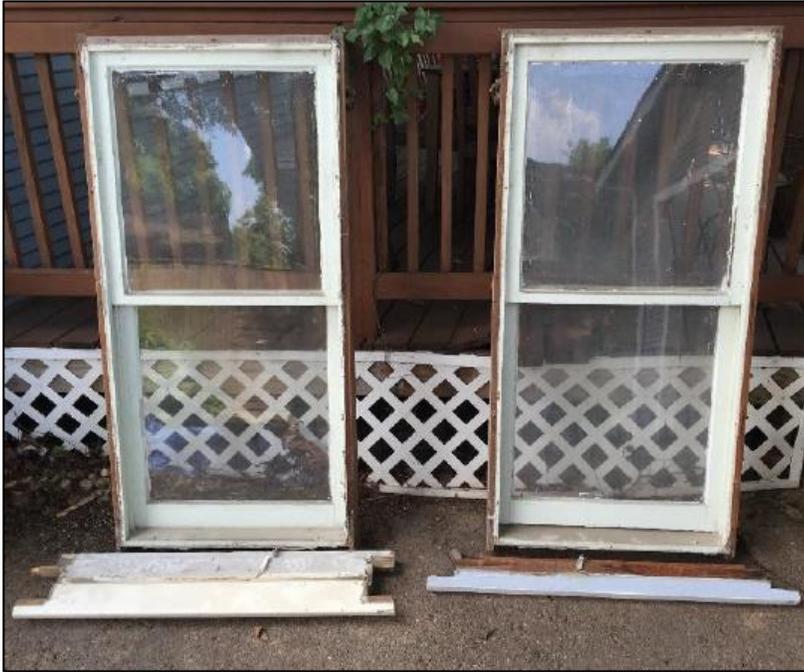
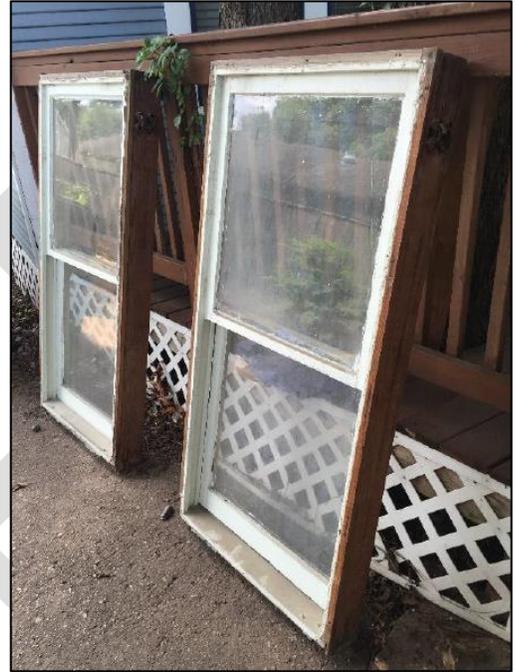
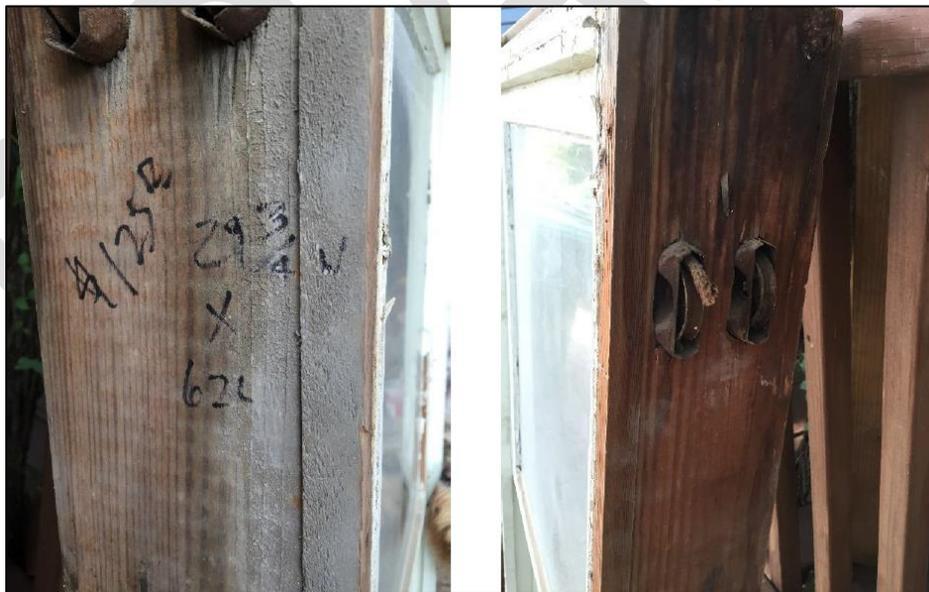
FRONT WINDOWS

PROPOSED SALVAGED WINDOWS (1 PAIR, NEED ADDITIONAL PAIR)

September 2015: The applicant proposes installing 4 salvaged, double-hung windows in 2 paired sets to replace the new double-hung windows that are currently installed. The applicants obtained 2 salvaged windows measuring 29³/₄" x 62", the same dimensions of all other original windows in the home. If COA is approved, the applicant will continue to monitor the Historic Houston Salvage Warehouse for additional windows of the same dimension and vintage, and also search in Austin, San Antonio, and Dallas for matching windows. The salvaged windows will then be refurbished by a local craftsman. The applicant proposes to keep the current replaced and altered east side window in place. See photos, window/door schedule, and drawings for more detail.

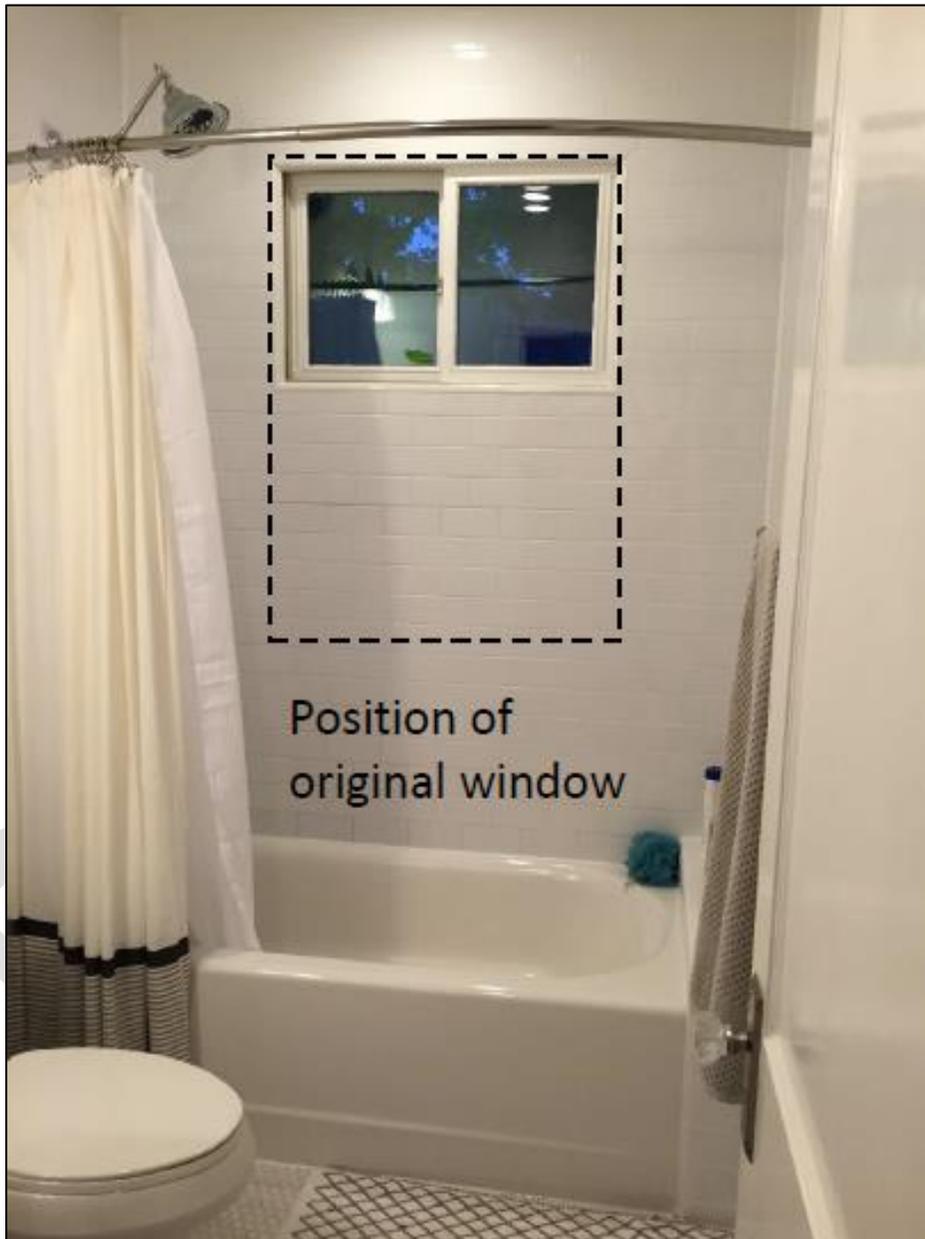
SIDE WINDOW – INTERIOR VIEW

(PROPOSED TO REMAIN AS INSTALLED)

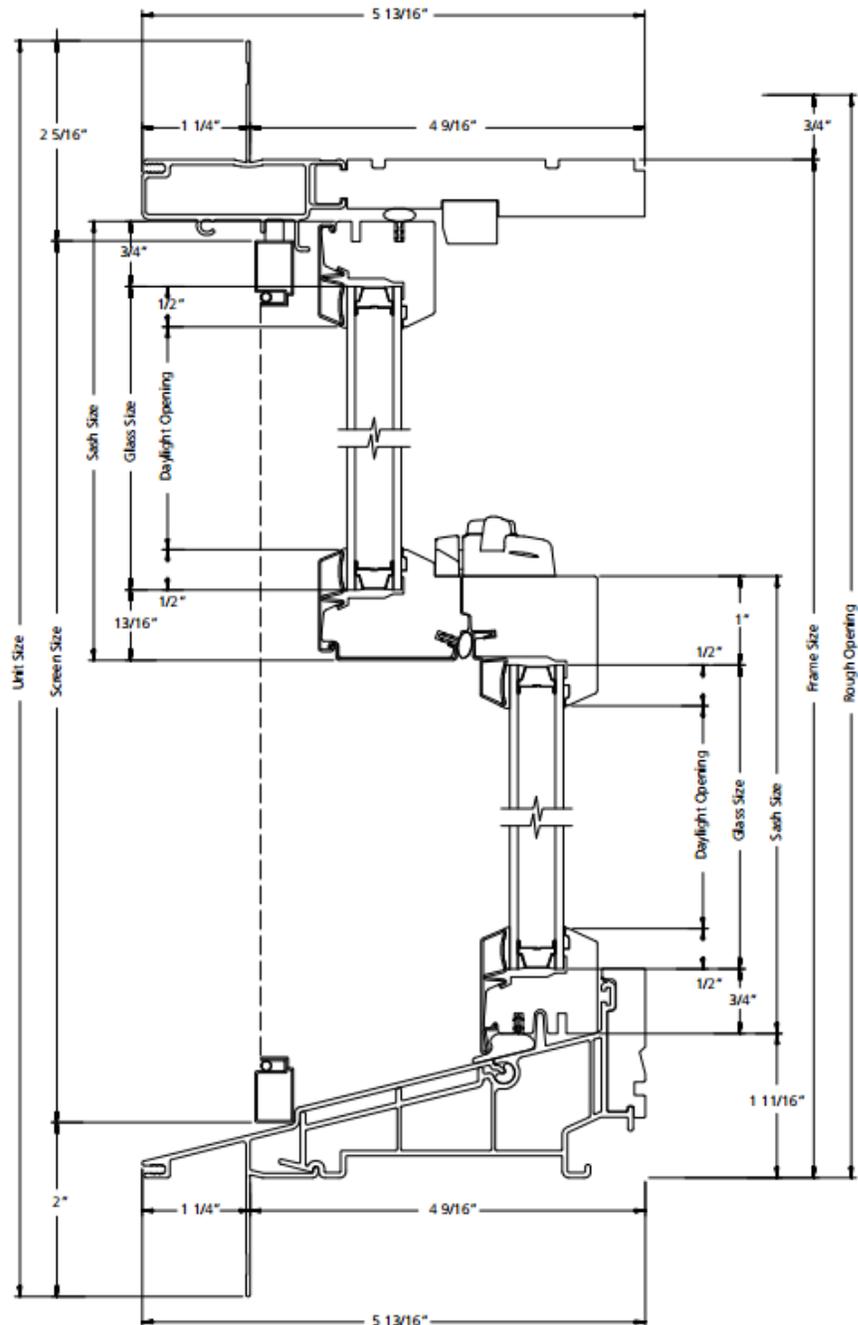
WINDOW DETAIL
(NEWLY INSTALLED WINDOWS)

JELD-WEN Double-Hung Windows
WINDOWS & DOORS W-2500

SINGLE UNITS

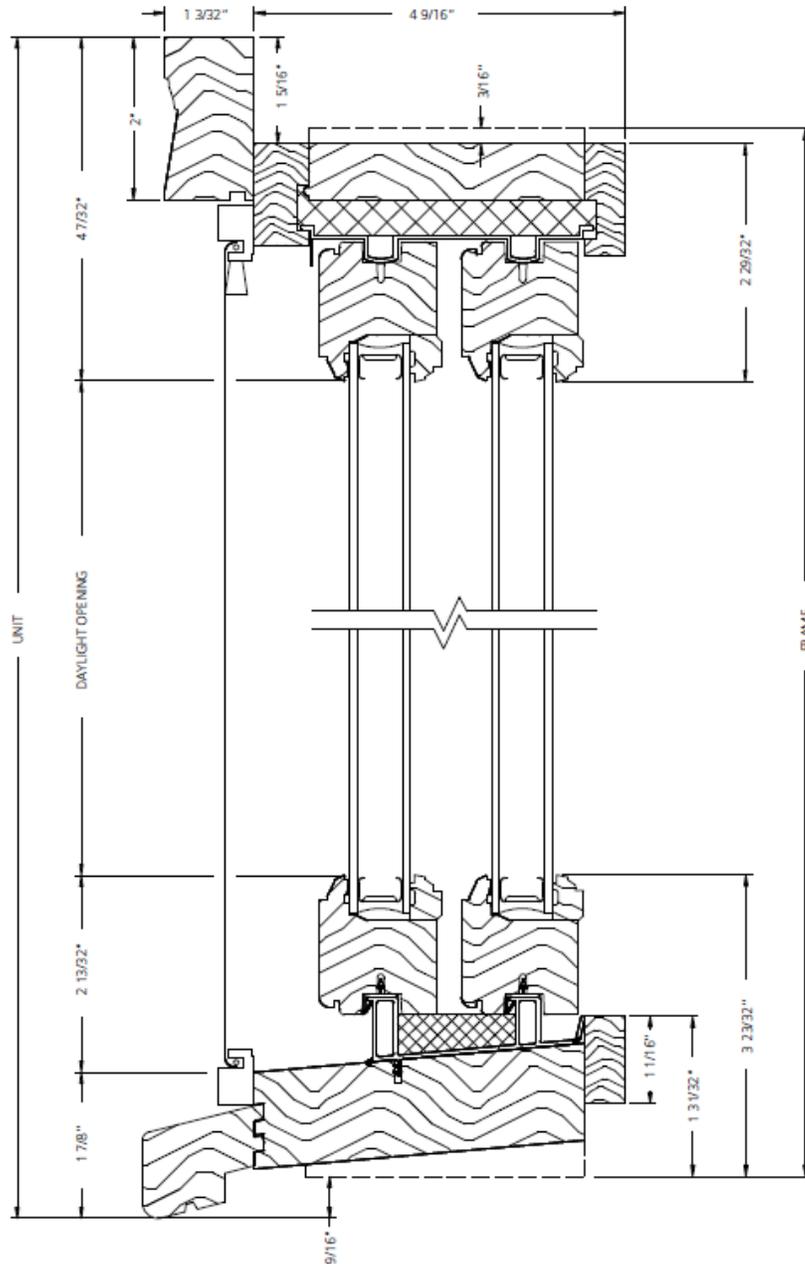
WINDOW DETAIL
(NEWLY INSTALLED WINDOWS)

Siteline Primed Sliding Windows
Premium Wood

SLIDING
