CERTIFICATE OF APPROPRIATENESS

Property: 625 Cortlandt Street, lot 6, tracts 5 & 7A, block 278, Houston Heights Subdivision. The property includes a historic 1,649 square foot, one-story wood frame single-family residence and a detached garage situated on a 10,560 square foot (80' x 132') interior lot.

Proposal: Alteration – Revision

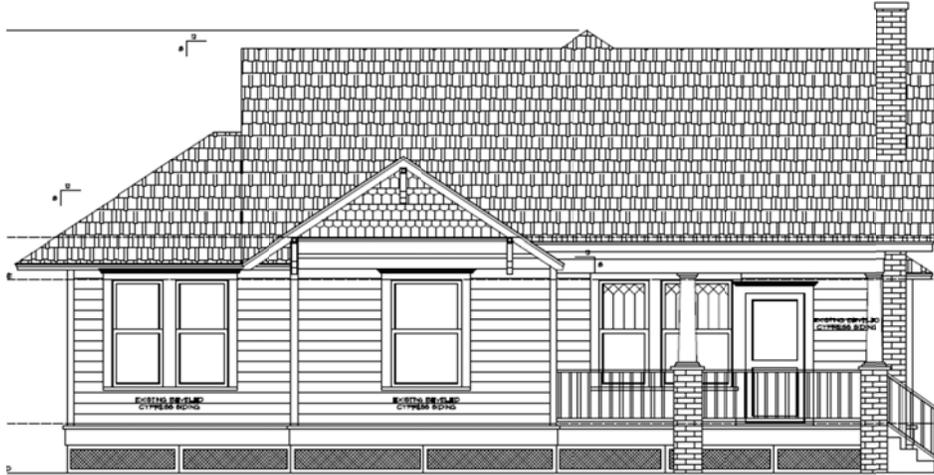
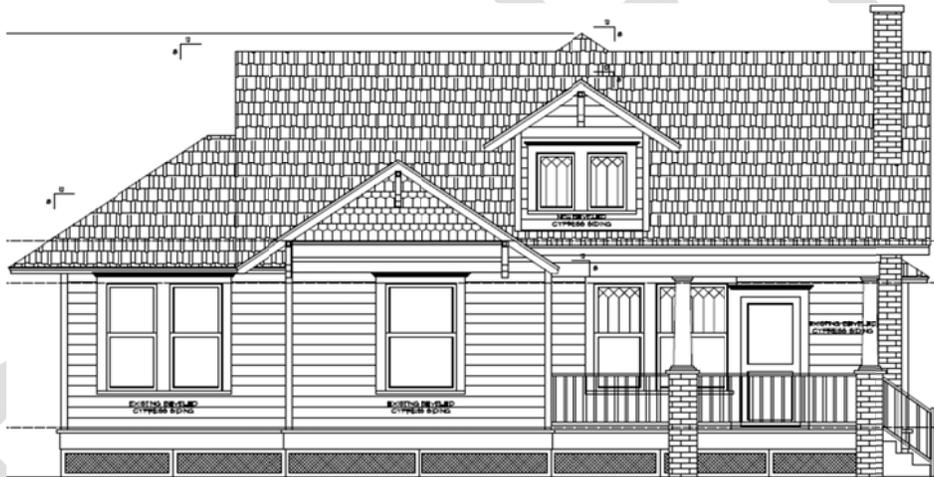
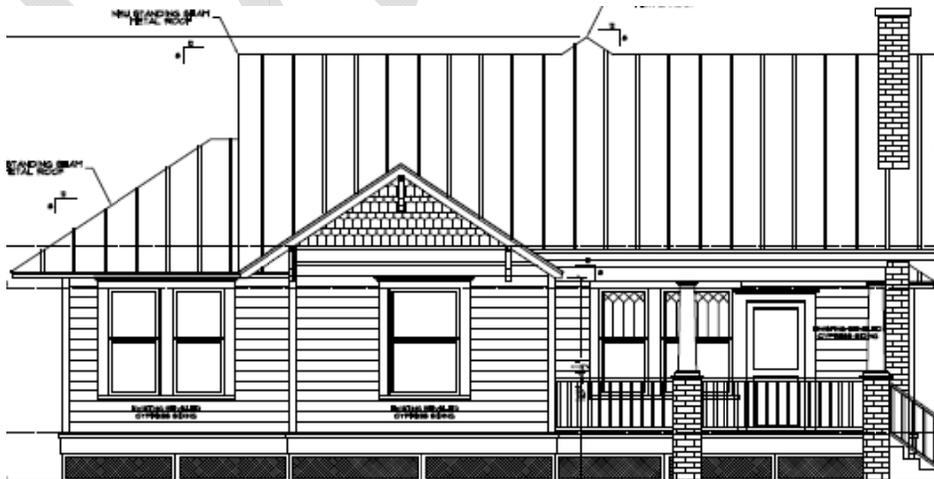
EAST ELEVATION – FRONT FACING CORTLANDT STREET

Front Elevation: The residence features five windows to remain and one front door to remain. No alterations will be visible.
(East)

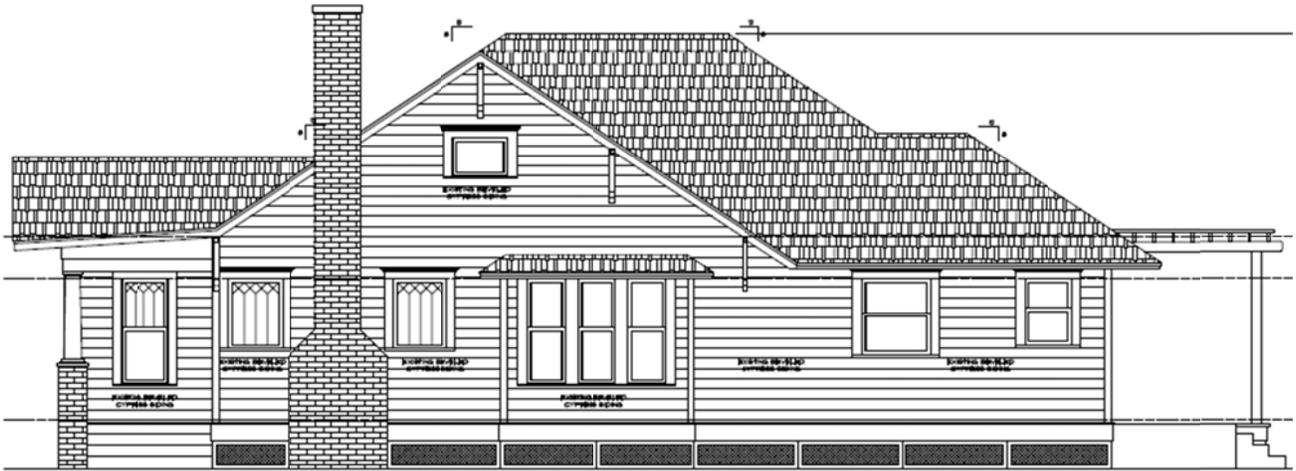
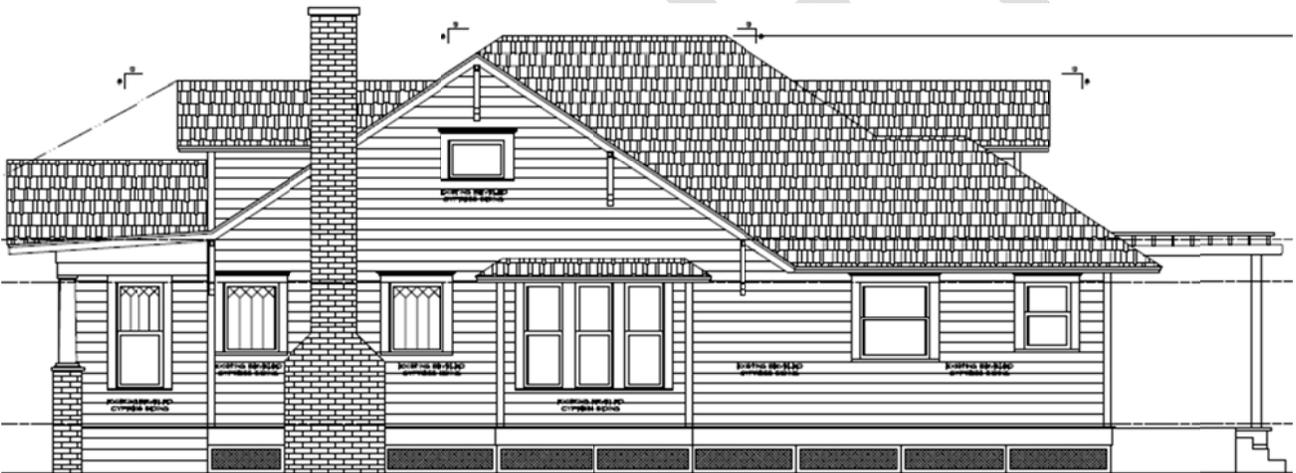
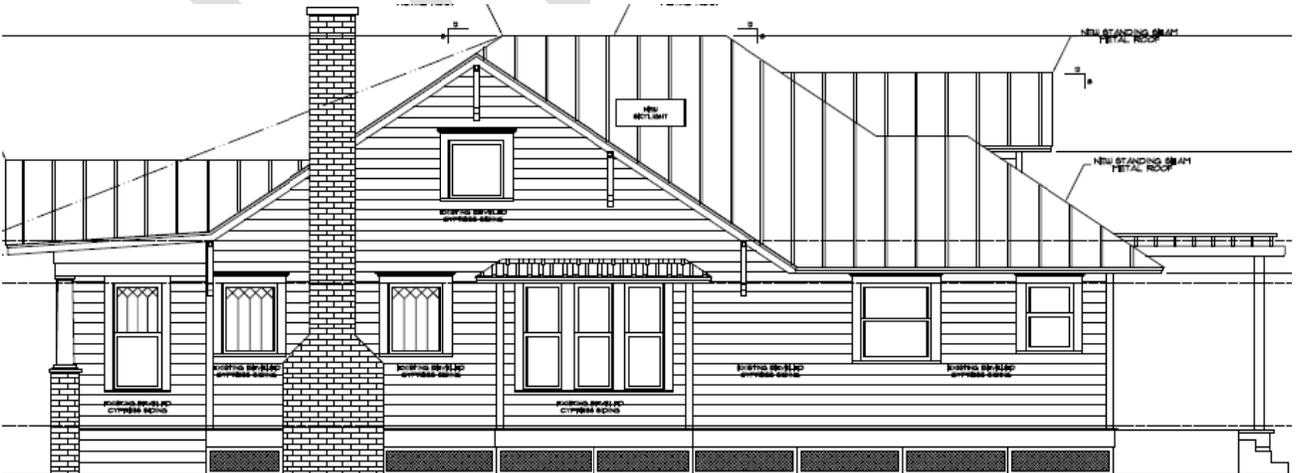
NORTH SIDE ELEVATION

Side Elevation: The residence features eight windows at the first floor and a chimney to remain. One window in the gable will be removed and replaced by a larger window.
(North)

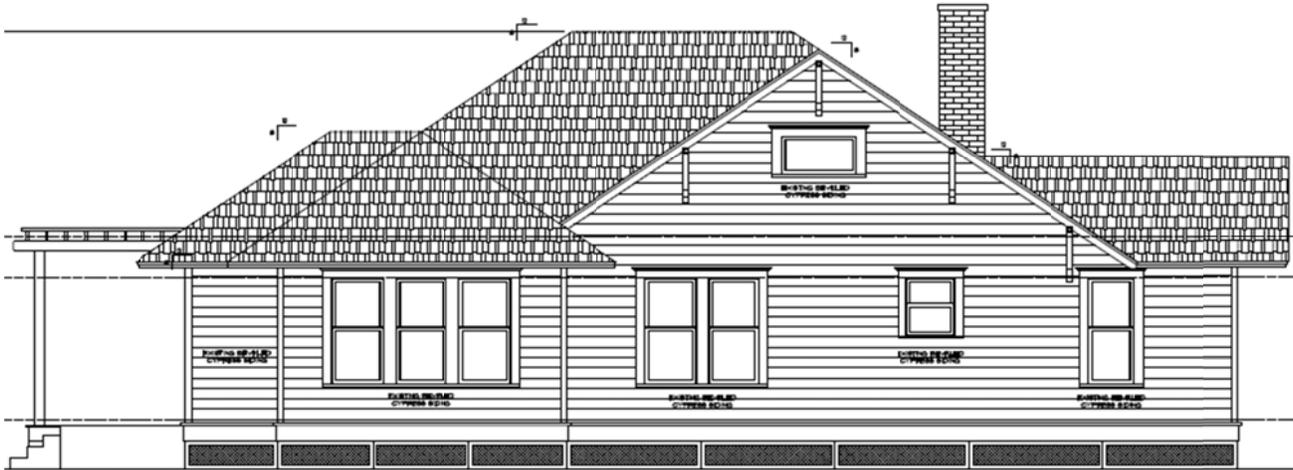
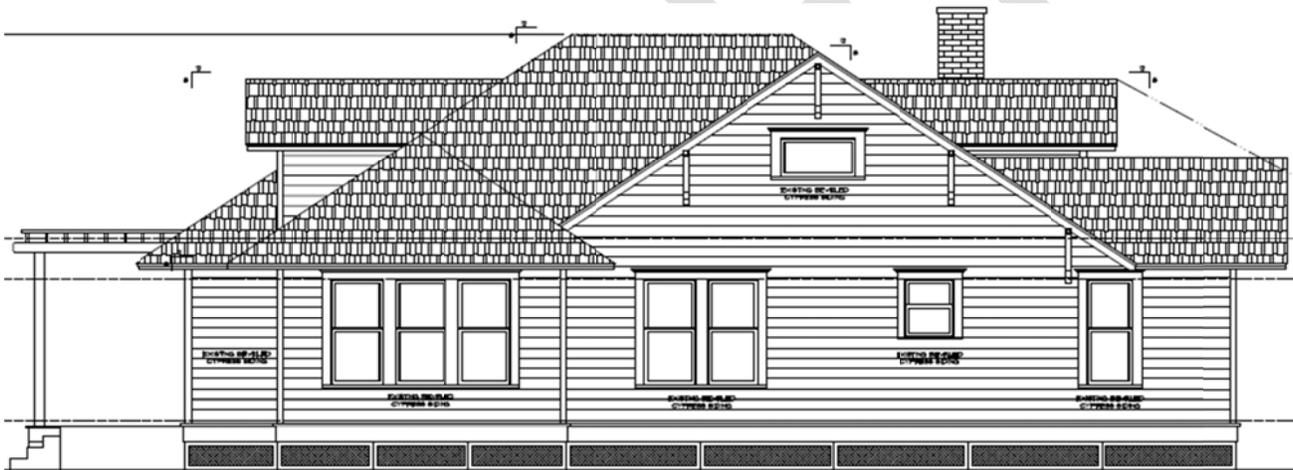
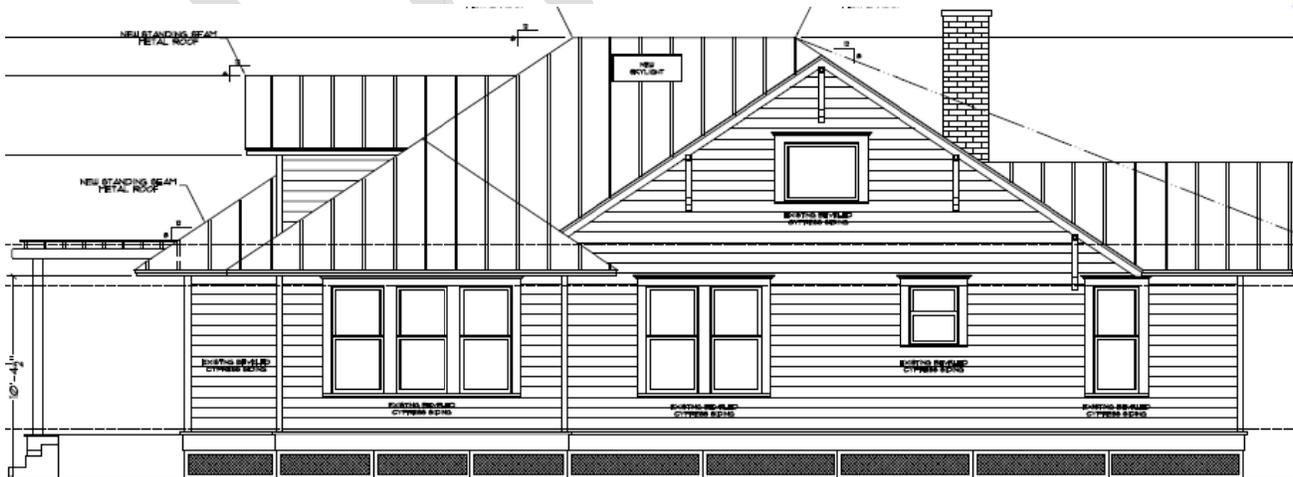
SOUTH SIDE ELEVATION

Side Elevation: The residence features seven windows on the first floor to remain. One window in the gable will be removed and replaced by a larger window.
(South)

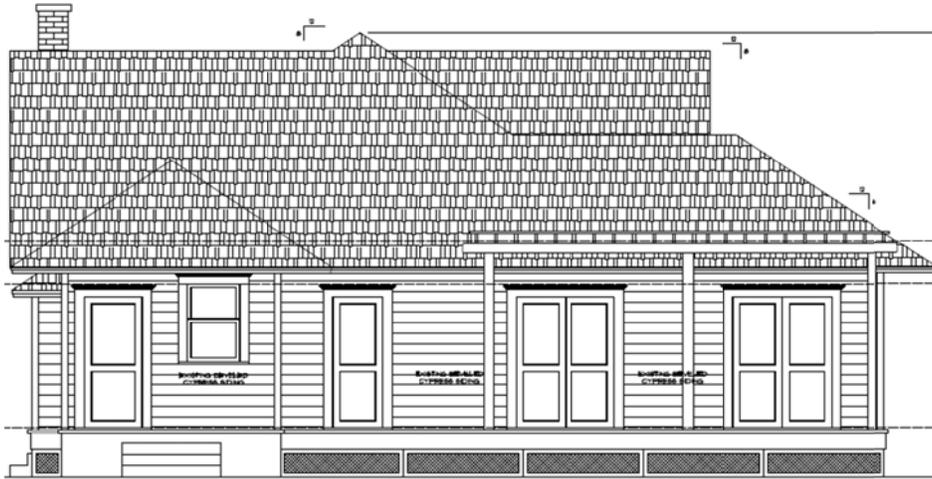
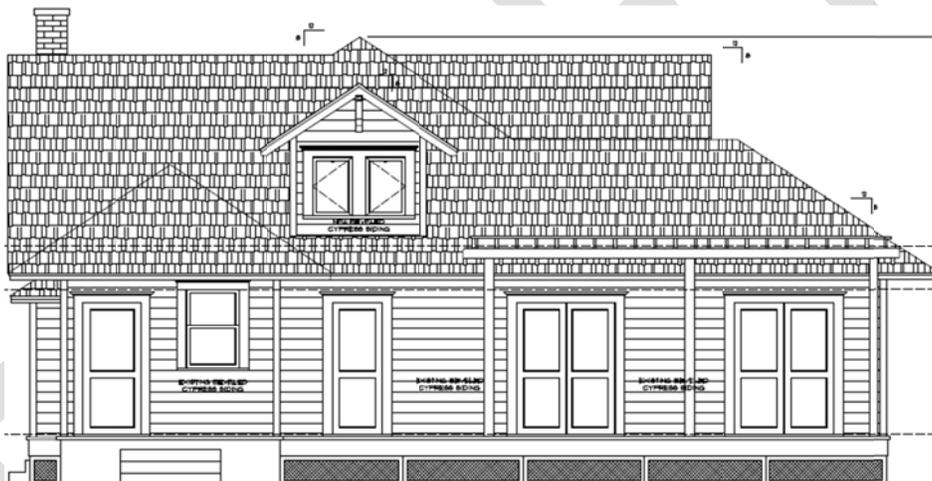
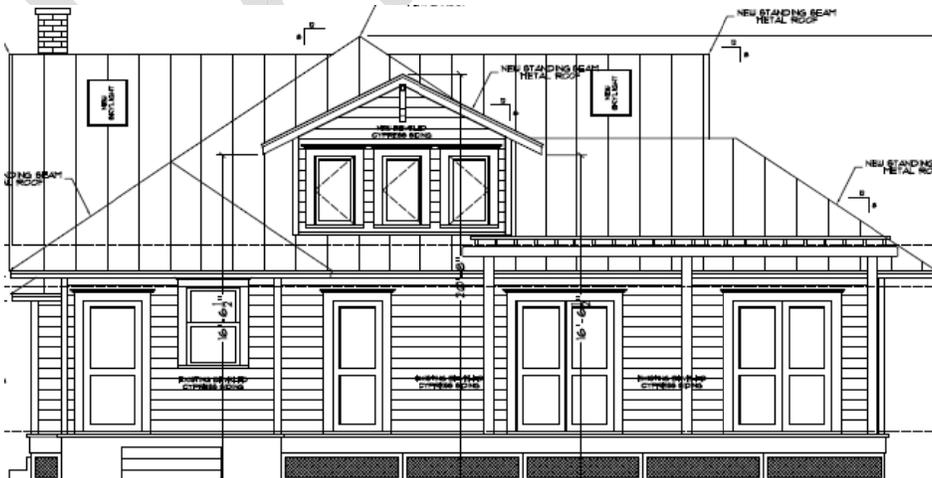
WEST (REAR) ELEVATION

- No front dormer is proposed
- The rear dormer will be increased in width from 6'-11" to 11'-1"
- Four skylights will be installed
- One window in the north side gable and one window in the south side gable will be removed and replaced with larger windows

Rear Elevation: Not visible from public right of way. See elevation drawings for details.
(West)

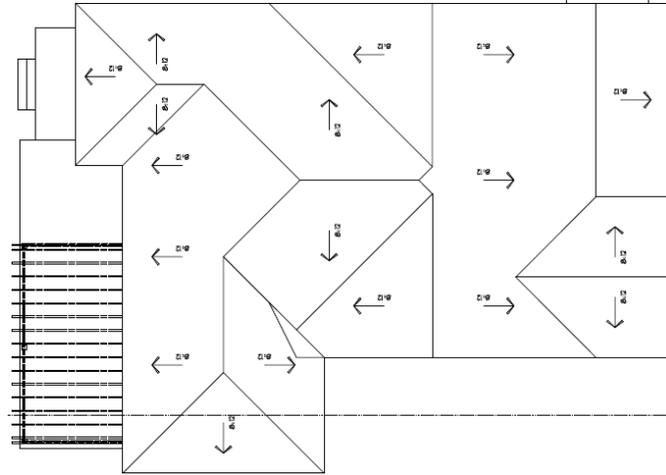
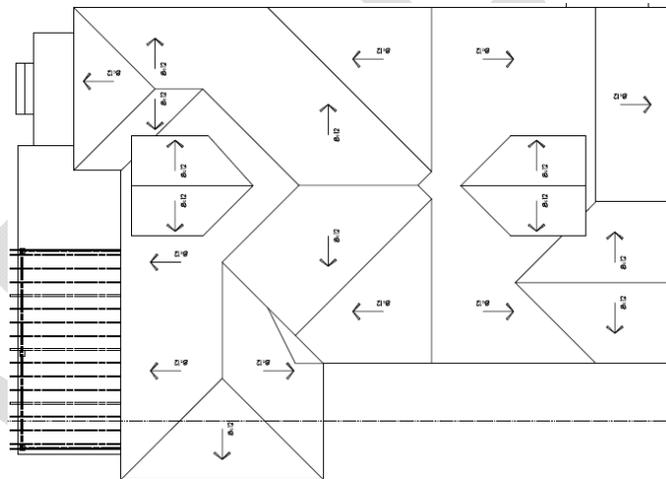
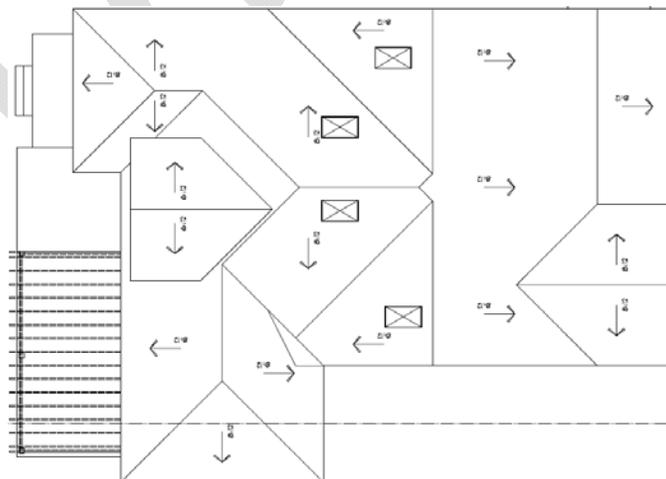
ROOF PLAN

Roof: The residence feature a side gable roof with a rear hip and a small gable projecting to the east, all with an 8/12 pitch clad in composition shingles. The composition shingles will be removed and replaced with standing seam metal and a rear dormer will be installed. Four skylights will be installed, two behind the main ridge facing west and two on the rear hip, one facing north and one facing south.

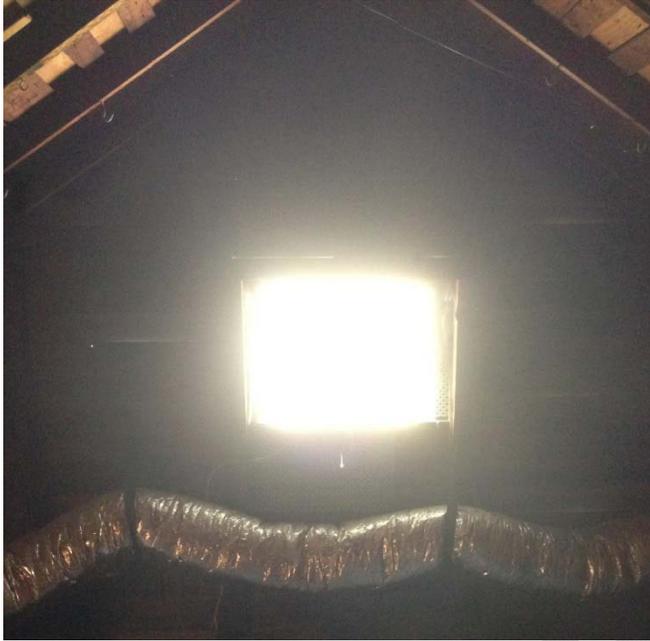
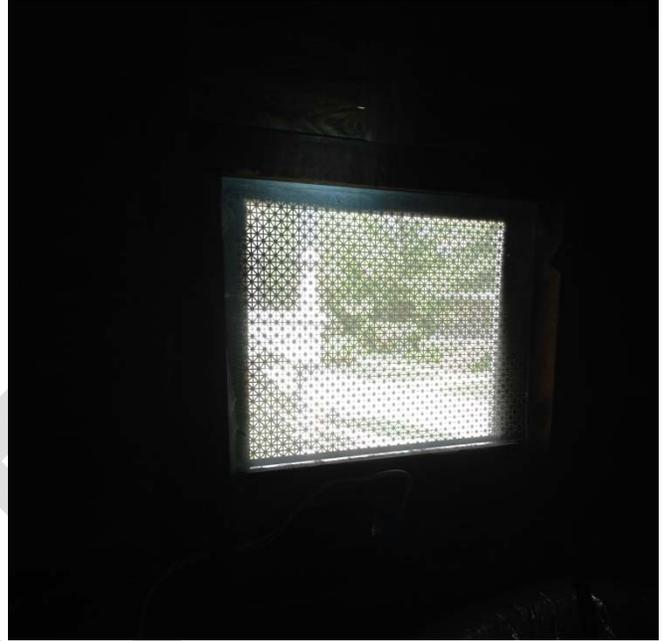
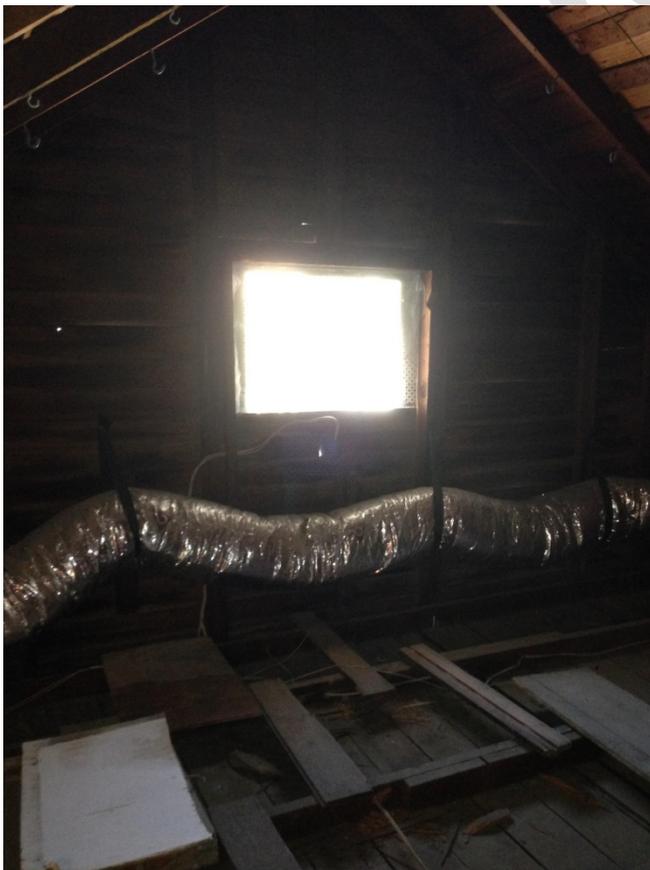
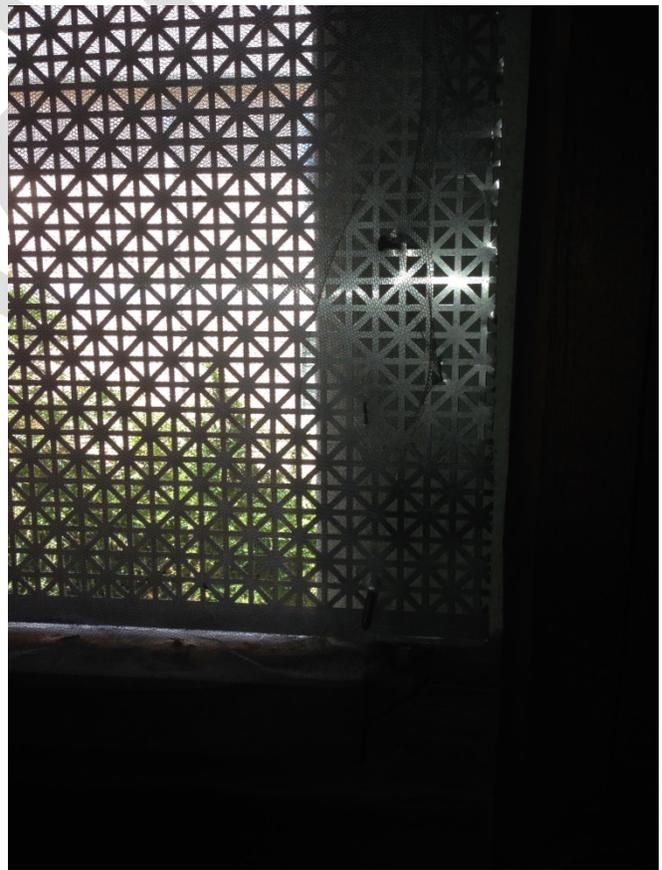
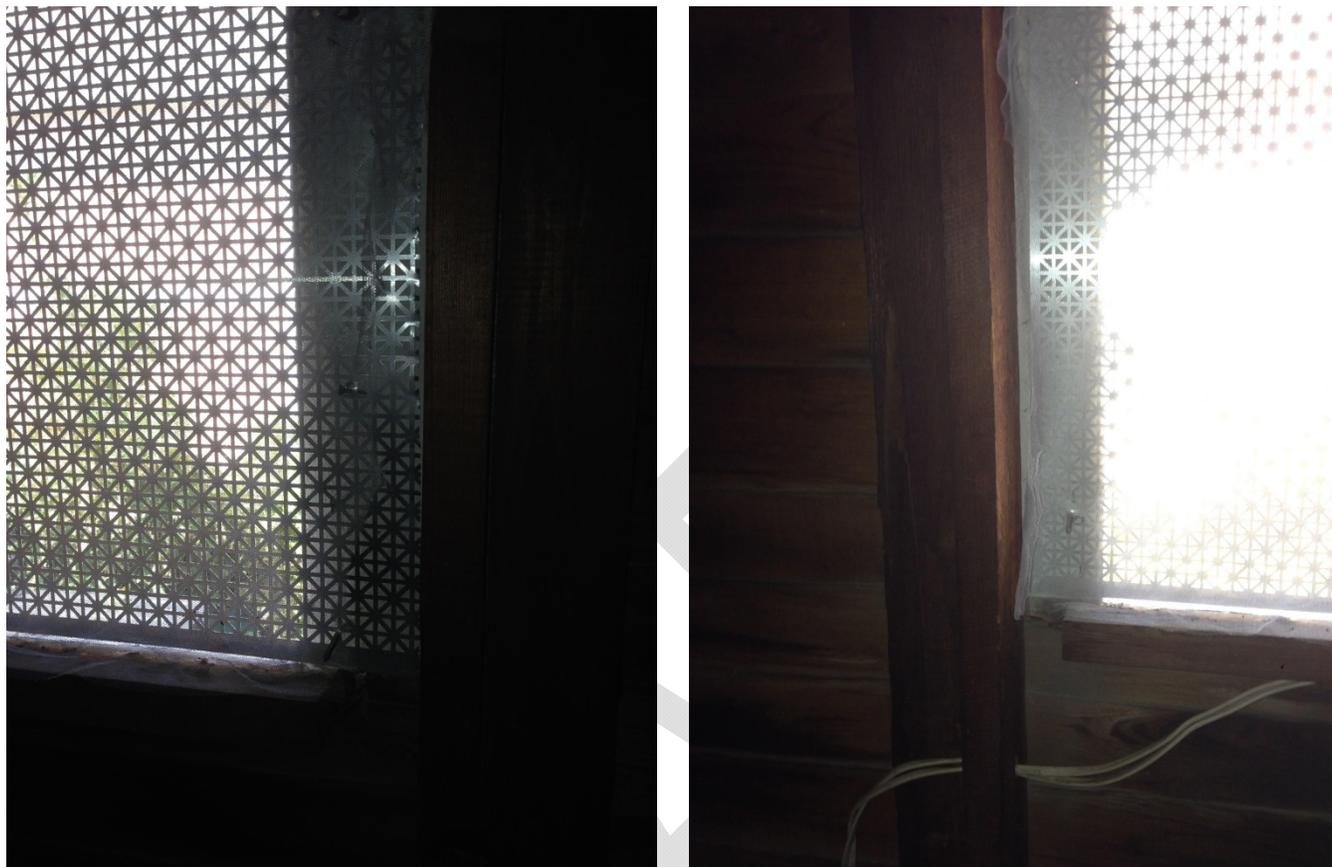
NORTH GABLE WINDOW DETAILS

Windows/Doors: The residence features double hung wood windows and a wood front door to remain. One non-original fixed wood window on the north gable (currently missing glass) will be removed and replaced by a larger window measuring 2'-6" wide by 3' tall within a 35" wide original opening. One fixed wood window on the south gable will be removed and replaced by a larger window measuring 3'-6" wide by 3' tall within a 38" wide original opening. Existing trim on both windows is cementitious and will be replaced in kind. Four skylights measuring 24" wide by 36" tall will be installed.
