CERTIFICATE OF APPROPRIATENESS

Property: 8607 Dover Street, Lot 2, Block 42, Glenbrook Valley Section 7 Subdivision. The property includes a historic 1,330 square foot, one-story wood frame single-family residence and attached garage situated on a 7,150 square foot (65' x 110') interior lot.

Proposal: Alteration – Windows.

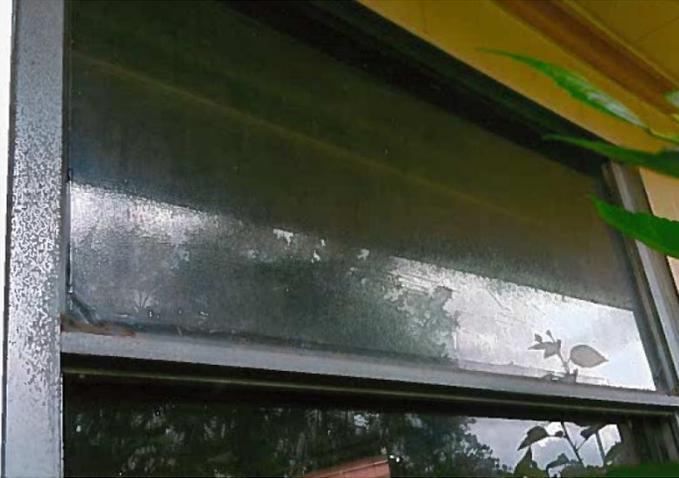
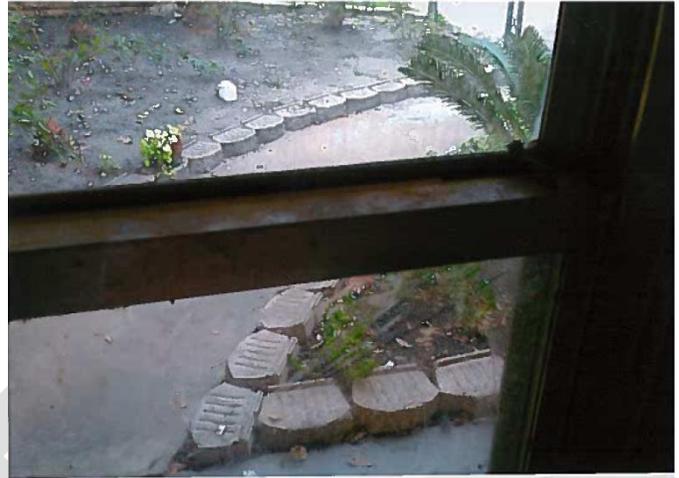
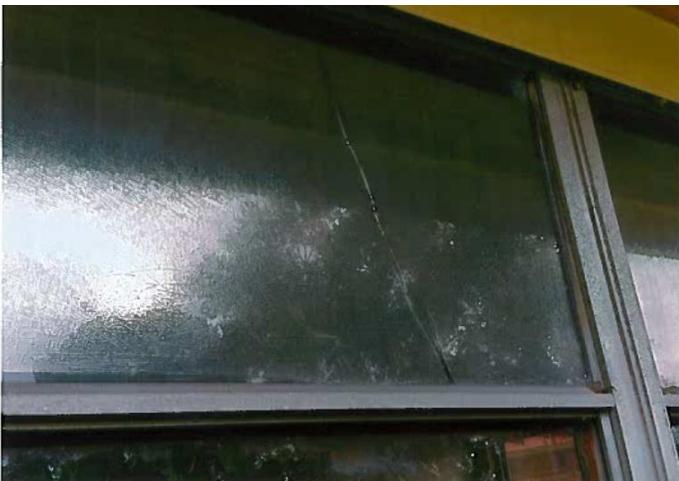
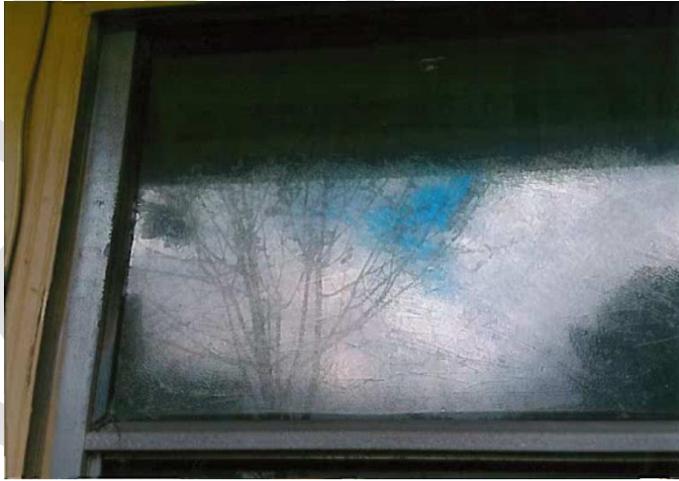
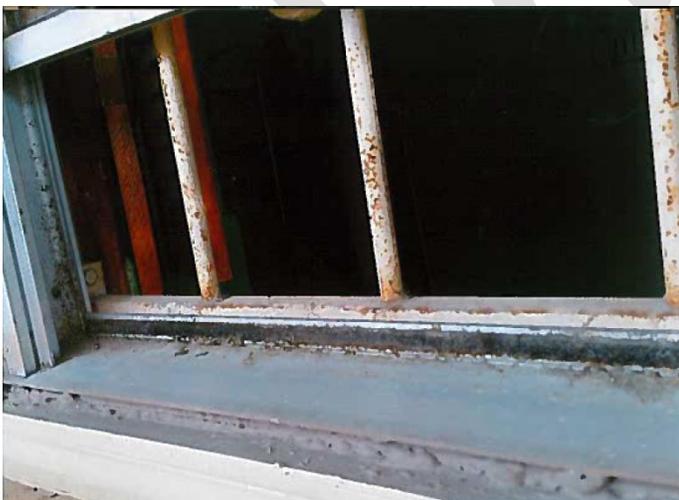
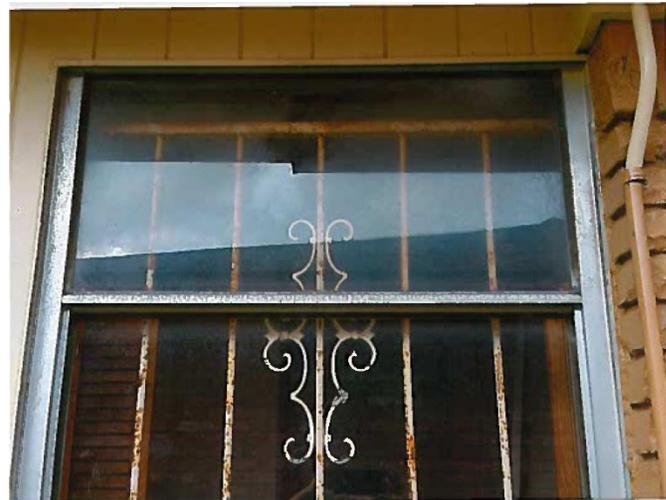
ORIGINAL HISTORIC WINDOWS

<i>The proposed windows seek to introduce a new 1-over-1 lite pattern instead of the wide, 2-over-2 horizontal panes that are a distinguishing characteristic of the structure.</i> |

<i>The proposed new windows do not replicate the historic lite pattern featured on the structure. Original materials should be maintained unless they are damaged beyond reasonable repair. Because the windows were removed without permission, staff was unable to evaluate their condition prior to removal.</i> |

In addition to any other remedies that HAHC sees fit to require, staff recommends the applicants find and install windows that mimic the lite patterns of the historic windows.

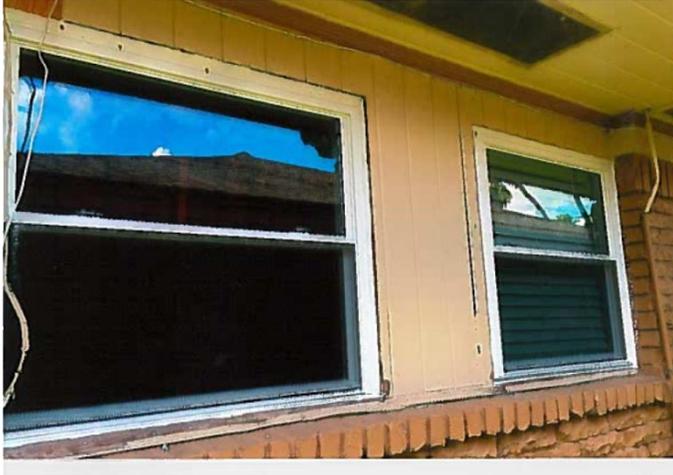
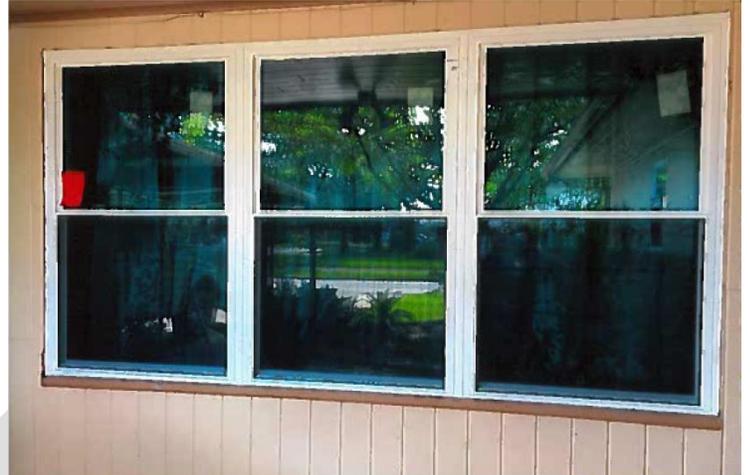
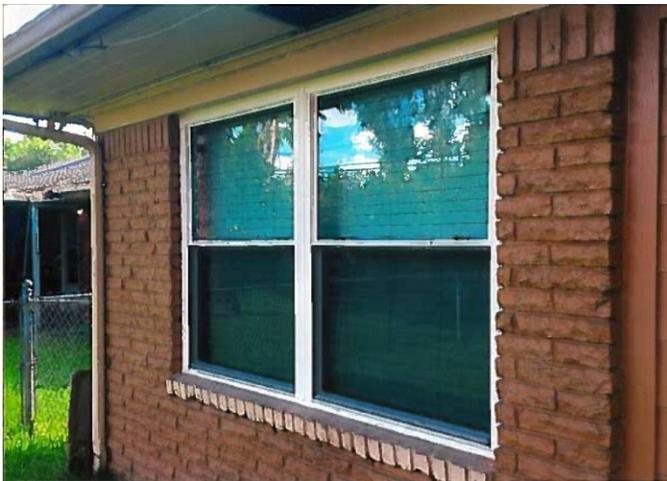
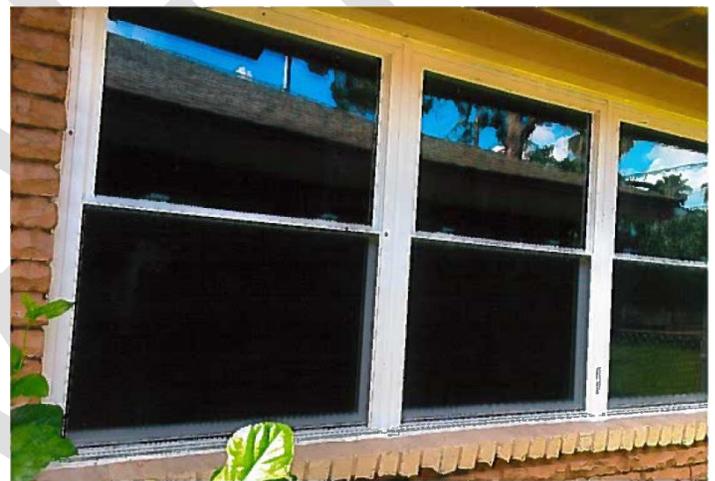
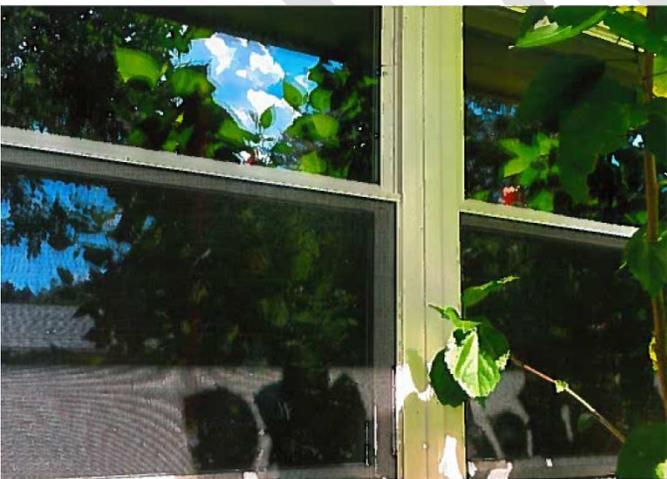
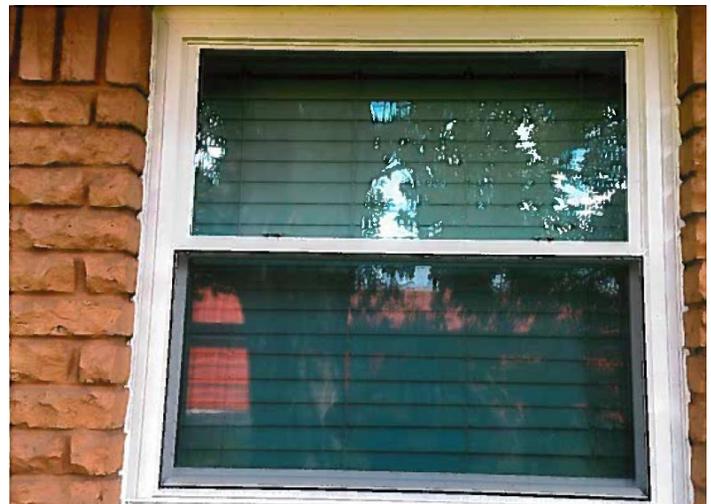
NEW WINDOWS INSTALLED WITHOUT PERMIT OR COA

The applicant has removed all 15 aluminum historic 1-over-1 and 2-over-2 windows on the house without a COA or permit and has installed new vinyl 1-over-1 windows. The applicant had previously met with staff to learn about the COA process to replace the windows but never submitted an application.

<i>Some of the proposed windows seek to create a later appearance by introducing a different lite pattern than the original, 1-over-1 instead of 2-over-2.</i> |

<i>The proposed new windows are not visually compatible due to the change in lite pattern.</i> |
