CERTIFICATE OF APPROPRIATENESS

Property: 7706 Glenheath Street, tracts 24A & 25, block 36, Glenbrook Valley Section 7 R/P Subdivision. The property includes a historic 1,943 square foot, one-story wood frame single-family residence situated on a 8,250 square foot interior lot.

Significance: Contributing traditional ranch residence, constructed circa 1960, located in the Glenbrook Valley Historic District.

Proposal: Alteration – Replace original aluminum windows with internally divided 6/6 vinyl windows:

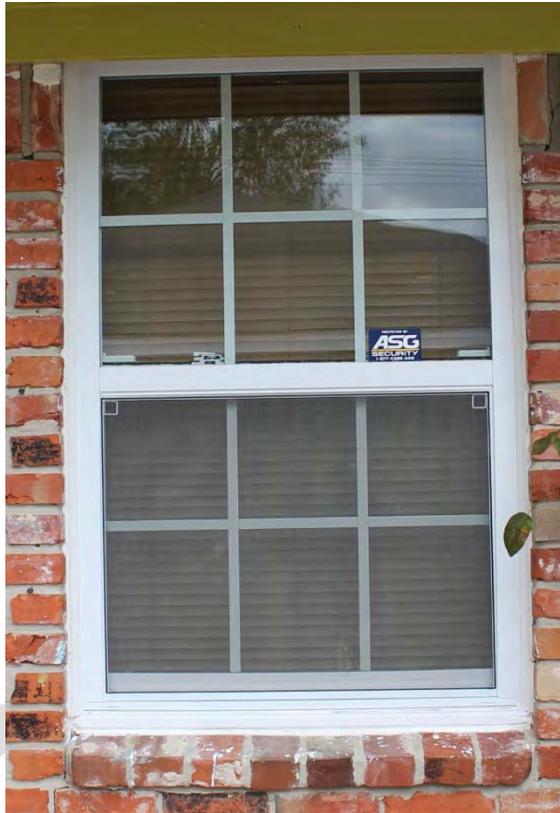
WINDOW A
CURRENT PHOTO

- (North)**
- Side Elevation:** Residence features one aluminum 1/1 window and one entrance door. Aluminum window is proposed to be removed and replaced with vinyl window with 6/6 lite pattern.

<i>This residence is partially defined by multi-lite windows on the front façade and 1/1 windows on the sides. Use of windows with a 6/6 lite pattern on the sides is inappropriate. One 1/1 window has already been replaced with a 6/6 pattern on the west wall and cannot be reinstalled.</i> |

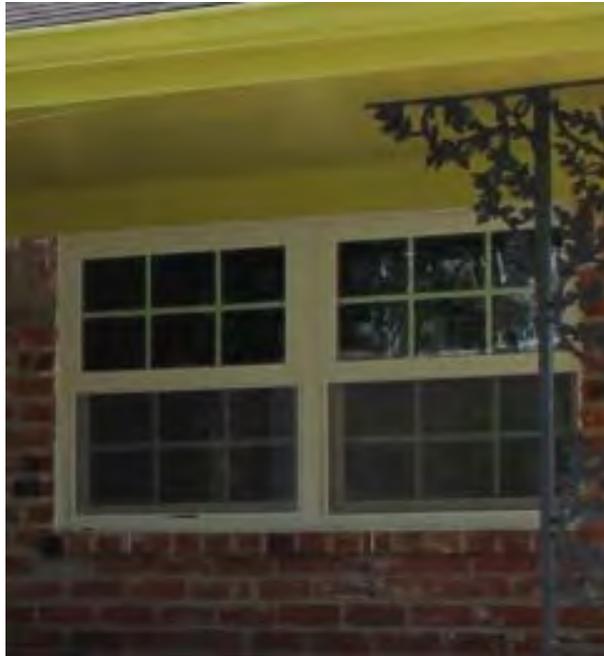
WINDOW B
CURRENT PHOTO

- Front Elevation:** Residence features one wood front door to remain, one set of three aluminum windows with a 6/6 lite pattern, and one set of three and one set of two aluminum windows with a 3/3 lite pattern. All windows will be replaced with vinyl windows with a 6/6 lite pattern.

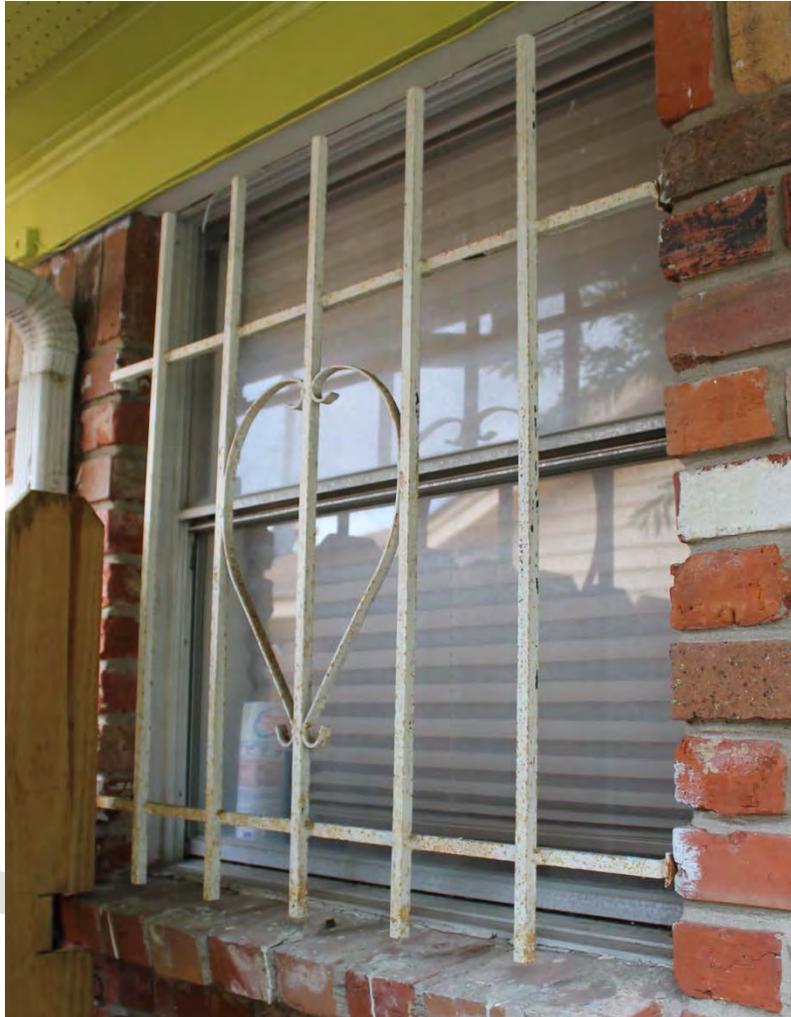
WINDOW E
CURRENT PHOTO

<i>Aluminum windows are a distinctive feature of traditional ranch and other midcentury residences, and removal of all of them constitutes destruction of significant historic material. Those that have already been removed cannot be re-installed, and the windows installed on the front façade are similar in lite pattern and appropriate to the house. The remaining 1/1 windows do not exhibit any evidence of damage and should be retained.</i> |

- (West)**
- Side Elevation:** Residence features two sets of three aluminum 1/1 windows and two separate individual aluminum 1/1 windows, all of which are proposed to be replaced with vinyl 6/6 windows.

Recommendation: Partial Approval: Approval of windows A, B, C & D. Denial of windows E, F, G & H.
