CERTIFICATE OF APPROPRIATENESS

Property: Lot 6, Block 289, Houston Heights Subdivision, City of Houston, Harris County, Texas. The site includes a 1,370 square foot contributing residence situated on a 6,600 square foot (50 x 132) lot.

Significance: Contributing Bungalow style residence, constructed circa 1920, located in the Houston Heights Historic District South. The owner was granted a Certificate of Appropriateness to construct a two story rear addition, which is currently under construction.

Proposal: Alteration – Addition – *Revision* The applicant was granted a COA on December 12, 2013 to construct a two story addition.

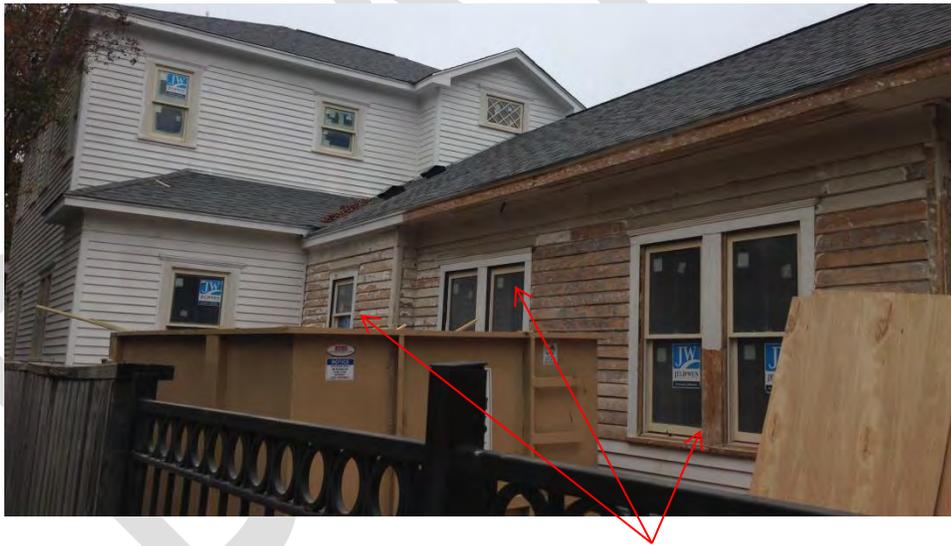
CURRENTLY EXISTING

New windows

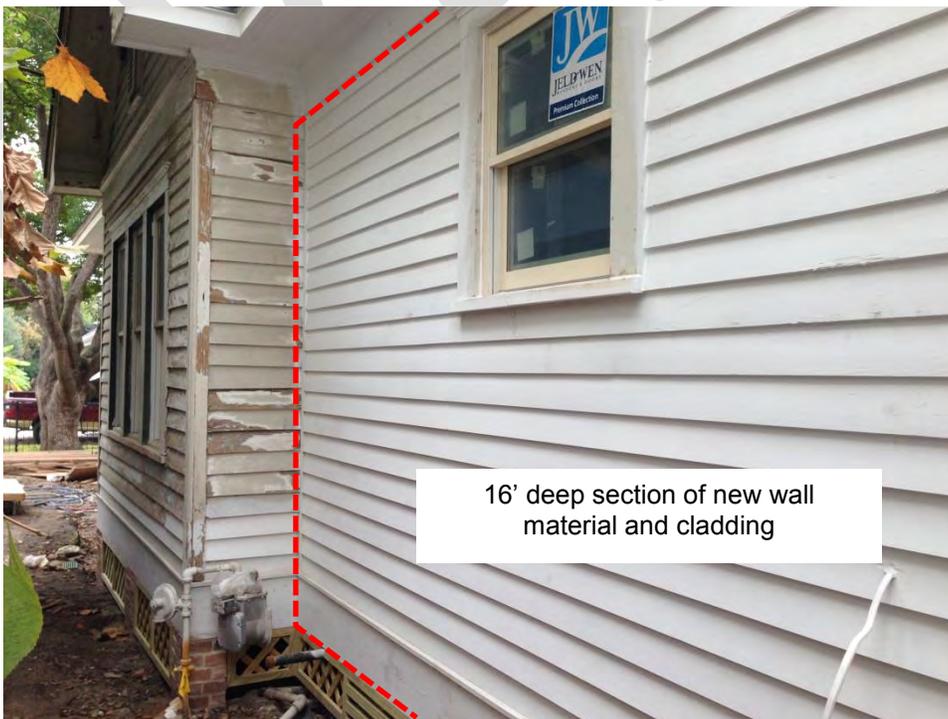
CURRENTLY EXISTING (VIEWING TOWARDS THE STREET)

- Proposed hipped roof above the existing structure's south facing bump out was not built as proposed. Instead, the applicant incorporated the bump out within the existing roof structure.
- A 16' deep section of exterior wall material and cladding were removed and replaced with new matching material.

Staff brought these additional changes to the attention of the applicant and requested they submit a revised demolition plan. The applicant asserts that removing the wall was necessitated by the need to add additional support for the revised window location of a north facing kitchen and the placement of second story living space on top of the historic wall and framing.

16' deep section of new wall material and cladding

<i>Replacing a section of the historic exterior wall impairs the essential form and integrity of the property.</i> | | |

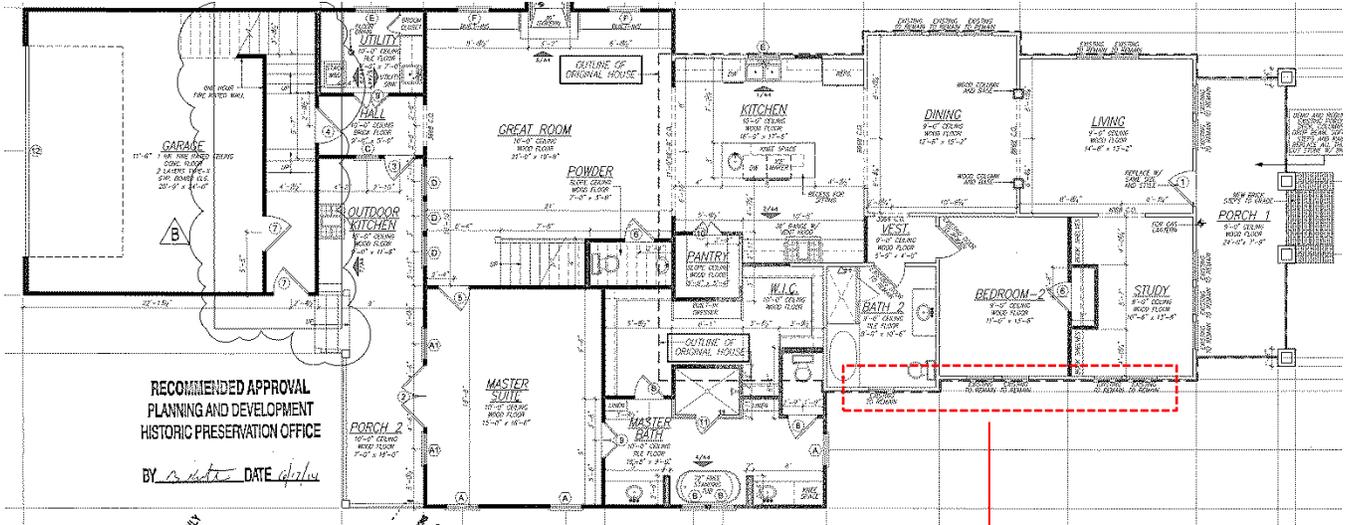
FIRST FLOOR PLAN

APPROVED 12/12/13 AND STAMPED 6/17/14

Existing to Remain notes by each window

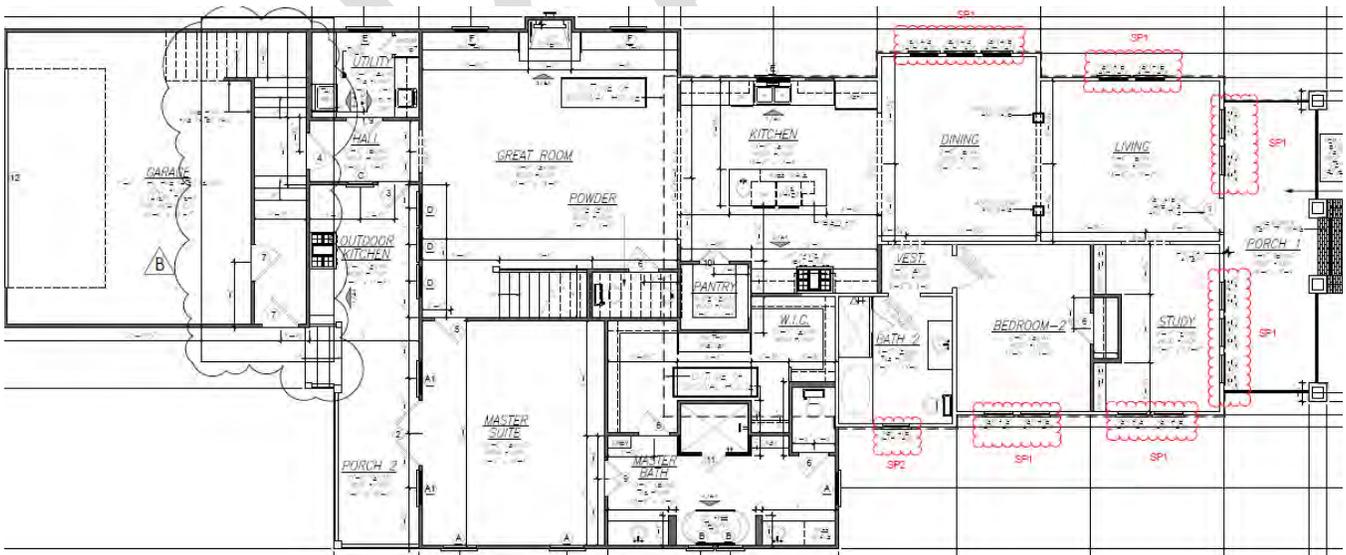
PROPOSED

Windows/Doors: Proposed Revision: Remove 15 original windows and replace with matching wood 1 over 1 interior mounted sash pack windows. These window sashes retain the existing window frames.

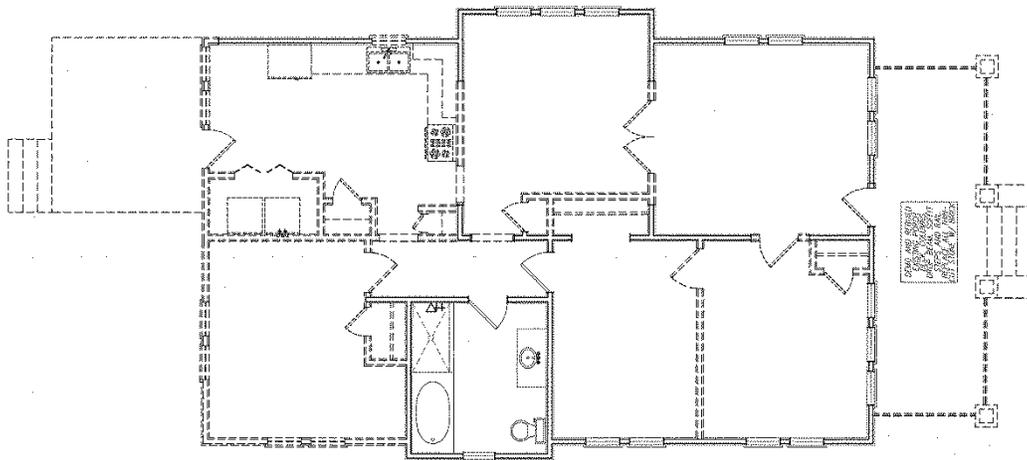
DEMOLITION PLAN

APPROVED 12/12/13 AND STAMPED 4/3/14

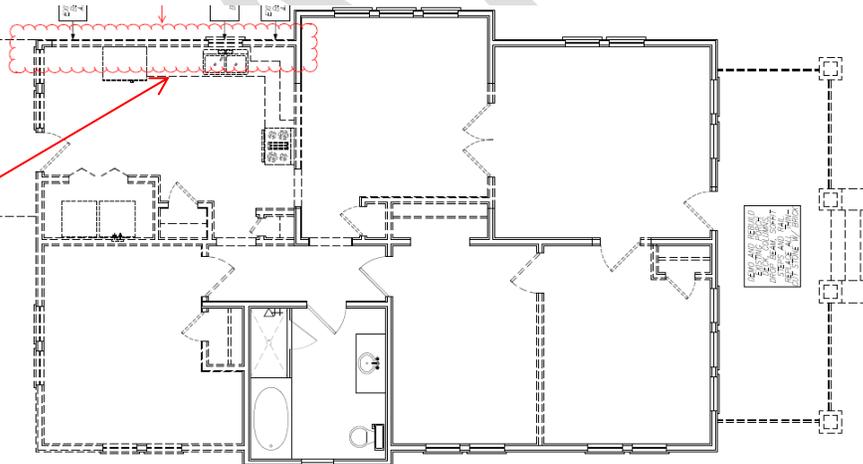
PROPOSED

Existing wall at kitchen had to be re-framed due to the kitchen window being relocated 2' towards the back of the home. Additional support for window and second floor framing were needed for structural integrity.

Shape/Mass: Remove the rear 16' of the original house's north side exterior wall. The new wall features new wood siding at a 4" profile matching the existing original siding.

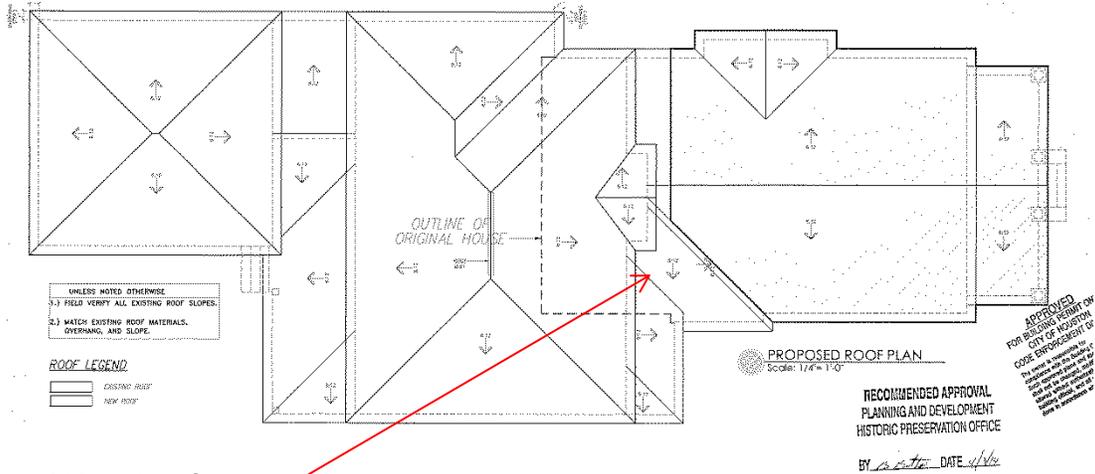
ROOF PLAN

APPROVED 12/12/13 AND STAMPED 4/3/14

Approved hipped roof over south facing bump out

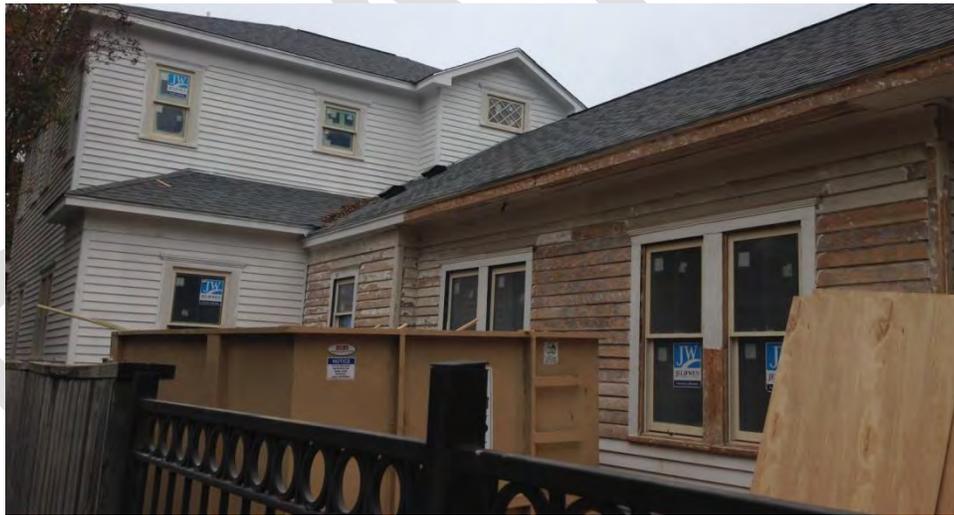
CURRENTLY EXISTING

Roof: The existing south facing bump out originally featured a side facing gable. The applicant was approved to remove this gable and replace it with a hipped roof. The applicant now proposes to eliminate the hipped roof over the bump out and instead extend the existing front open gable roof structure to the rear to cover the bump out.

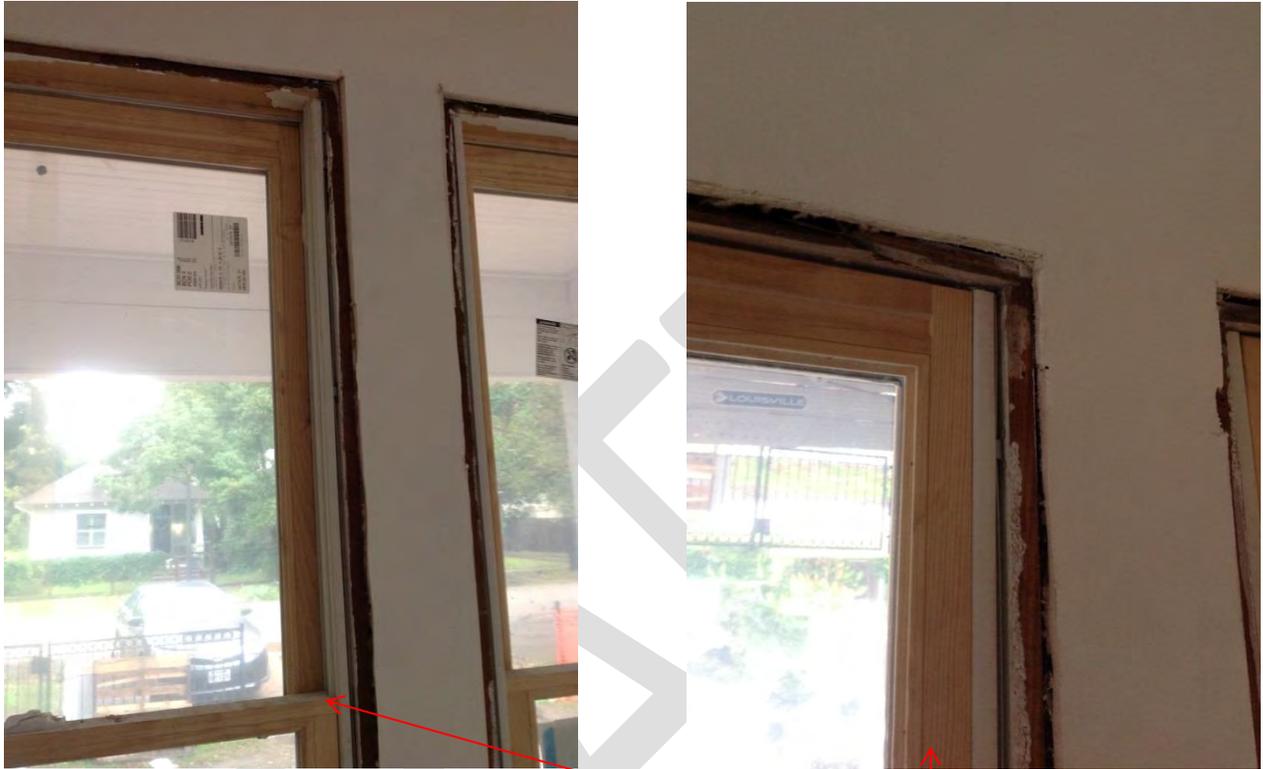
PHOTOS OF WINDOW FRAMES

New window sashes installed within the existing window frames

<i>Historic wood sash windows are a character defining feature of historic properties within Houston Heights Historic District South. Replacing them with new windows represents a failure to preserve the historic character of the property.</i> | | |

<i>Wood sash windows are a distinguishing quality of turn of the century bungalows. Replacing all of them represents a failure to preserve this structure's distinguishing qualities.</i> | | |

<i>Wood sash windows are a product of skilled craftsmanship that characterizes the Contributing Structures within Houston Heights Historic District South. Replacing all of them represents a failure to maintain examples of skilled craftsmanship.</i> | | |
