CERTIFICATE OF APPROPRIATENESS

Property: 8734 Glenloch Drive, Lot 4, Block 52, Glenbrook Valley Section 9 Subdivision. The property includes a historic 2,282 square foot, one-story brick veneer single-family residence with attached garage situated on a 9,040 square foot (80' x 113') corner lot.

Significance: Contributing Traditional Ranch residence, constructed circa 1959, located in the Glenbrook Valley Historic District.

Proposal: Alteration – In July 2014 the applicant replaced 14 original aluminum single lite fixed windows, 2-part and 3-part single lite slider windows with 11, 9-lite slider, 6-over-6 sash windows, and a 3-part bay window, replaced the front entry door with a 9-lite front entry door, installed inoperable shutters, and replace the sectional overhead garage door with a new garage door without a City Permit or Certificate of Appropriateness.

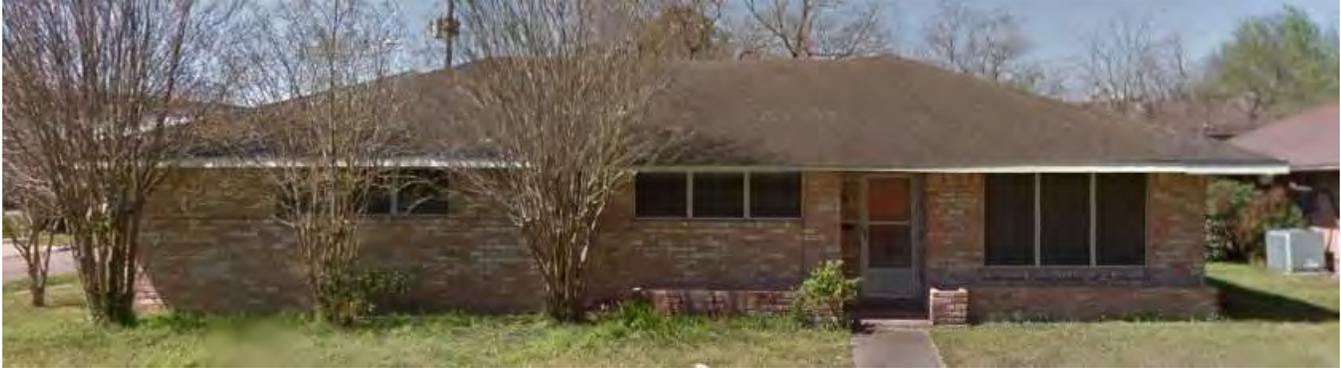
EAST ELEVATION – FRONT FACING GLENLOCH DRIVE

<i>The removal of the original aluminum windows, entry door results in the loss of historic material. The loss of original windows along with the installation of the bay window alters the historic character of the Traditional Ranch.</i> |

Front Elevation: Three single lite fixed windows were replaced with a 3-part bay window consisting of two 9-over-9 sash windows and a 9-lite picture window. The solid entry door was replaced with a 9-lite entry door. Two, 3-part windows were replaced with two 3-part 9-lite slider windows; a fixed window was replaced with a 6-over-6 sash window.

Replace the existing 9-lite slider and sash windows with single- lite slider windows and 1-over-1 sash windows, remove the bay window and install 3, single lite windows to match the original condition and remove the inoperable shutters.

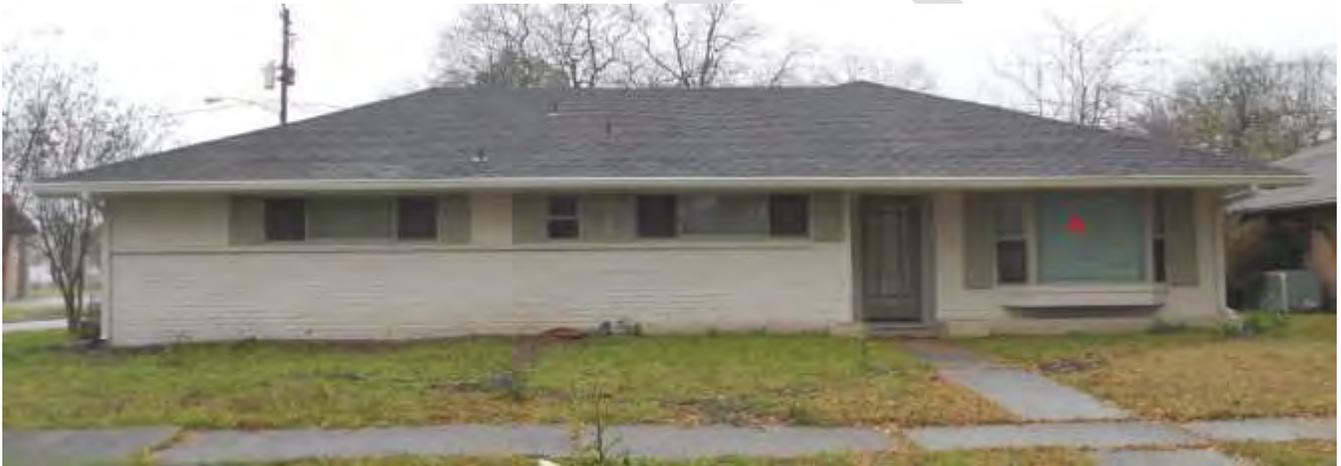
EXISTING

<i>The installation divided lite craftsman style windows, shutters and bay windows introduce new architectural features that are not compatible with and alter the character of the 1959 Traditional ranch.</i> |

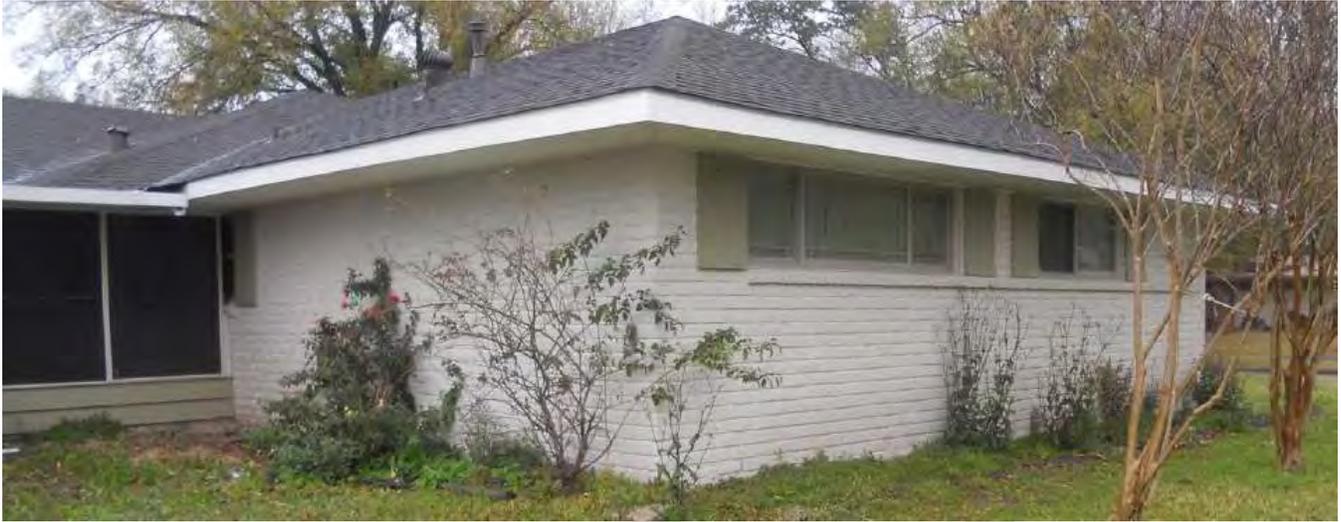
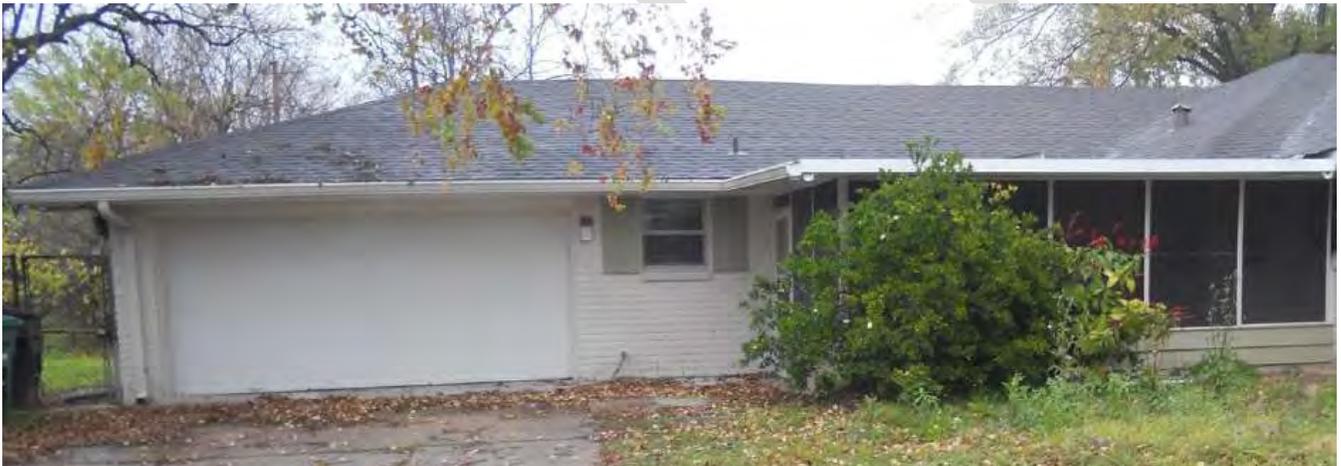
EXISTING

<i>The replacement of the single lite aluminum windows with divide lite sash and slider windows and the replacement of the solid entry door with a 9-lite entry door do not replicate the original simple single lite windows and entry door.</i> |

Side Elevation: A 2-lite slider window was replaced with a 2-part 9-lite slider window; replace a 3-part slider window with a 3-part 9-lite slider window. Replace two fixed windows with two 6-over-6 sash windows. The sectional overhead garage door was replaced with a new metal sectional overhead garage door,

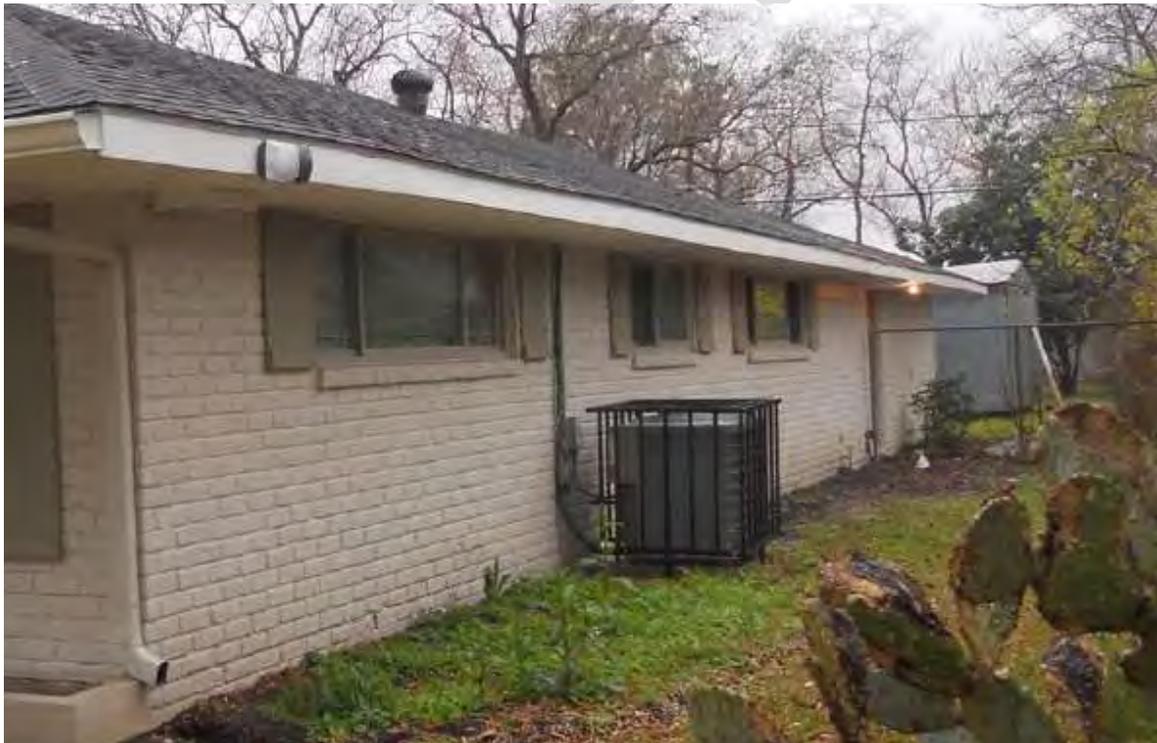
EXISTING

Side Elevation: Two 3-part slider windows were replaced with two 3-part 9-lite slider windows; a 2-lite slider window was replaced with a 2-part 9-lite slider window.

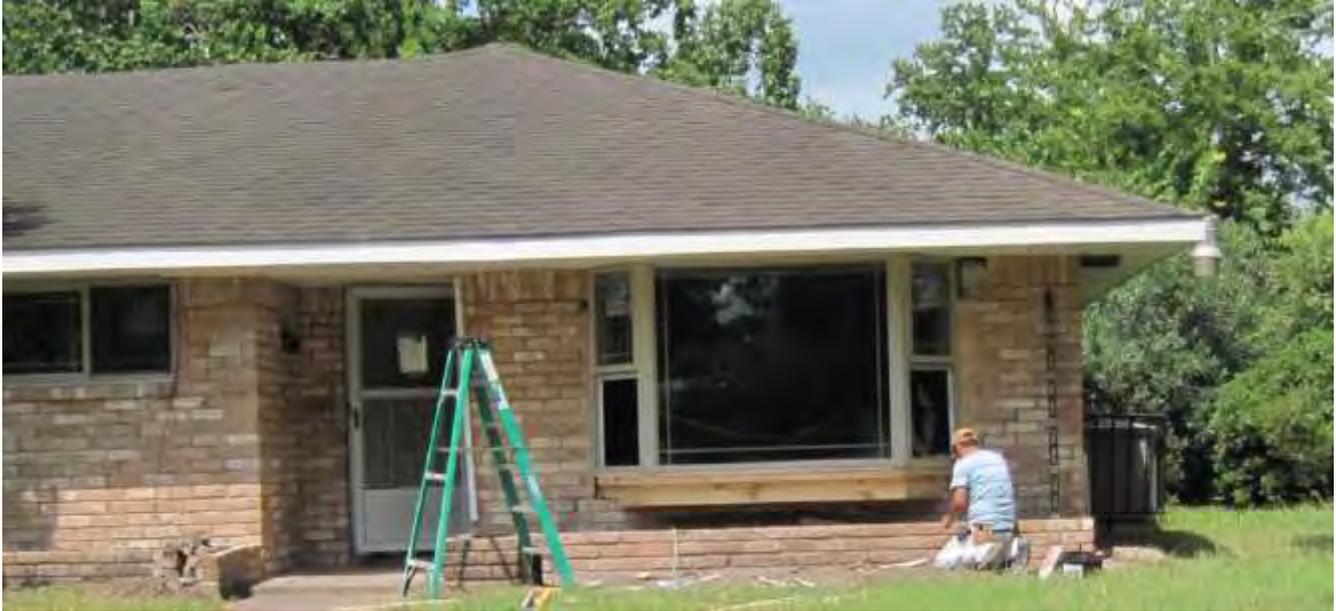
INSPECTOR SITE VISIT – 1/9/15

USE OR OCCUPANCY R341 windows changed without Building Permit and

FIRE RATING B Inspection and in Historic District, without

OTHER SECTIONS INVOLVED Certificate of Appropriateness and without approvals
 ELECTRICAL _____
 PLUMBING _____
 A/C & BOILER _____
 HEALTH _____
 OTHER _____

NO STRUCTURAL PLANS REQUIRED IF REPAIRED BACK TO ORIGINAL STRUCTURE
(NOTE: PLANS MAY BE REQUIRED FOR OTHER SECTIONS)

YES - TYPE OF PLANS floor, elevation, profiles for building permit
(PLOT, FOUNDATION, FLOOR, FRAMING, OTHER)
