CERTIFICATE OF APPROPRIATENESS

Property: 1108 Arlington St, Lot 14, Block 197, Houston Heights Subdivision. The property includes a historic 2,300 square foot, one-and-a-half-story wood frame single-family residence and a detached garage situated on a 6,600 square foot (50' x 132') interior lot.

Proposal: Alteration – Siding

- Remove original 117 siding to execute repairs to water/termite damage and add insulation.
- Reinstall original siding upon completion of repairs/insulation.
- Existing damaged siding will be replaced in-kind.

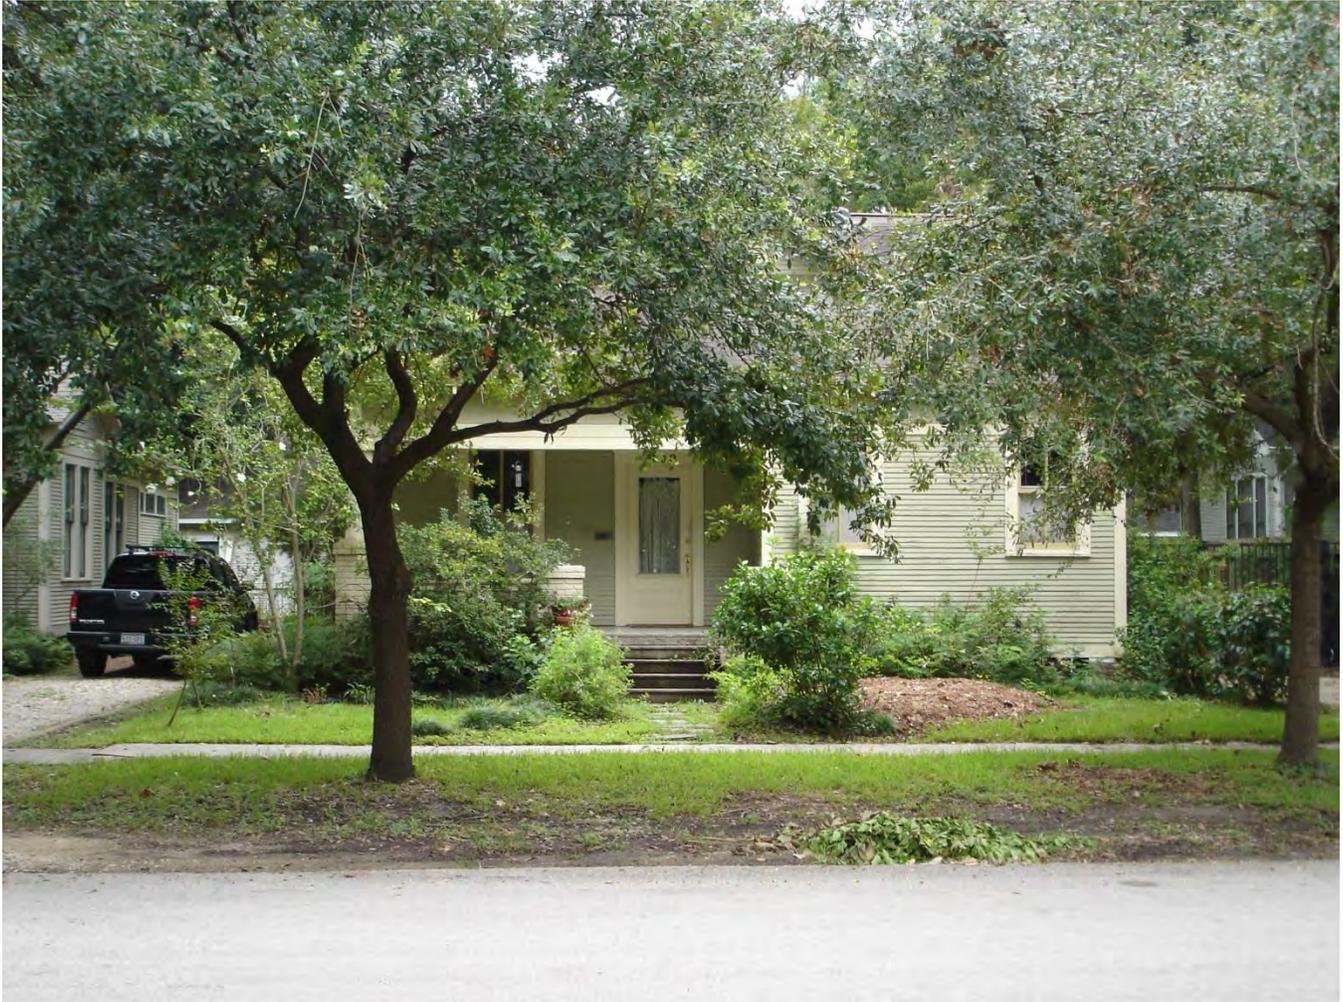
INVENTORY PHOTO

Significance: Contributing Craftsman Bungalow residence, constructed circa 1915, located in the Houston Heights Historic District East.

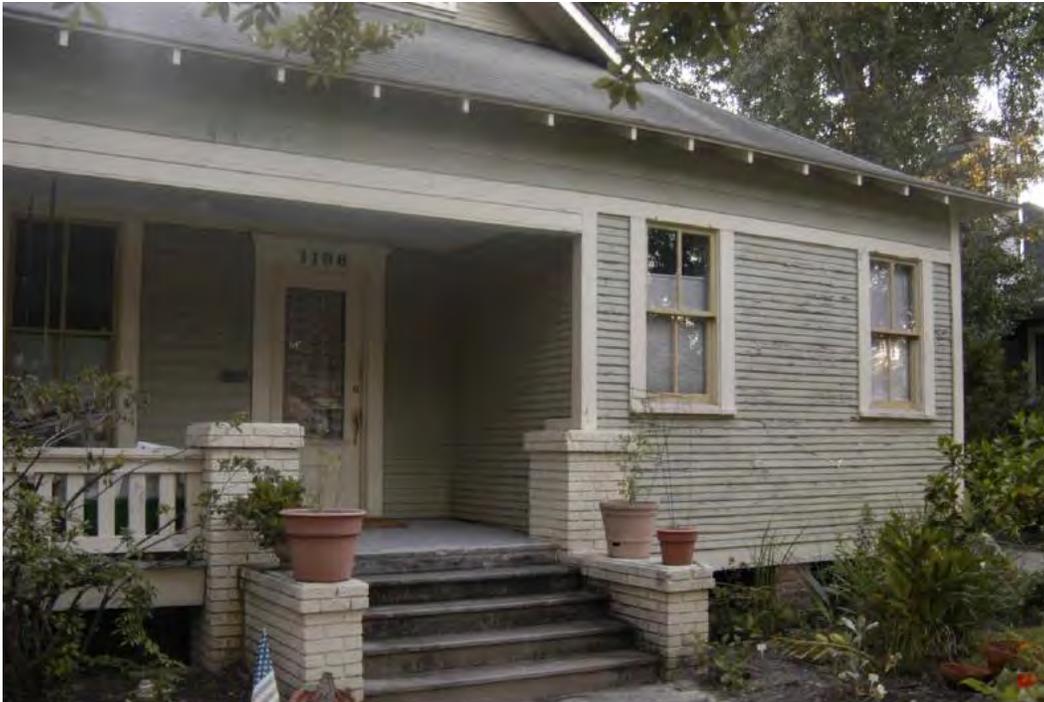
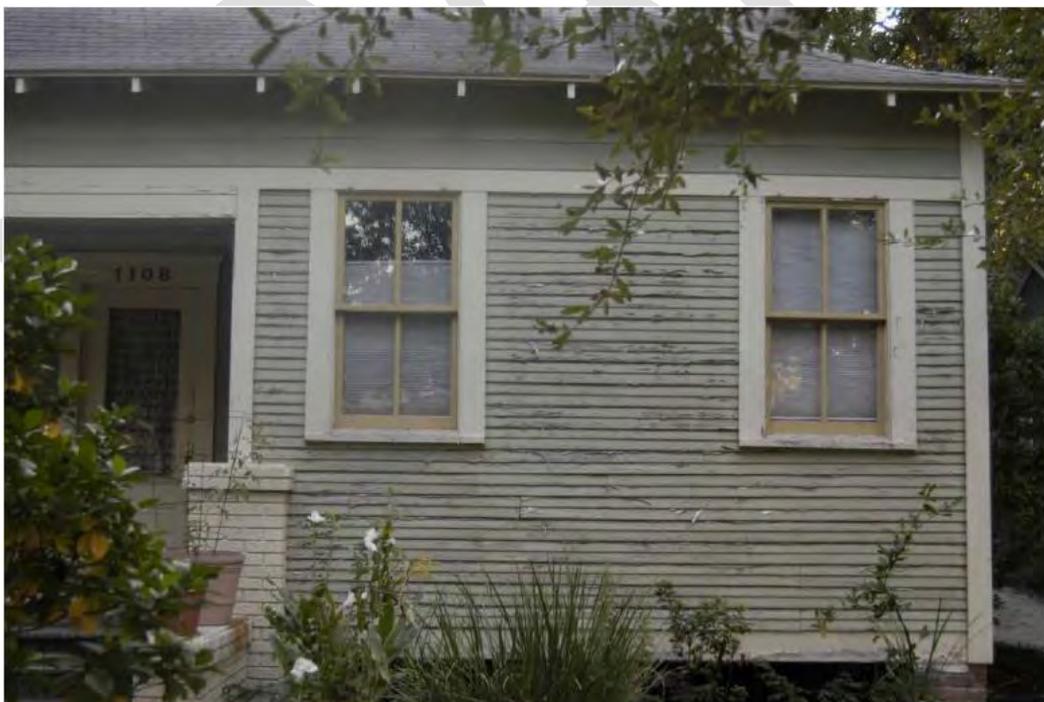
APPLICANT PHOTOS – EXISTING SIDING
WEST ELEVATION – FRONT FACING ARLINGTON

Exterior Materials: The front and side elevations are clad in original 117 siding. The applicant proposes to remove the original siding to execute repairs to water/termite damage and add insulation. The applicant will number the panels to not their existing location. The applicant will use a Sawzall to cut the nails from behind the siding in order to remove it. The siding will be reinstalled per original layout upon completion of repairs/insulation. Existing damaged siding will be replaced in-kind.

- 1.) Number the panels and note existing location
- 2.) Utilize a Sawzall to cut the nails from behind the siding rather than pry the boards off
- 3.) Perform repairs and install insulation/vapor barrier
- 4.) Reinstall per original layout.
