AGENDA ITEM: IVp

HPO File No. 101116

SITE LOCATION: 814 Colquitt Street – First Montrose Commons Historic District

CERTIFICATE OF APPROPRIATENESS

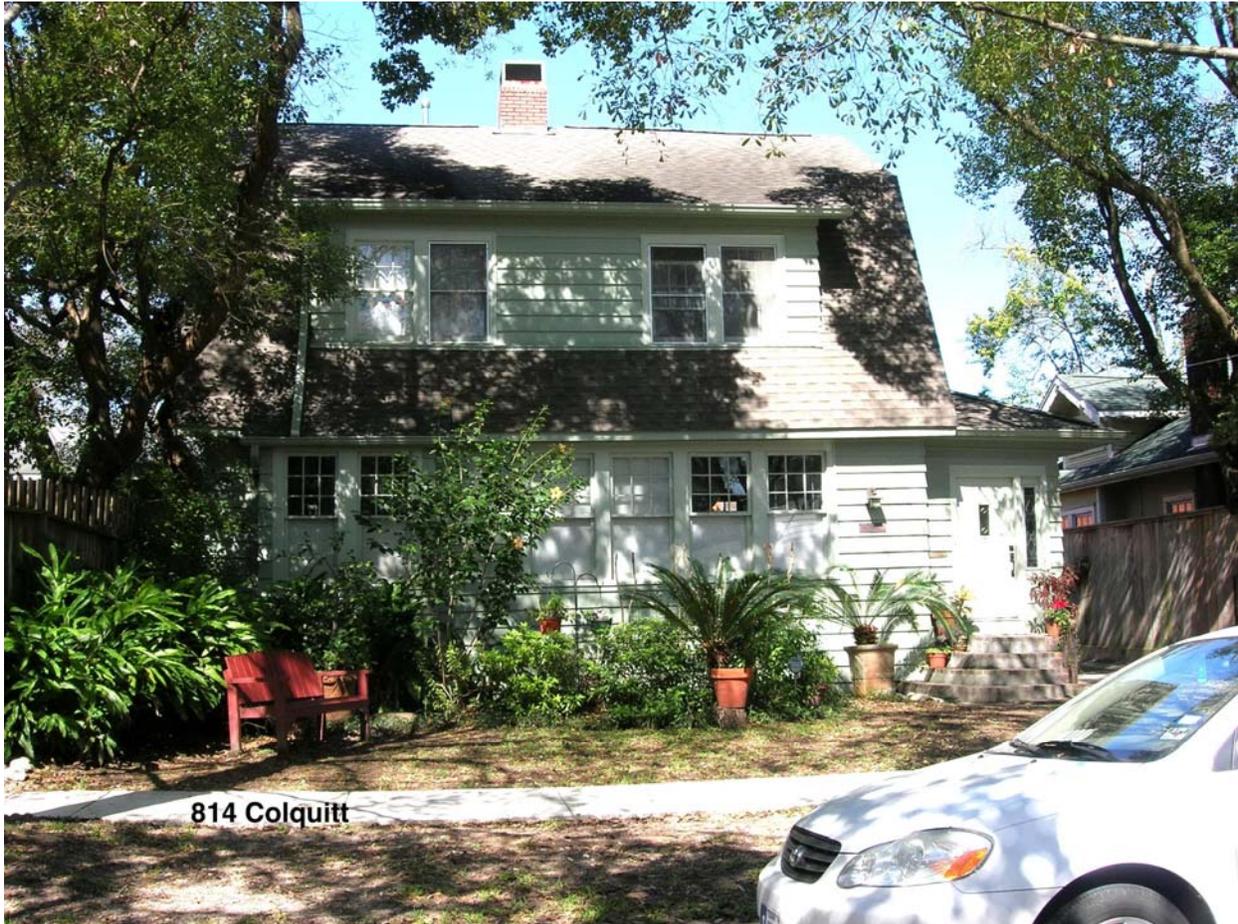
Photograph of Existing House

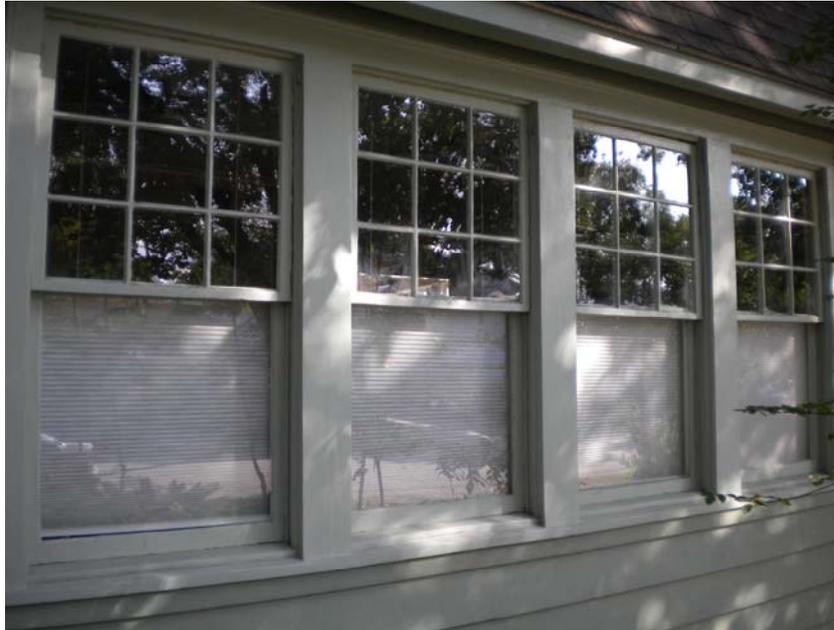
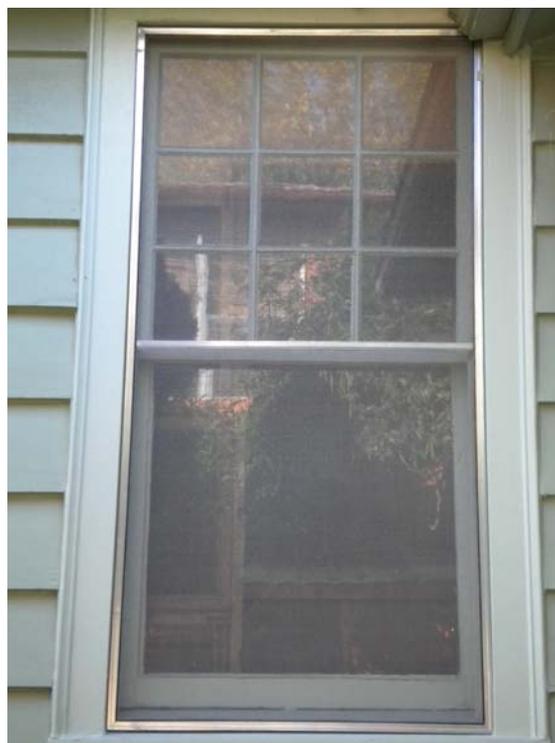
The proposed activity seeks to remove all of the original windows and install composite replacement windows. The existing original windows are an important historic component that contributes greatly to the significance of the building. The installation of replacement windows does not preserve the historical character of the property and will seriously alter the look of the building.

Existing Wood Windows

STAFF RECOMMENDATION: Denial of the certificate of appropriateness

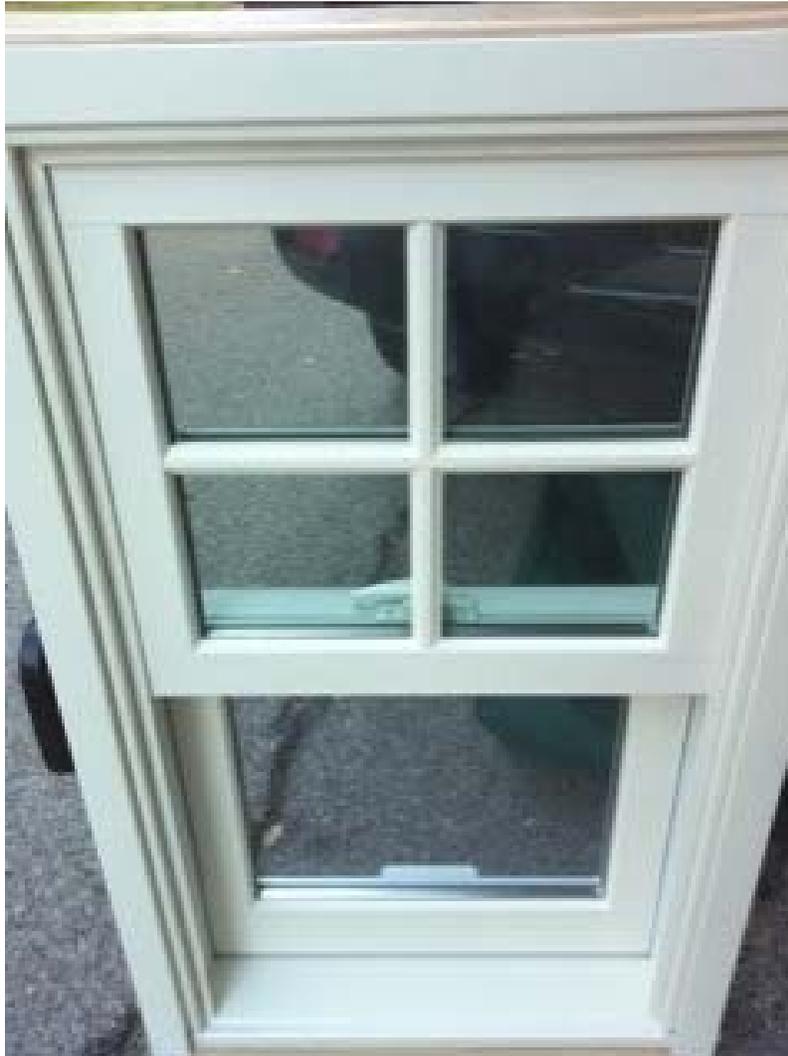
Replacement windows do not accurately reflect the same visual qualities as original wood windows. The smooth texture, larger jambs, stiles, muntins and dissimilar profile of the window frame replacements gives an entirely different appearance to the overall look of the historic building.

Example of Proposed New Window
