**Crime Prevention
Through Environmental Design Survey
Confidential Information**

**Jewish Community Center & Associated Facilities
5601 South Braeswood
Houston, Texas**

**Conducted by:
Stephen T. Daniel
Senior Community Liaison**

**Houston Police Department
Public Affairs Division**

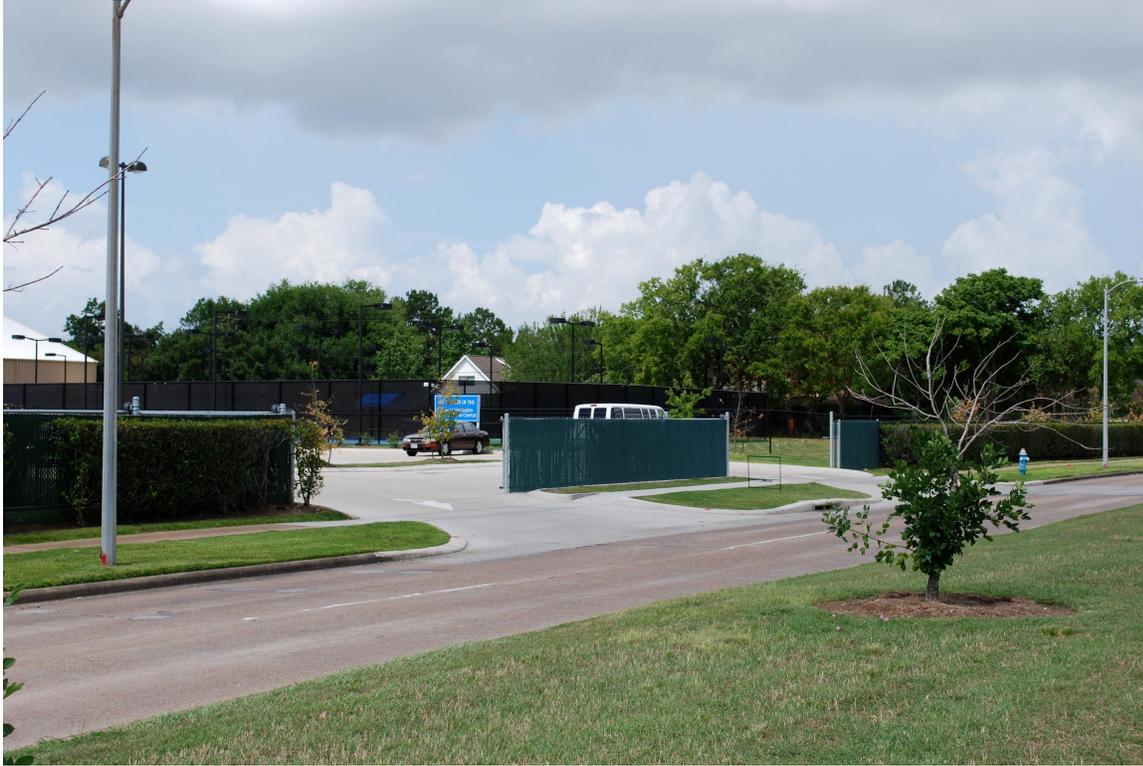
Perimeter Control

Perimeter control along Braeswood is good. The implementation of automatic gates is good. The shrubs along the fence line should be removed in order to provide more natural surveillance of the property.

Perimeter control along Atwell Drive does not exist. This is both positive and negative. While it provides open access to the front of the property and excellent natural surveillance, it also presents a welcoming appearance. The negative is, it does allow individuals unrestricted access to the subterranean play area by the front of the building. Calls for Service do not indicate any significant vehicle theft. Should auto theft become an issue, then consideration of fencing and gates for a limited area on Atwell should be considered.

The new perimeter fencing down the property line between the JCC and residential homes is an excellent step. If not already planned, gates should be considered in order to control traffic access to the pool, tennis, and school area.

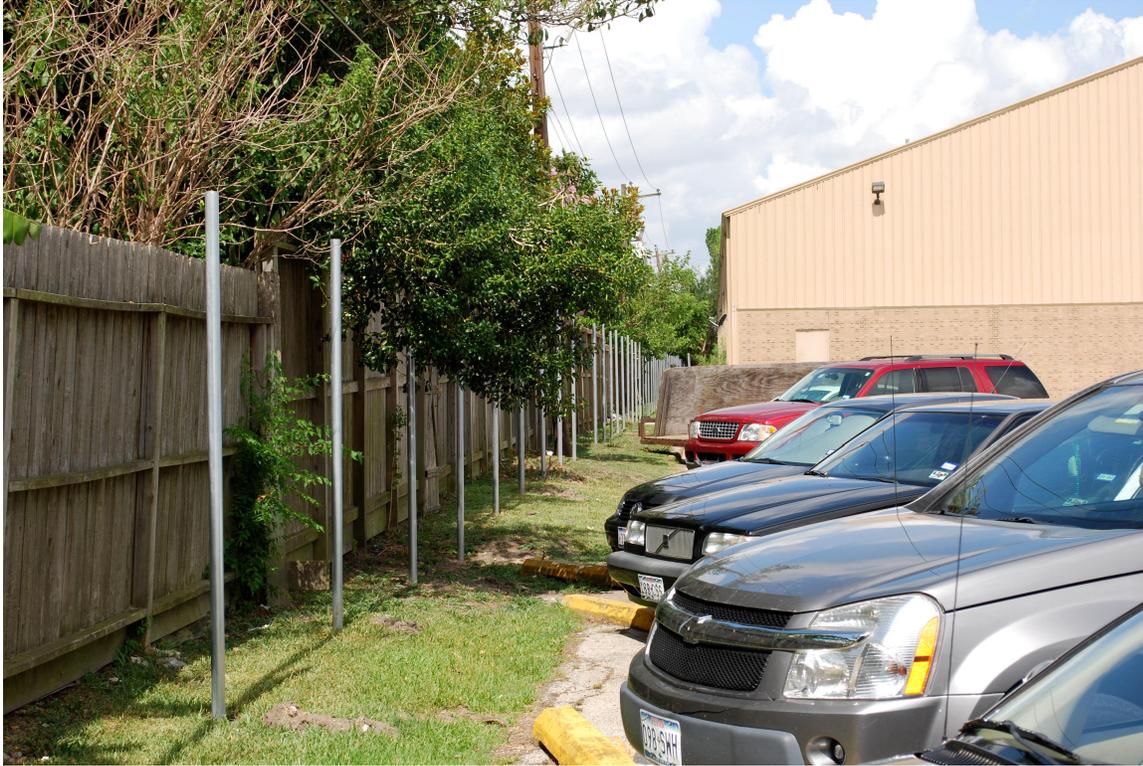
Vegetation around Mullins Street to S. Braeswood should be maintained. The vehicle gate at Mullins Street should be maintained and in good repair. Effort should be made to insure the gate is secured at all times except when actually needed for access.

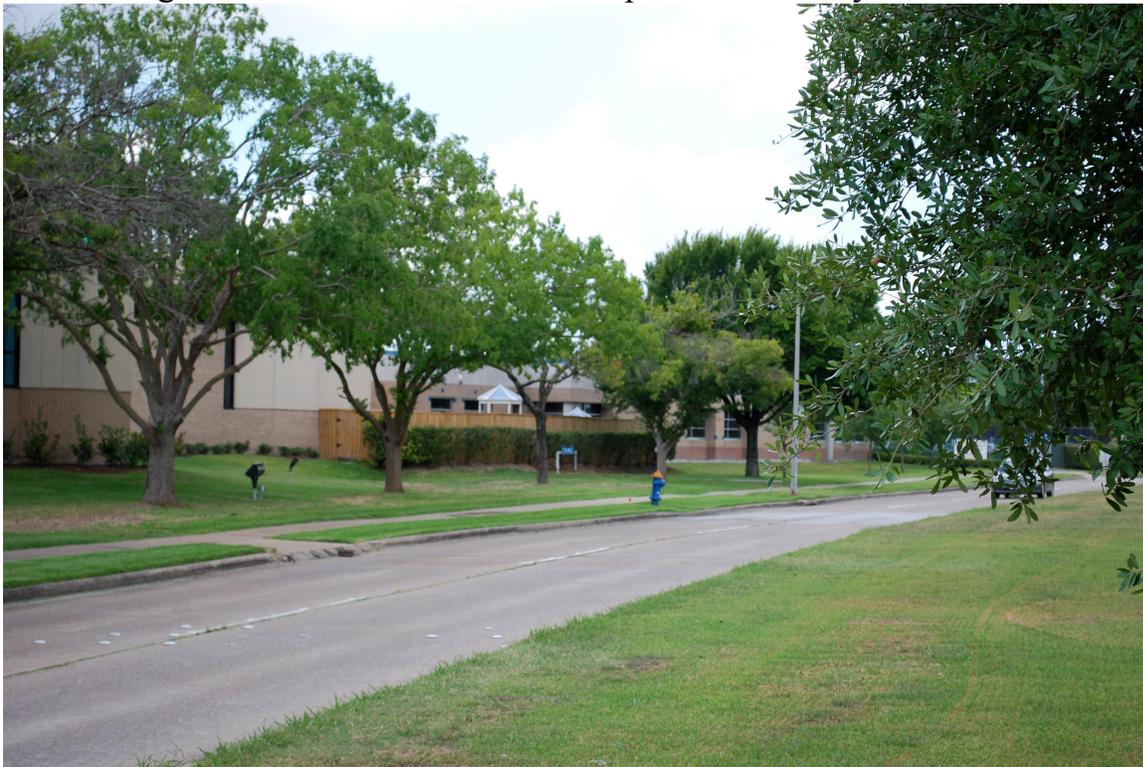
Wood fencing obscuring the play area of the school eliminates all natural surveillance. This would be better served by metal fencing as employed along S. Braeswood near the outdoor tennis courts.

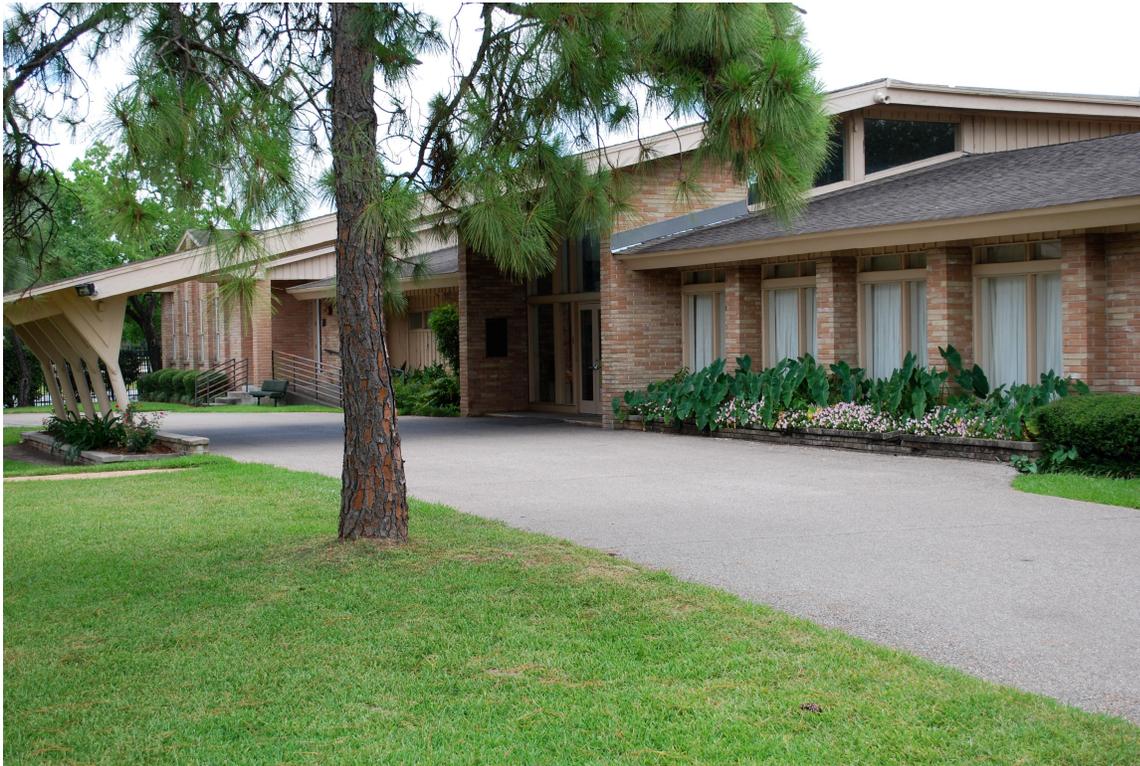
Merfish Teen Center

Access Control – The facility is designed in such a manner that lends itself to good access control, however it is not employed. Gates were open during all hours of observation, both day and night. There was no control over the front door. After walking into the facility and down a hallway, I was challenged by a senior staff member. I had exposure to 30 to 50 children before being challenged.

The area of the parking exit gate is dark and provides places to hide from the view of a patrolling officer.

The front door should have an electronic locking device controlled by someone of responsibility. Staff and campers should be readily identifiable. Any visitors should be signed in, the reason for their visit verified, and a visitors ID worn.

Video and recording of the front door is recommended. The ability to monitor this real time from the JCC is also recommended. A panic button in the area of the front door, which is monitored at the JCC, would serve as a good back up.

If some interior lights were left on it would improve the ability of patrol officers to view any activity inside the building.

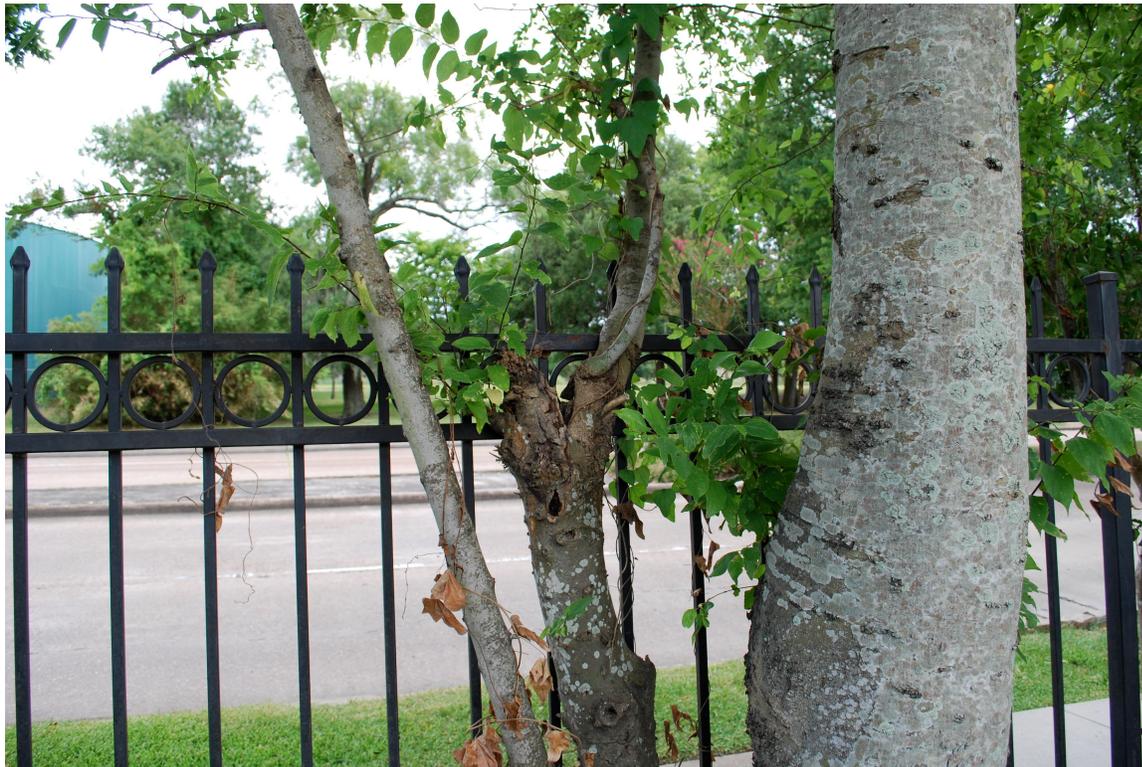
Perimeter Control

Fencing is good along Rice Blvd. and N. Braeswood. Attention should be given that spaces do not develop that allow individuals to crawl under this fence. Fencing from the each street to the back corner needs maintaining. Vegetation provides too many places for concealment. Victims could easily be forced to this fence line and assaulted. Clearing of vegetation would be beneficial.

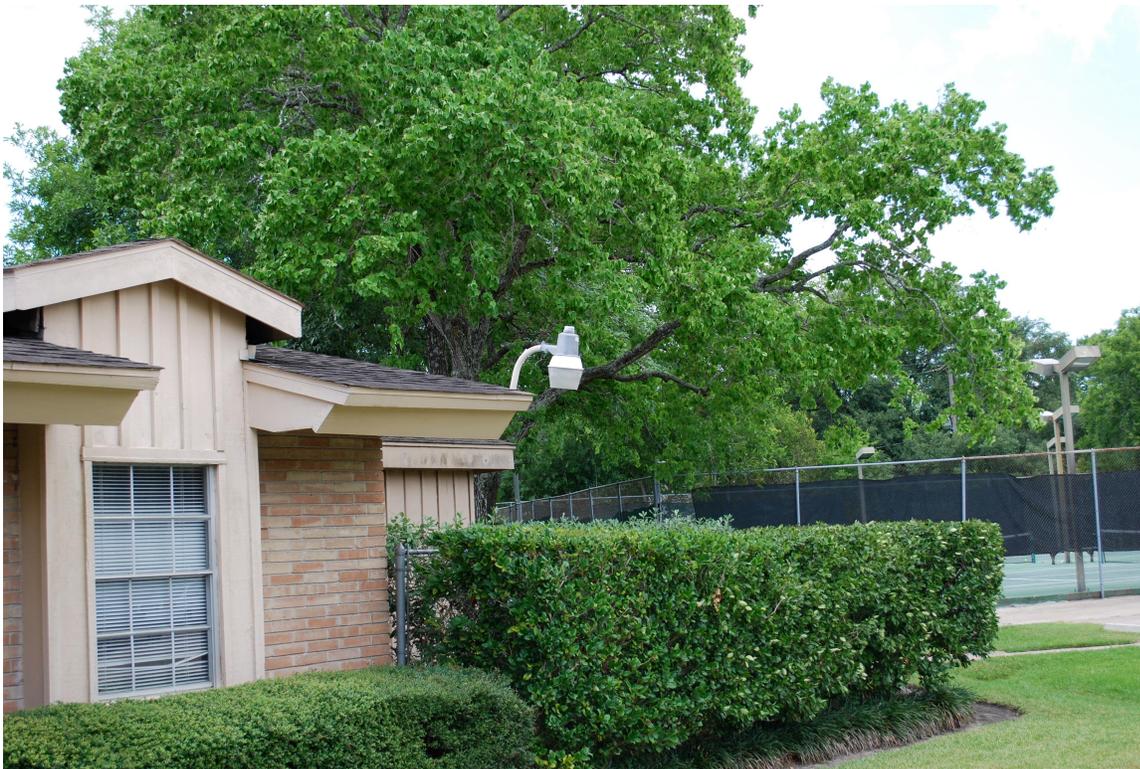
Lighting

As you drive into the parking area at night the tennis court lights shine into your eyes. This reduces the ability of patrol officers to view activity on the grounds. Redirecting

them would be beneficial. There is a disparity between lighting levels in the parking area and the activity field. Bright lights in the parking area reduce your ability to view the activity field.

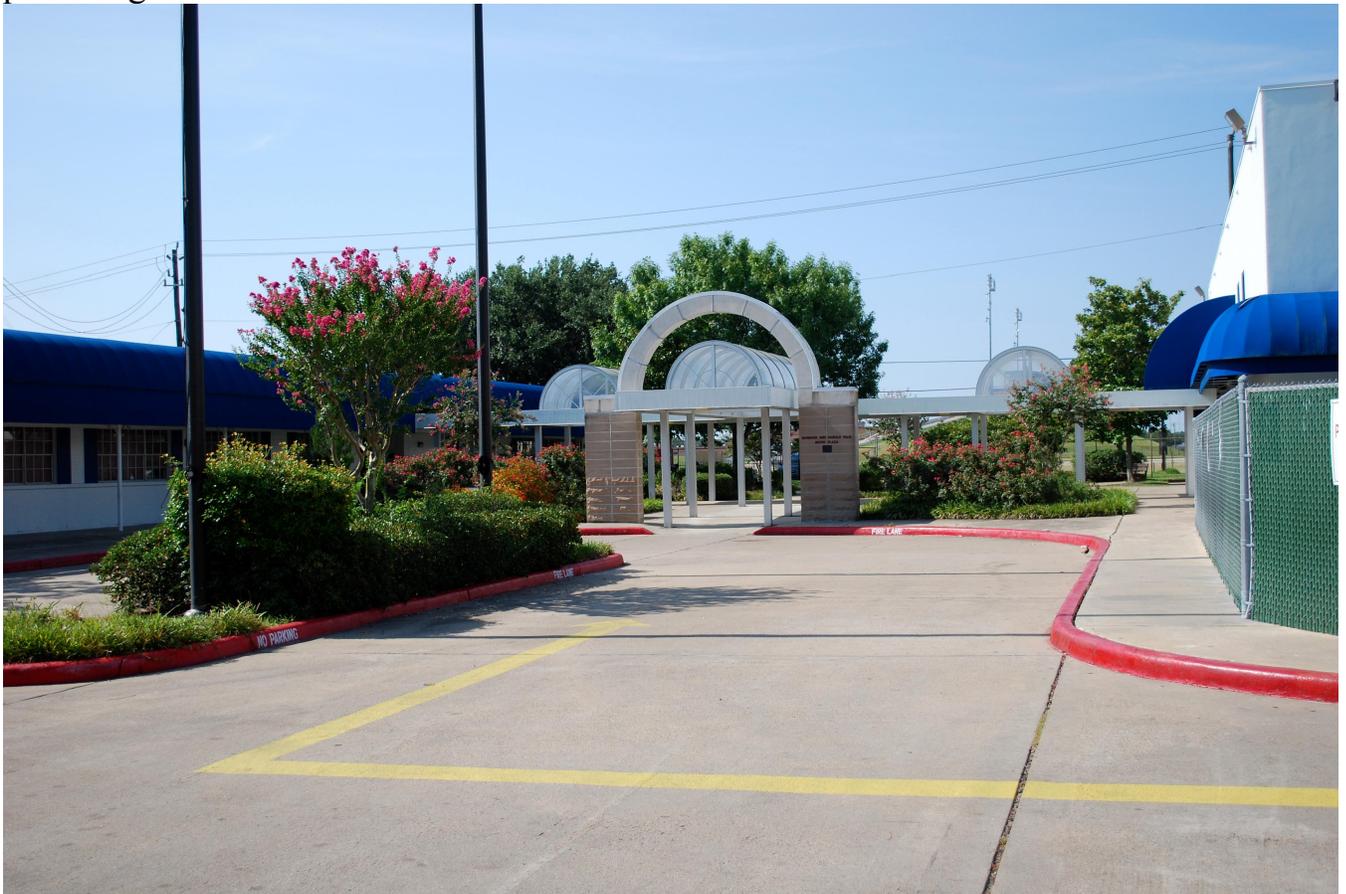
**Jewish Community Center/West Houston
&
Ellen Boniuk Early Childhood Center**

Access Control – The greatest natural advantage for this facility is the fact that it sits off of Dairy Ashford a reasonable distance, thus not calling attention to itself. Access control for the Ellen Boniuk Early Childhood Center front door was very good. Access control for the Community Center was not present. The south end door to the Childhood Center was not controlled. It is recommended that the south door be locked when staff are not on the play ground. A camera of the playground, monitored at the front desk would provide

Fencing along the south border next to the Tully Field Parking is reasonably good, but caution should be taken to insure this fence is well maintained. The gate is left open for convenience during the day and was found open at night. This should be secured after staff arrive to limit access from the field. Additionally, the low fence along the south playground and the courtyard should be raised to the height of the other fences. It is not a deterrent to anyone walking in off the street. Vegetation around the power transformer in the north playground should be cleared. Classroom doors should be lockable from the inside.
