CERTIFICATE OF APPROPRIATENESS

Property: 1918-1920 Hickory Street, Lot 7, Block 268, Baker NSBB Subdivision. The property includes a historic wood frame landmarked church structure and attached parsonage building for a total of 1,798 square feet, situated on a 5,000 square foot (50' x 100') corner lot.

Proposal: Demolition – Demolish the City Landmarked Mallalieu United Methodist Church and attached parsonage building.

Attachment C: Property Inspection Report

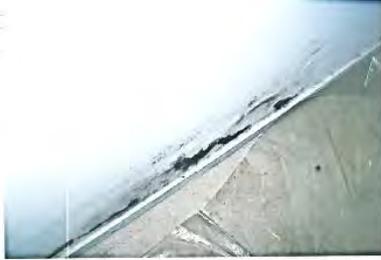
Water damage between beams & back side of Parsonage
appears to be mold

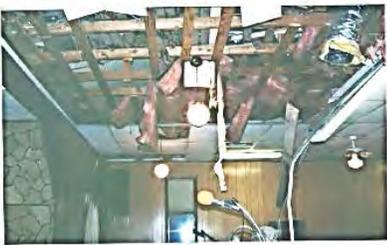
Water damage to the wooden ceiling in Parsonage

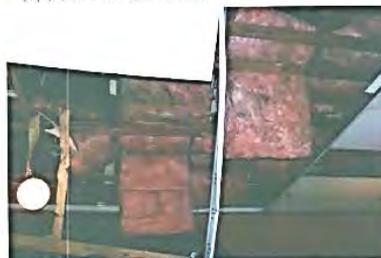
Water damage on wooden ceiling in the Parsonage

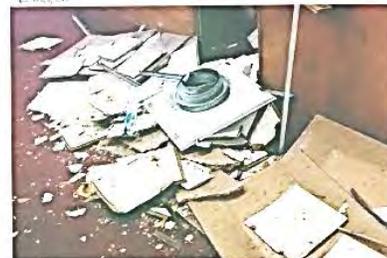
Fallen debris from collapsed ceiling - 2011

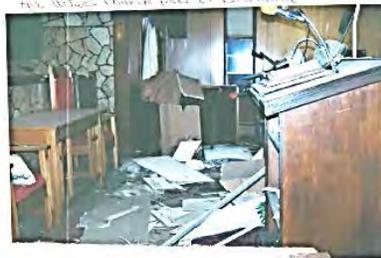
Debris on floor of Parsonage -

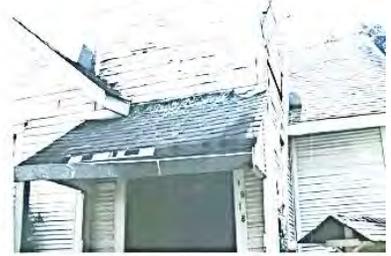
Porch needs to be repaired

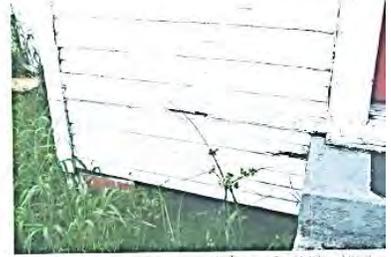
Front porch of building needs to be restored

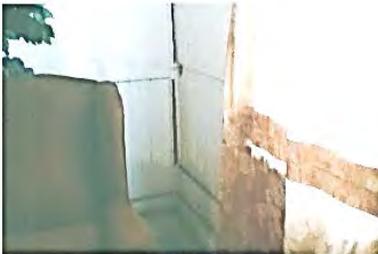
Peeling base of wall - more wall
destruction

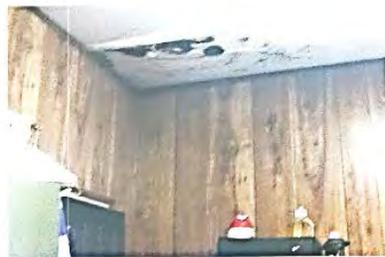
Office - Note damage to the
ceiling

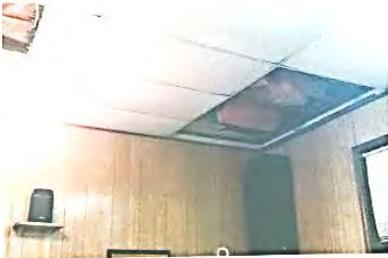
Missing tiles on drop ceiling outside Church

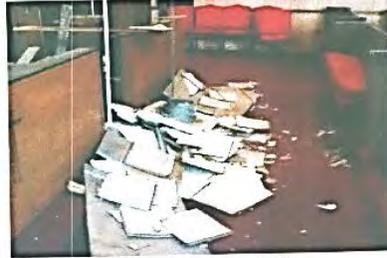
Pattern debris from outside ceiling

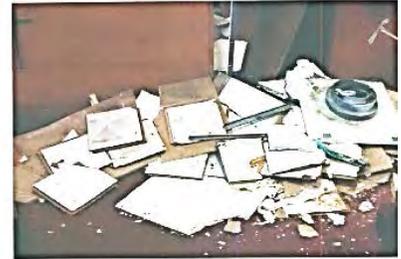
Close up of pattern debris

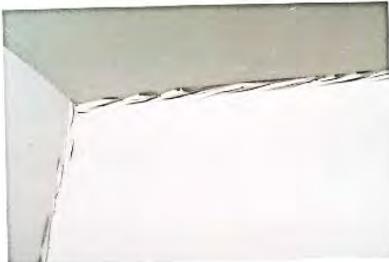
The jagged hole appears to be bursting from walls

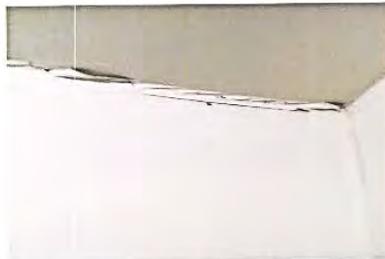
Pattern debris from outside ceiling

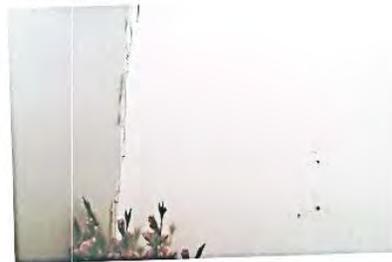
View of hole in ceiling

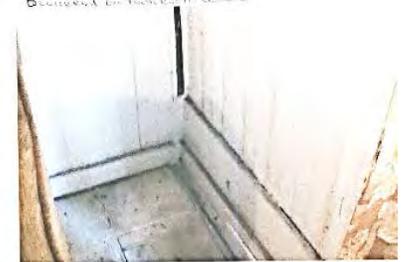
Continuation of hole in ceiling - walls

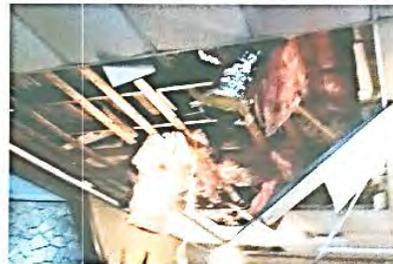
View of ceiling in the back of church (looking forward)

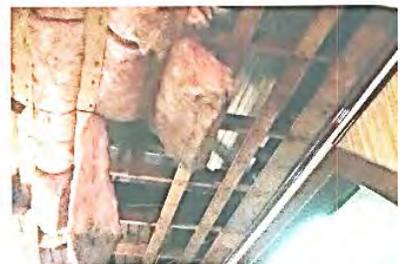
View of ceiling in the back of church (looking forward)

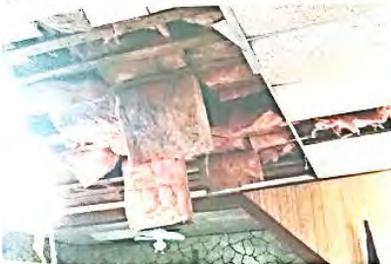
View of ceiling in the back of church

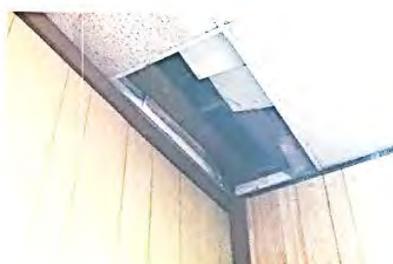
View of ceiling in the back of church

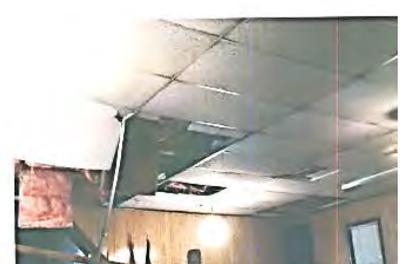
View of ceiling in the back of church

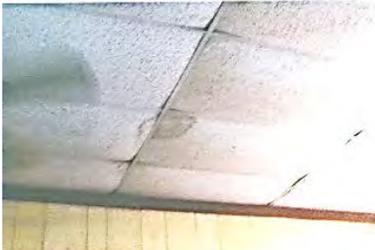
Water damage on Church ceiling

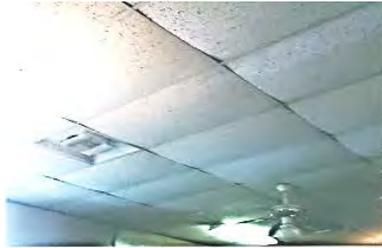
Water damage on Church ceiling

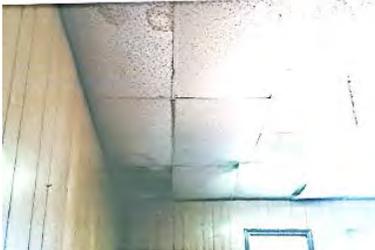
Water damage on Church ceiling

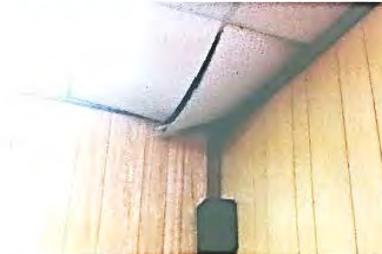
Water damage on Church ceiling

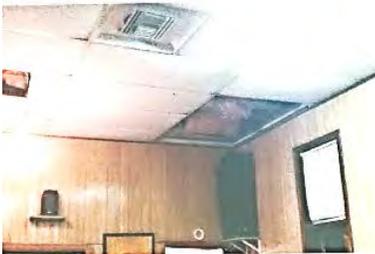
Water damage on Church ceiling

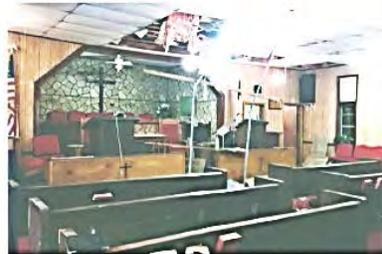
Water damage on Church ceiling

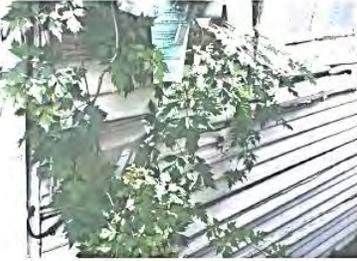
Close up picture - Back of Church

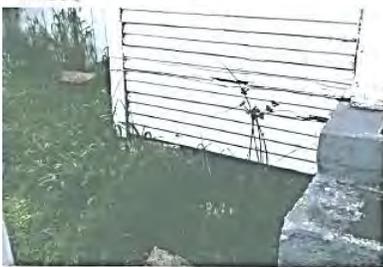
More rotten wood - Side entrance

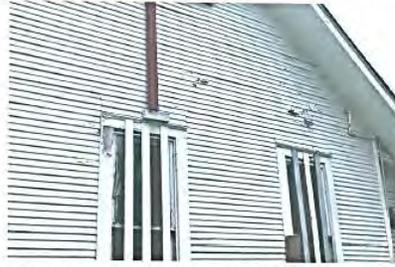
Rotten wood on back side of Church

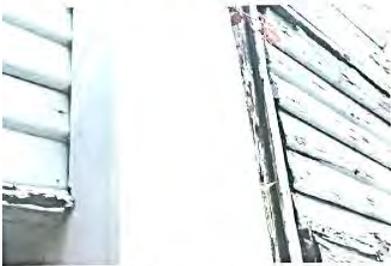
What appears to be separator of the outside walls - on side of church

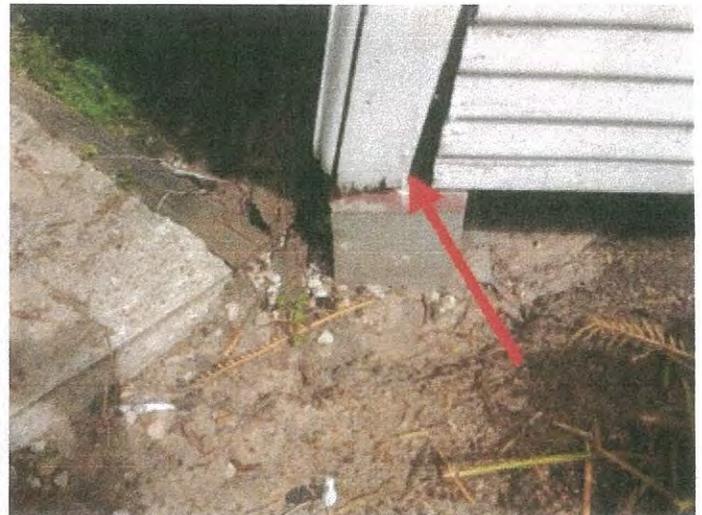
Piers appear to be shifting

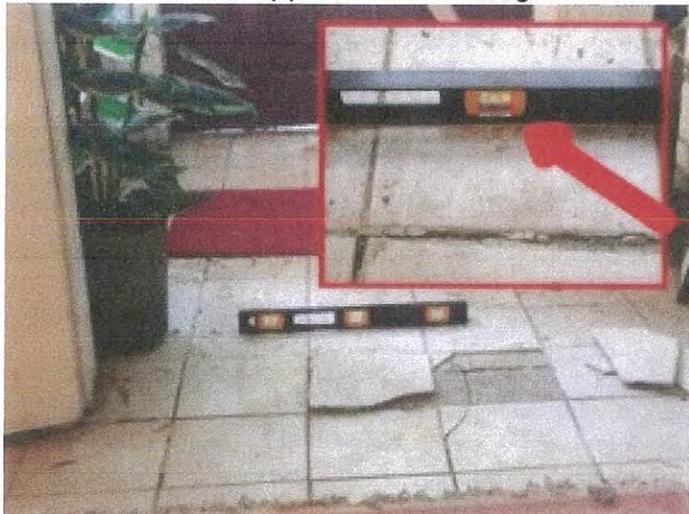
Flooring is not level

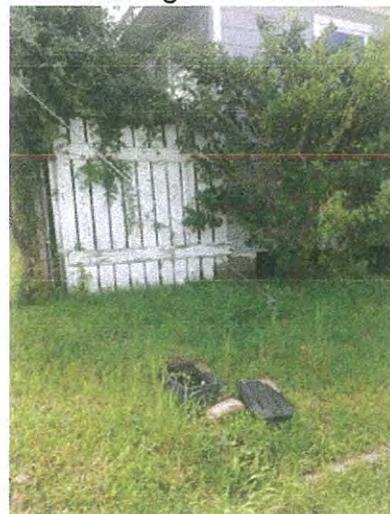
Vegetation too close to structure.

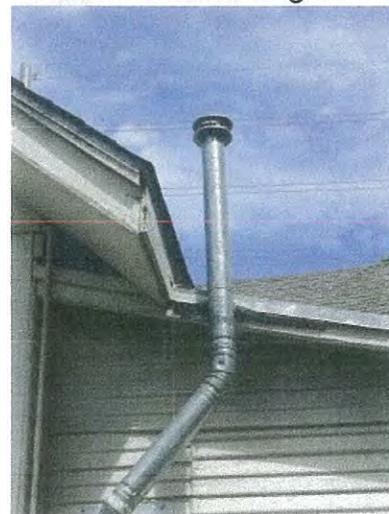
Flashing is lifting

B vent for the heating system does not extend high enough above the roof covering of the structure

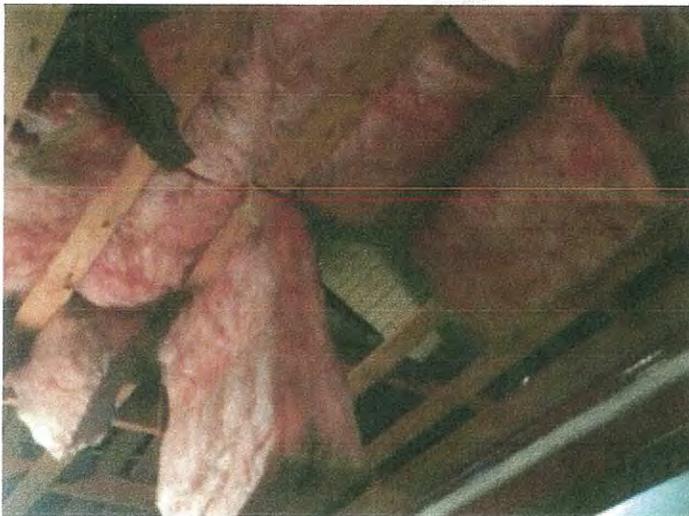
Large areas of the ceiling in the main area of the structure have collapsed
