CERTIFICATE OF APPROPRIATENESS

Property: 511 Arlington Street, Lot 10, Block 288, Houston Heights Subdivision. The property includes a historic 1,158 square foot, one-story wood frame single-family residence and a detached garage situated on a 6,600 square foot (50' x 132') interior lot.

Proposal: Alteration – Construct a 2,135 square foot two story addition and attached garage at the rear wall of the residence.

Recommendation: Approval with conditions: The eave height of the addition be 1' lower (20'-8") and windows 2, 4, 5, 12, 13, 15 & 16 be repaired and retained

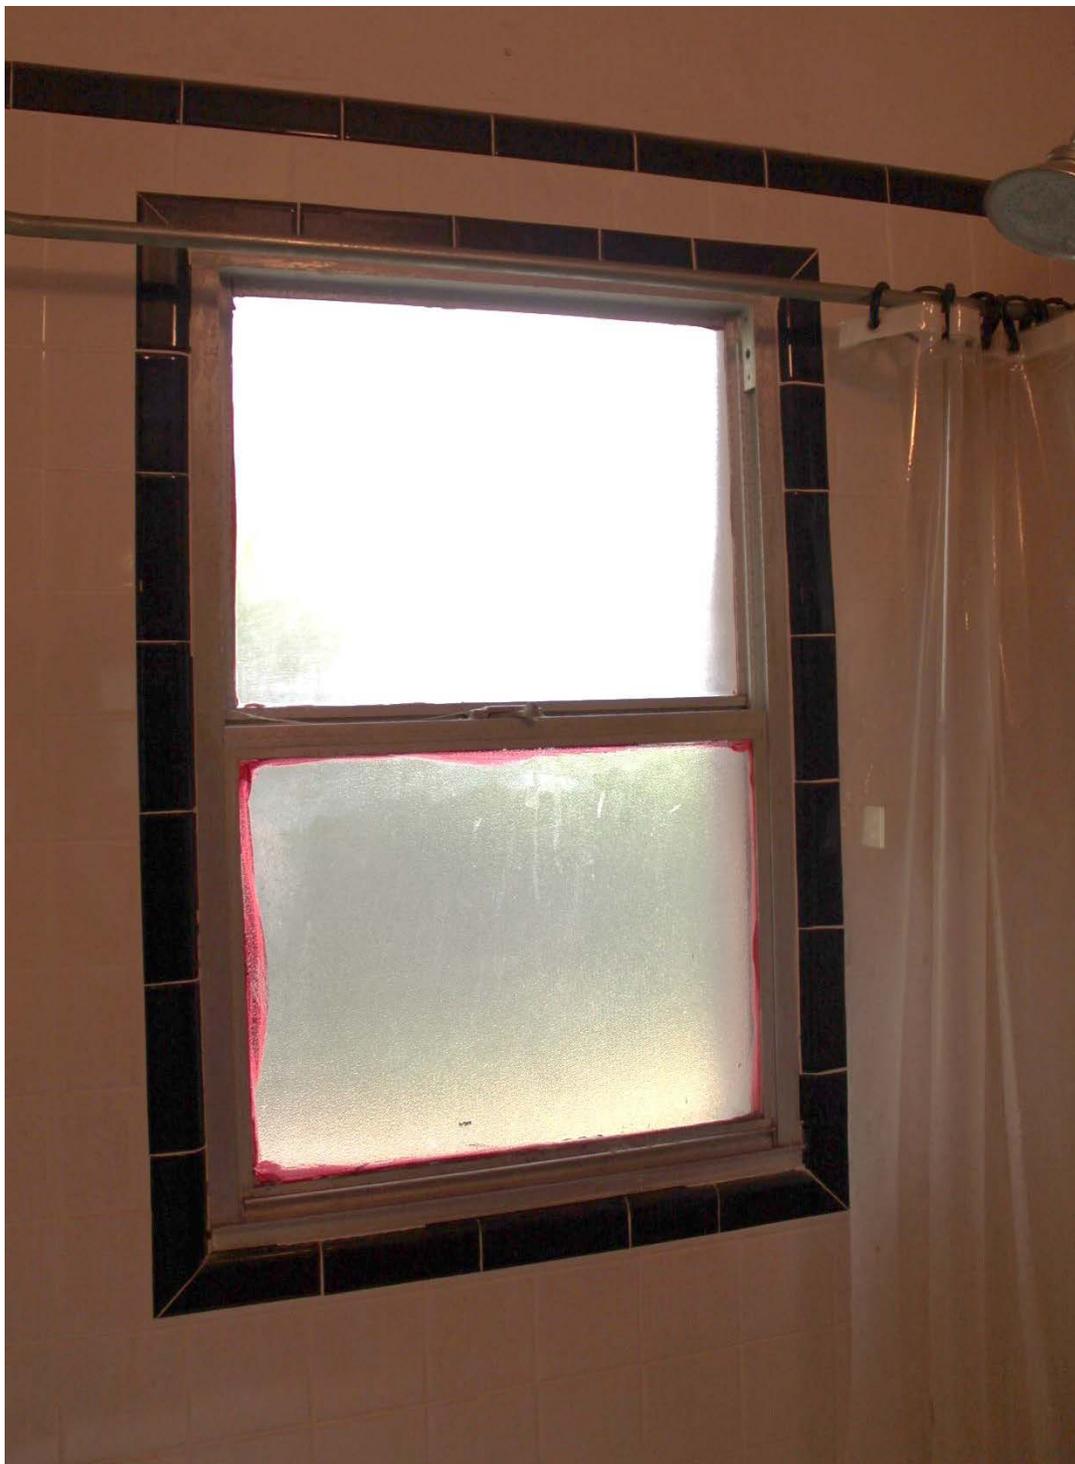
WINDOW 14 (NON-ORIGINAL)

14. EXISTING - 24"X36" 1/1, ALUMINUM DOUBLE HUNG TO BE REPLACED WITH WOOD
15. EXISTING - 33"X69" 2/2, WOOD DOUBLE HUNG
16. EXISTING - 33"X69" 2/2, WOOD DOUBLE HUNG

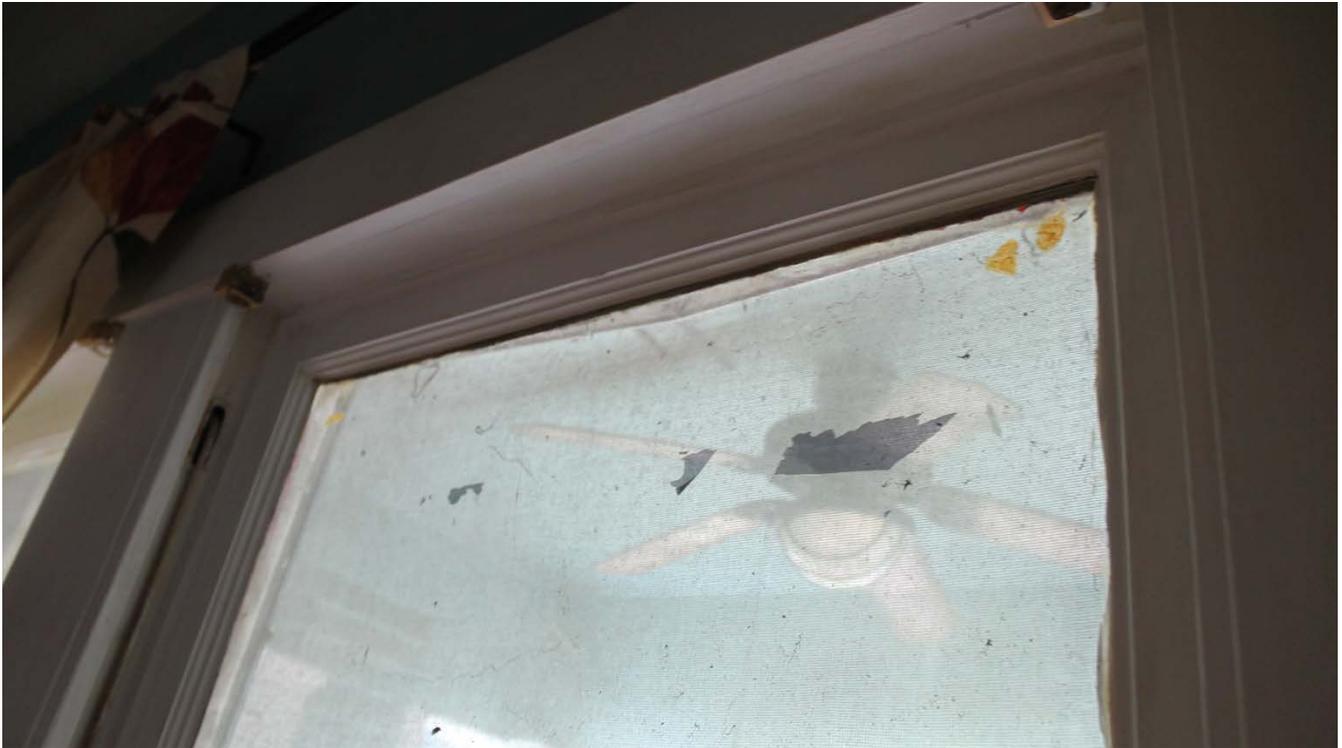
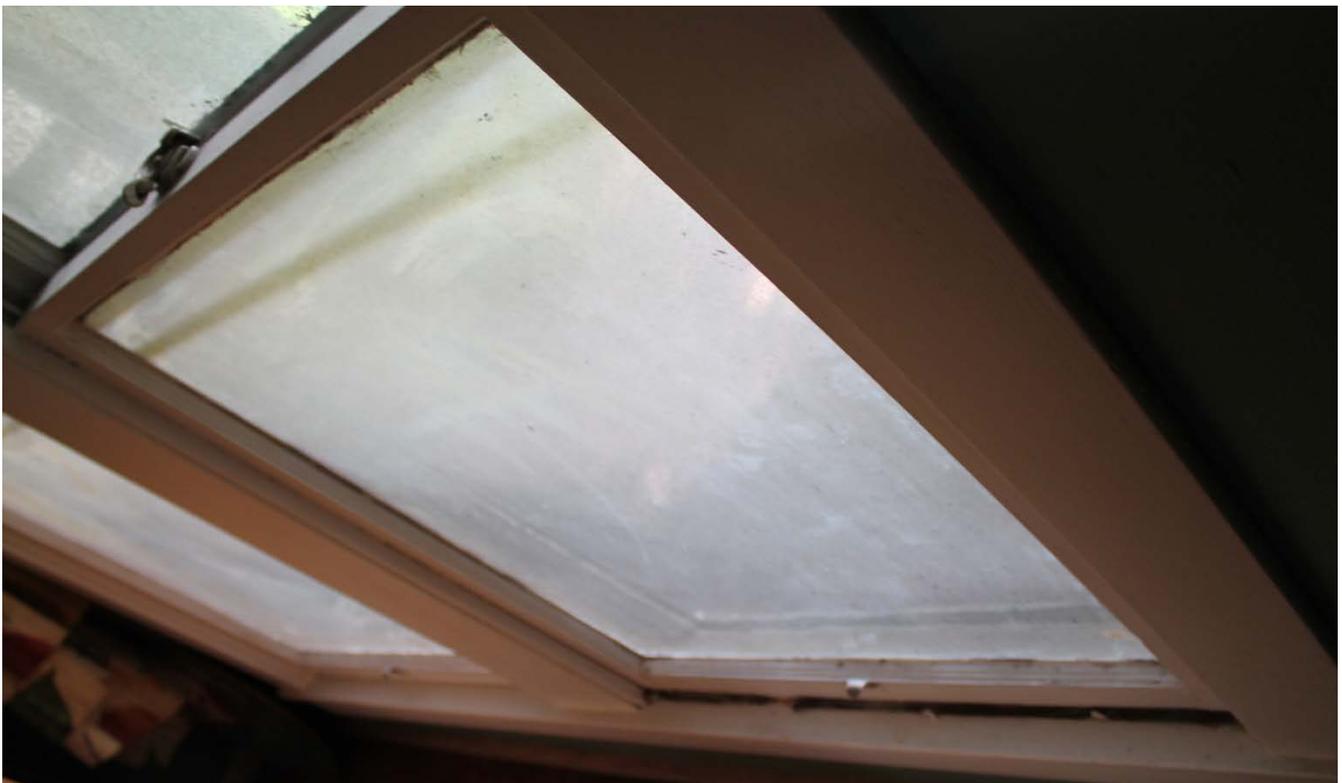
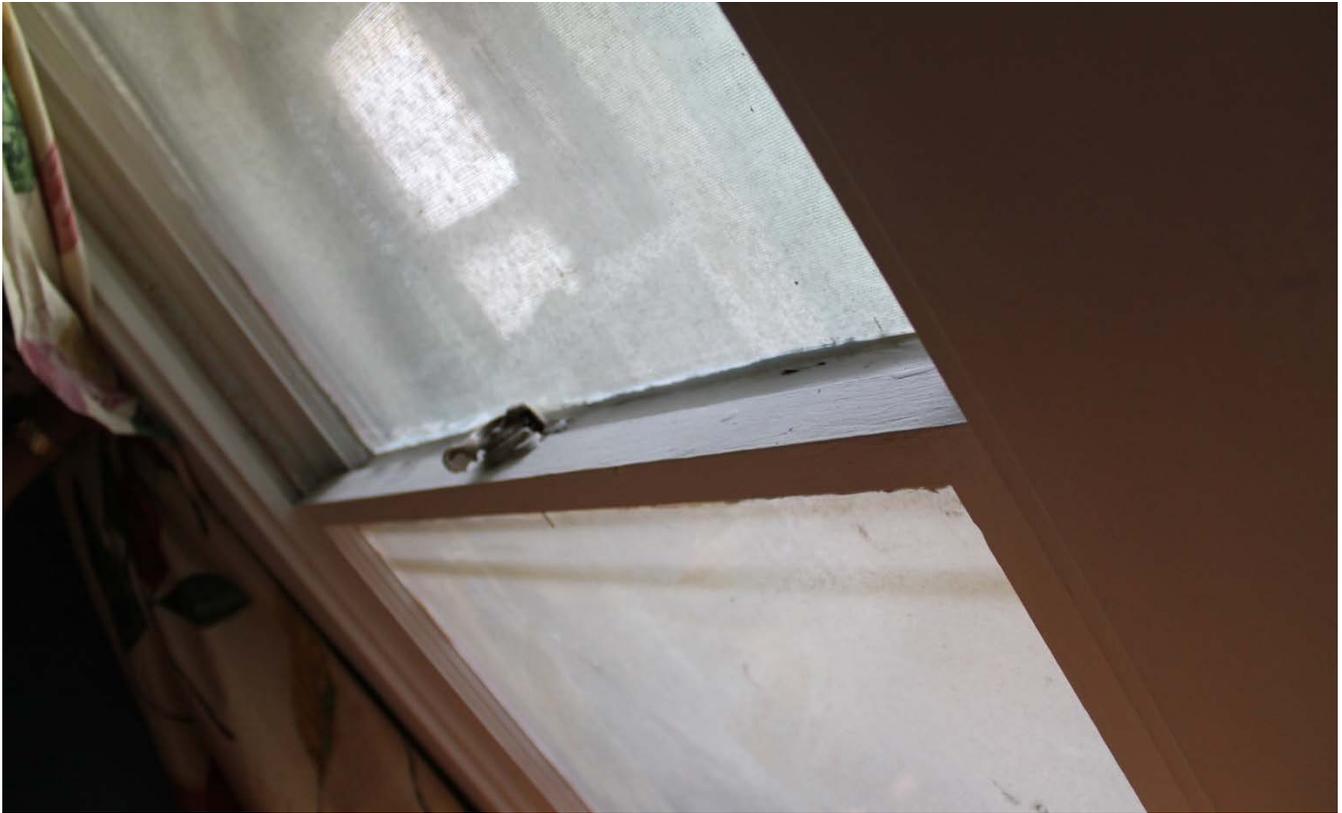
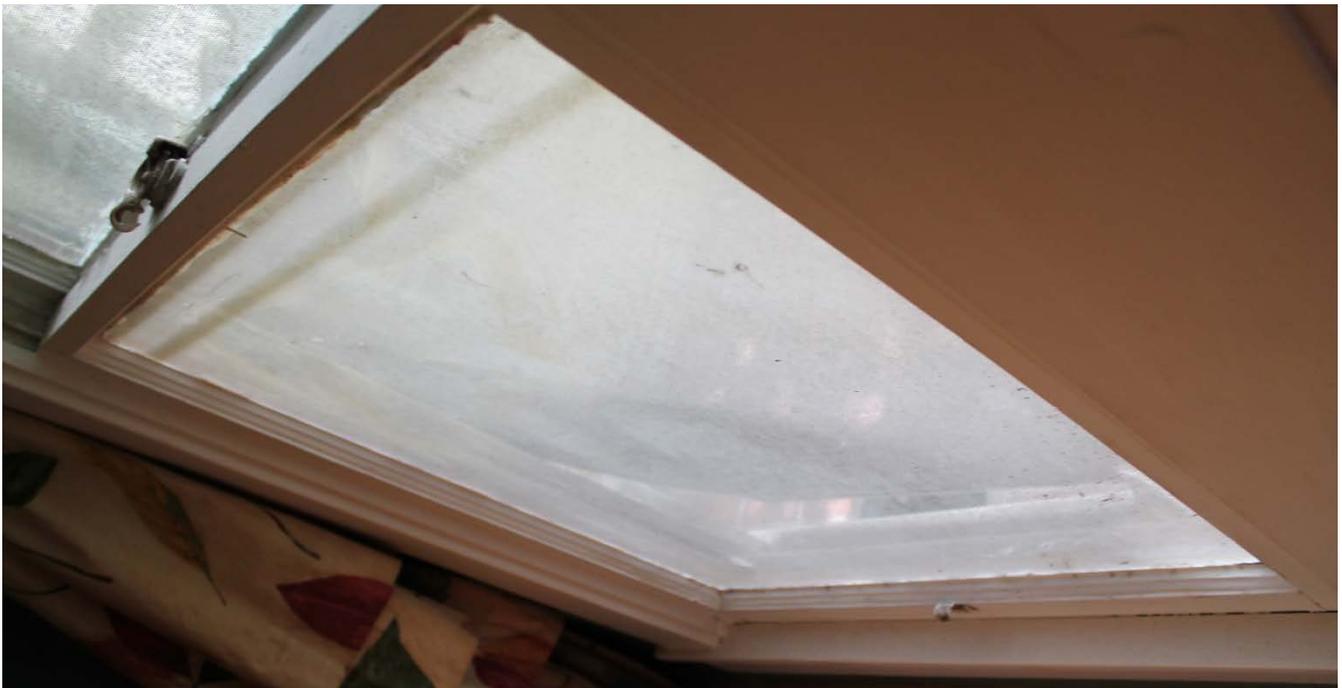
STAFF PHOTOS
WINDOW 17 (PAIR)

17. EXISTING - (2) 32"X70" 1/1, WOOD DOUBLE HUNG, TO BE REPLACED WITH 2/2 WOOD

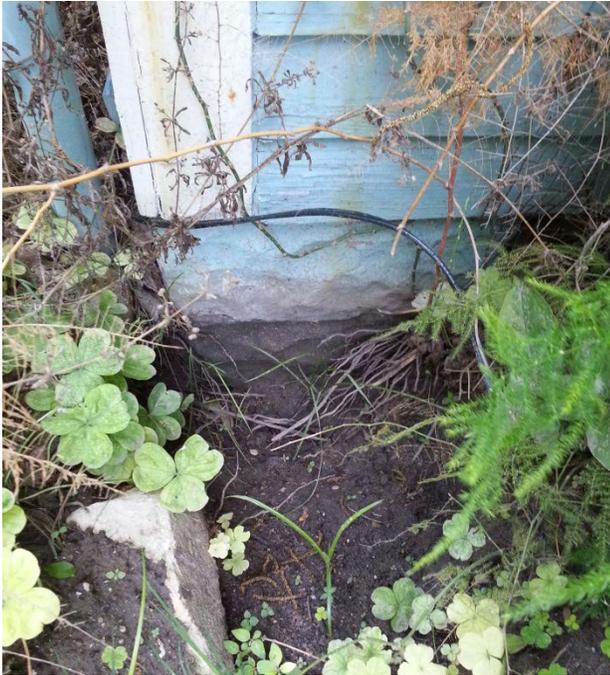
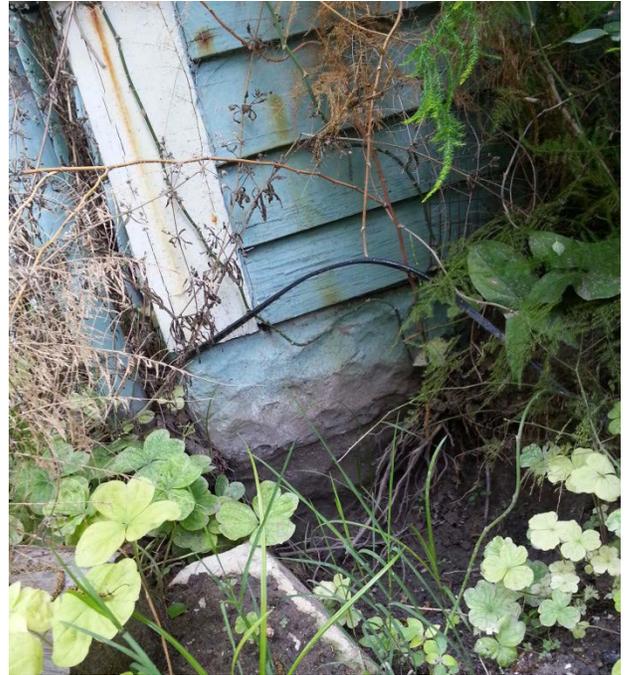
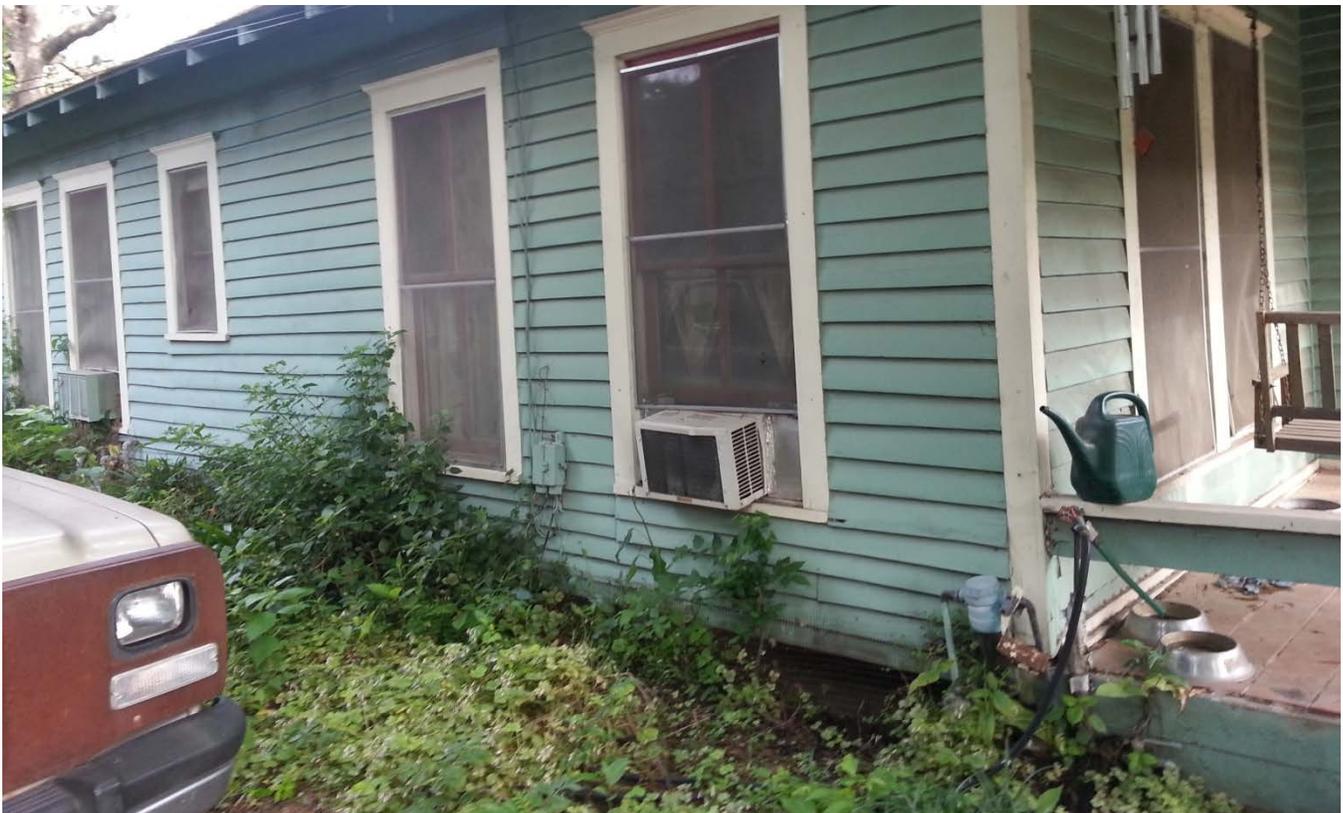
INSPECTOR PHOTOS
FOUNDATION CONDITION

Foundation: The residence features a pier and beam foundation with a finished floor height of 24" from grade. The residence will be raised for a final finished floor height of 30" from existing natural grade. The addition will feature a pier and beam foundation with a 30" finished floor height and a slab on grade foundation.

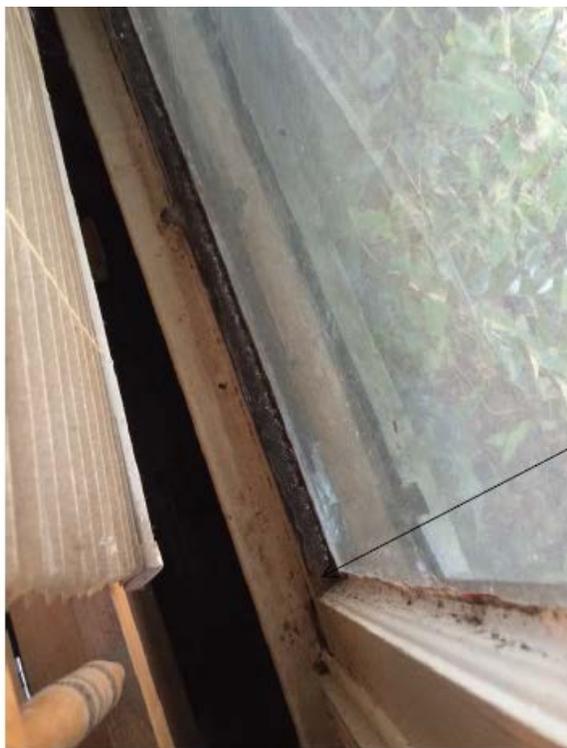
Window 2 – Bottom single pane does not match other windows.

only 2/1 window in
the house- believe
to be not original
bottom

1. EXISTING - (2) 32"X70" 1/1, WOOD DOUBLE HUNG, TO BE REPLACED WITH 2/2 WOOD
2. EXISTING - 33"X69" 2/1, WOOD DOUBLE HUNG, REPLACE SASH KIT, 2 PANE BOTTOM TO MATCH OTHERS

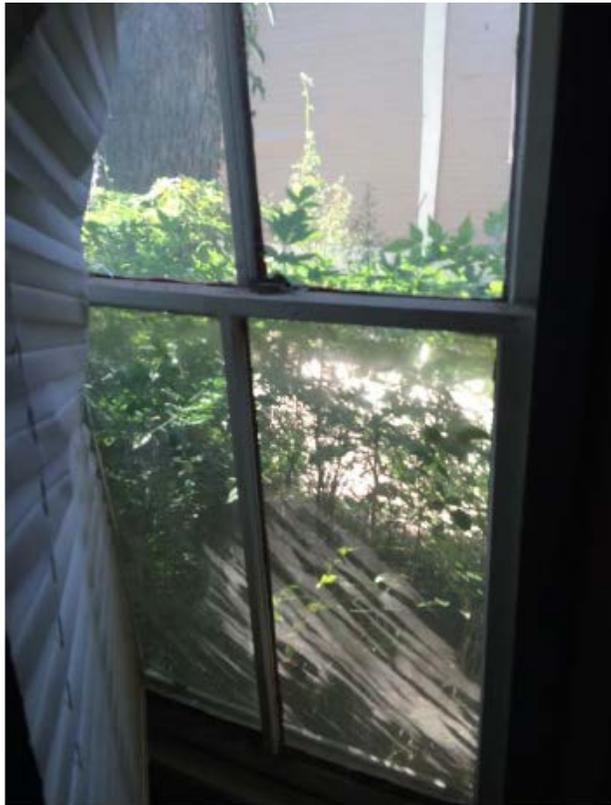
Window 4 – damaged by A/C unit

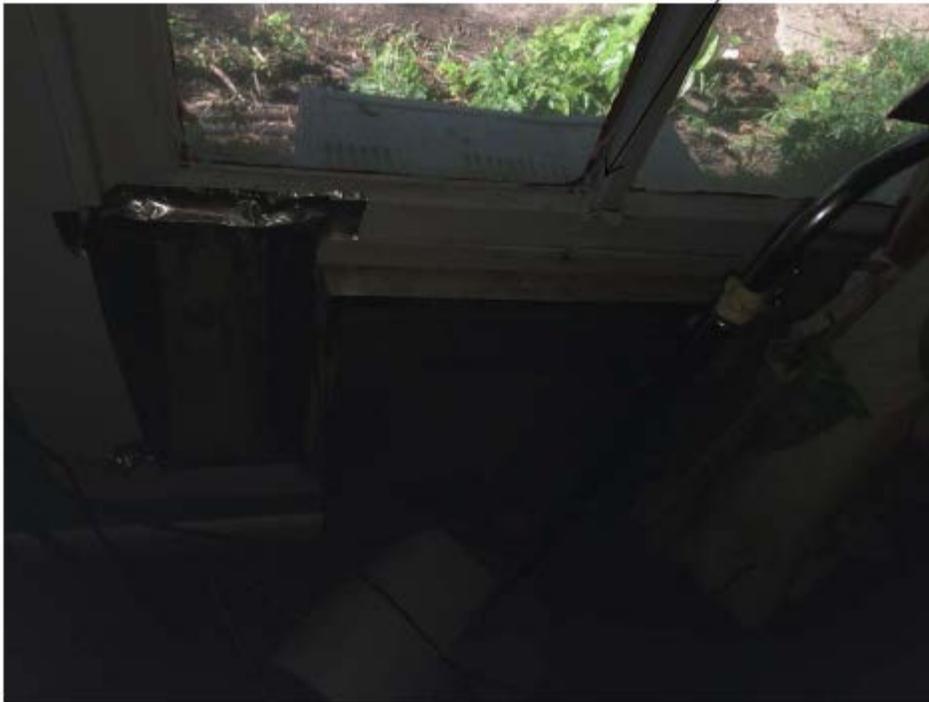
Window 16

rotting wood

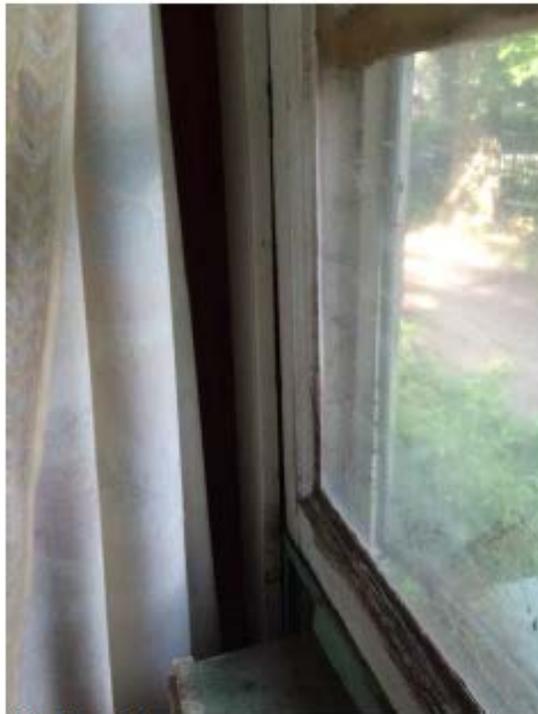
Window 13

mold & rotten wood
