**CERTIFICATE OF APPROPRIATENESS**

**Property:** 939 Harvard Street, Lot 3, Block 230, Houston Heights Subdivision. The property includes a historic 704 square foot, two-story wood frame garage apartment situated on a 6,600 square foot (50' x 132') interior lot.

**Proposal:** Demolition – Demolish a contributing garage apartment structure

**STRUCTURAL INSPECTION REPORT**

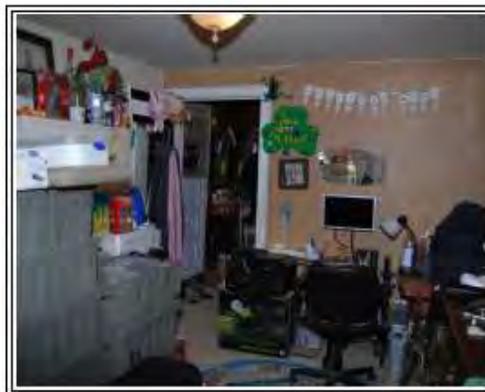
First Floor Living Area

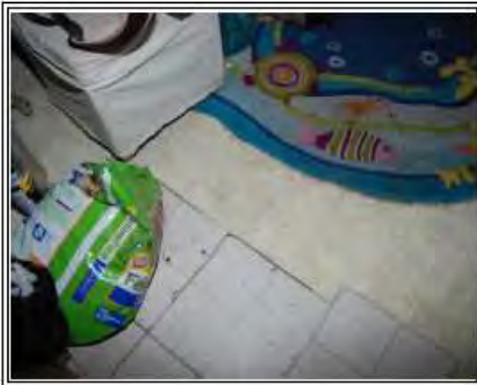
Flooring Over Concrete

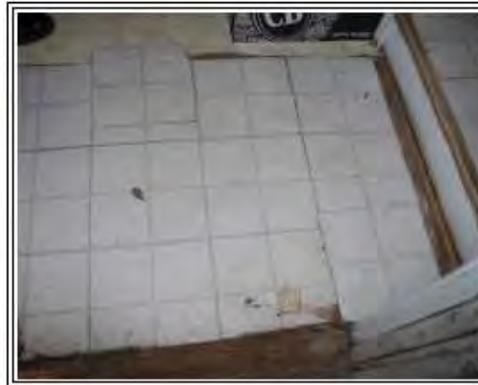
Flooring Over Concrete
