**CERTIFICATE OF APPROPRIATENESS**

**Property:** 1918-1920 Hickory Street, Lot 7, Block 268, Baker NSBB Subdivision. The property includes a historic wood frame landmarked church structure and attached parsonage building for a total of 1,798 square feet, situated on a 5,000 square foot (50' x 100') corner lot.  
Total church owned property encompasses 15,000 square feet and is comprised of Lots 5, 6, and 7, Block 268, Baker NSBB Subdivision. See survey for more detail.

**Proposal:** Demolition – Demolish the City Landmarked Mallalieu United Methodist Church and attached parsonage building.  
See enclosed application materials and detailed project description on p. 4-47 for further details.

*Arsenal Inspection Services*  
Property Inspection Report

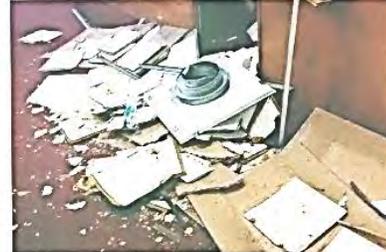
Fallen debris from collapsed ceiling - An

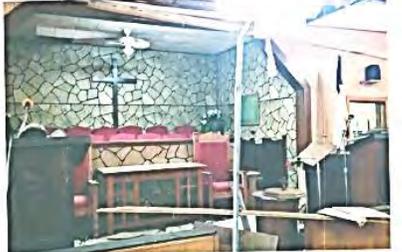
Another view of present area with  
debris

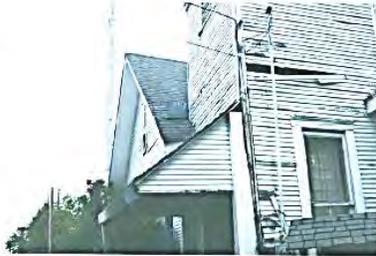
4. Close  
up  
of  
the  
roof

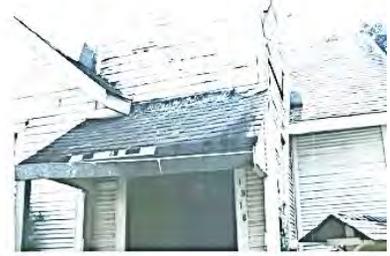
5. Roof  
view  
to  
be  
restored

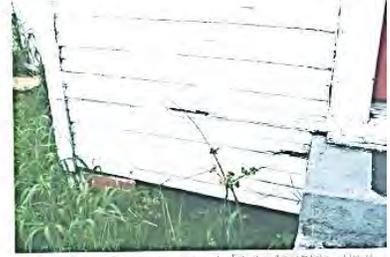
8. Front  
side  
of  
church  
to  
be  
restored

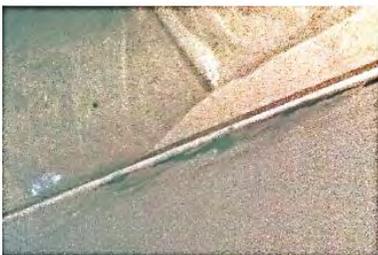
Areas to be mold remediation

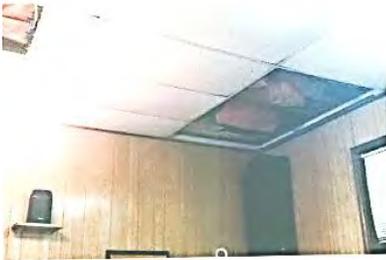
removing tiles on back side inside Church

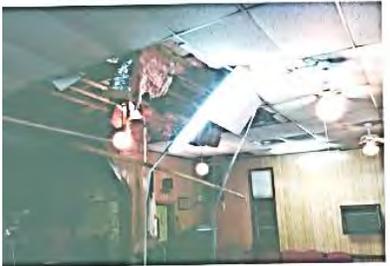
View of ceiling in front of church

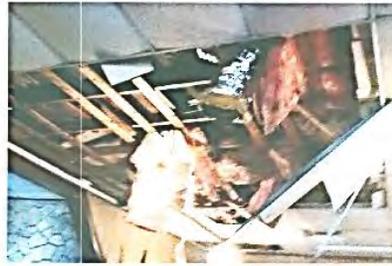
View of ceiling in front of church (Close up)

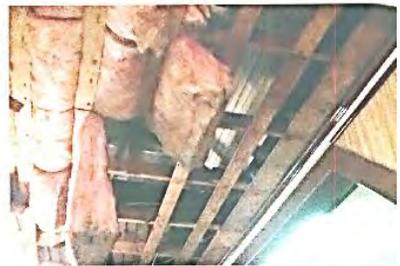
View of ceiling in front of church (Close up)

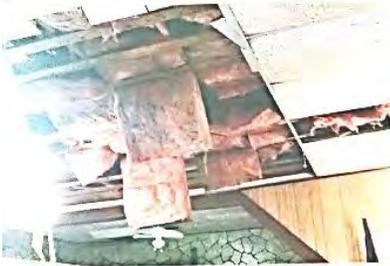
View of ceiling in front of church

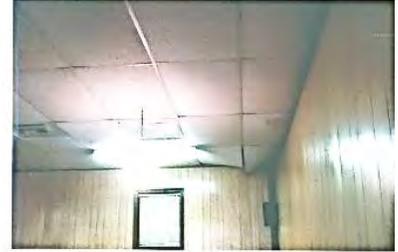
WOOD PANELING IN CHURCH SANCTUARY (SEE PHOTO)

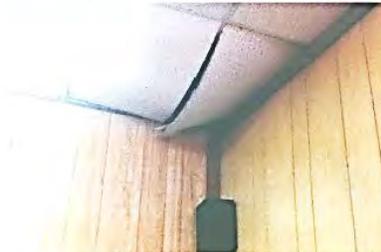
WOOD PANELING IN CHURCH SANCTUARY (SEE PHOTO)

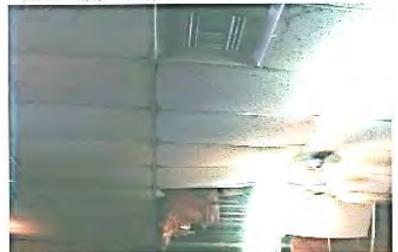
WOOD PANELING IN CHURCH SANCTUARY (SEE PHOTO)

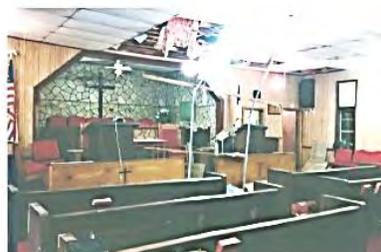
WOOD PANELING IN CHURCH SANCTUARY (SEE PHOTO)

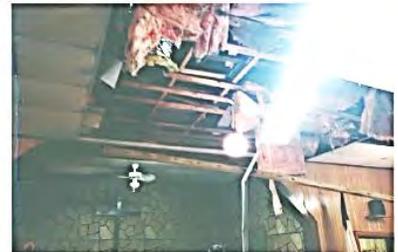
WOOD PANELING IN CHURCH SANCTUARY (SEE PHOTO)

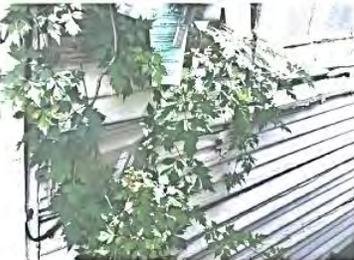
Close up picture - Back of Church

- Complete structural framing repairs, floor, wall, ceiling, and roof.
- Remove rotten base plates, and studs due to water damage to exterior wall. Install new base plates, and add sister studs to the existing studs to complete repair of entire exterior.
- Replace all floor joist.
- Replace all floor decking.
- Replace all structural studs, plates, and joist.
- Install new hardie siding through out exterior.
- Install all new Windows, and doors to match.

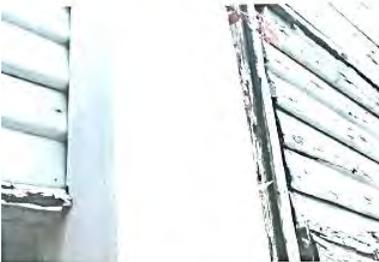
what appears to be separation of the outside walls - on side of Church -

**Structural Report:** Structurally, the major issues with the existing buildings may be focused on the foundation. The foundation piers have shifted, leading to significant movement and damage to the walls of the exterior and interior of the structure. The property inspection report notes that the foundation does not appear to be performing as intended and recommends contacting a structural engineer. In addition to the foundation issues, portions of the building's protective envelope have been compromised or lost, which has left the structure open to the elements resulting in water infiltration and deterioration, including cracked walls, uneven floors, and mold growth. Much of this may have been caused by deferred maintenance. See Property Inspection Report (*Attachment C*) for more detail.
